Victorian Desalination Project | Independent Reviewer & Environmental Auditor

IR&EA REPORT

COMPLIANCE WITH ENVIRONMENTAL PERFORMANCE
REQUIREMENTS QUARTER 1 2010

QUARTERLY REPORT TO THE MINISTER FOR ENVIRONMENT AND
CLIMATE CHANGE

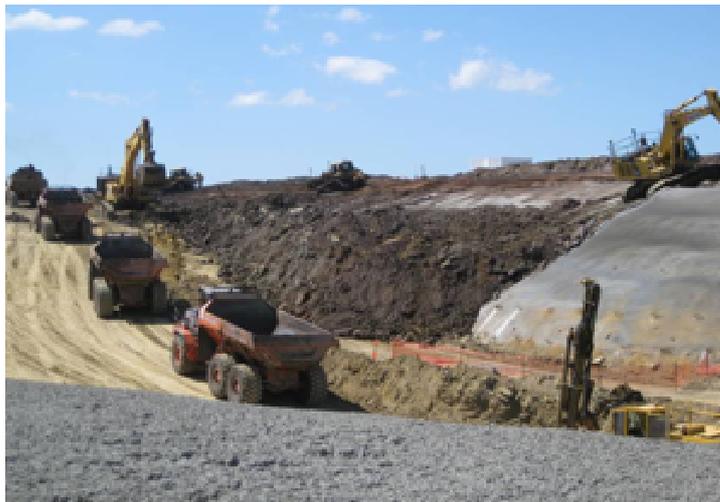
Figure 2. Box cut excavation, February 2010

Works during January - March 2010 included site establishment activities, such as the construction of temporary construction roads and facilities (offices, storage areas etc), bulk earthworks to excavate the building footprints and the box cut, and installation of environmental monitoring equipment and environmental controls. Views of these construction activities are shown in Figures 2 and 3.

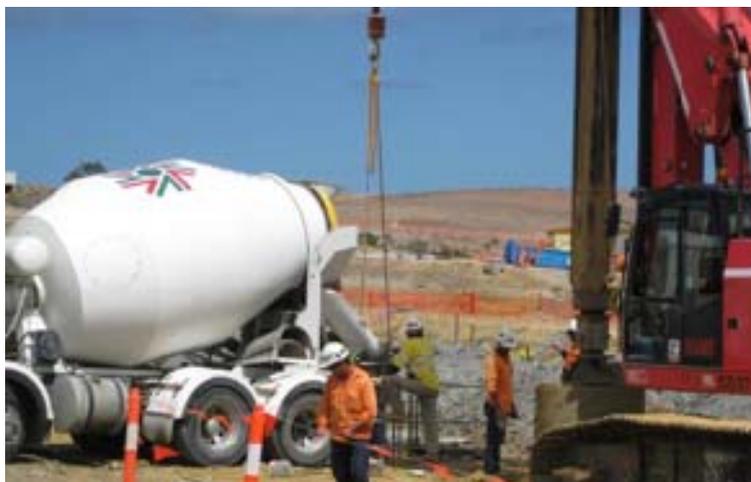
Figure 3. DMPF pad concrete pour, February 2010

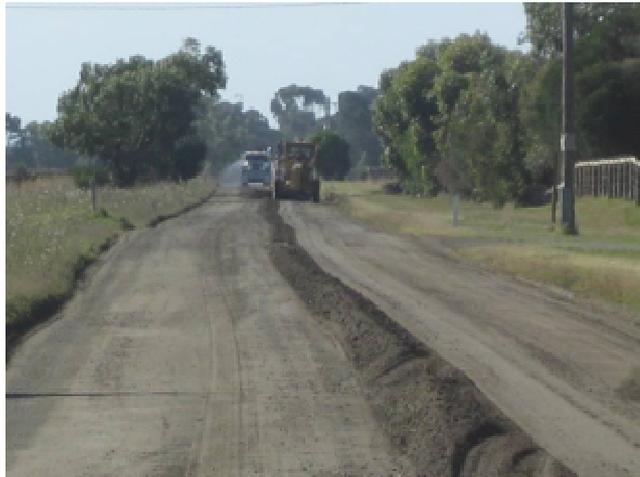
Figure 4. Grading the utilities corridor. January 2010.

Vegetation clearing, and construction of haul roads and Right of Ways (ROWs) continued along the utilities corridor. Trenching and pipe laying commenced in February 2010. Views of works in the utilities corridor are shown in Figures 4 and 5.

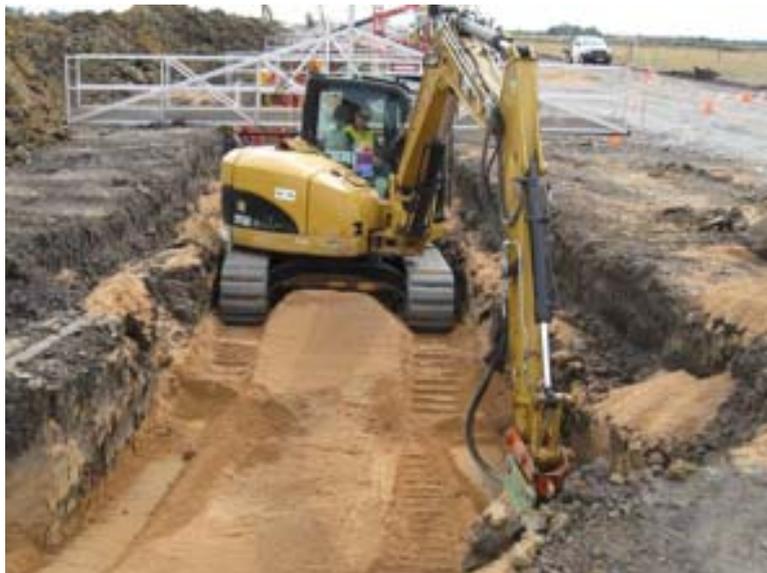
Figure 5. Placing bedding sand in pipe trench. March 2010.

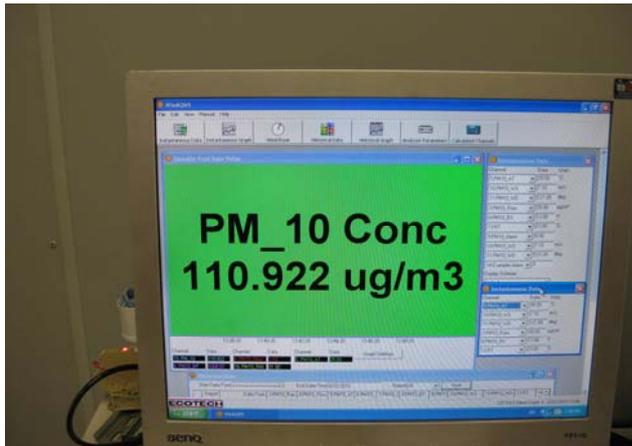
environmental monitoring and reporting requirements in the EMPs to ensure that appropriate monitoring as undertaken, and reported. A view of a real-time monitoring alert is shown in Figure 6.

Figure 6. On-line, real-time dust alert. Plant site February 2010.

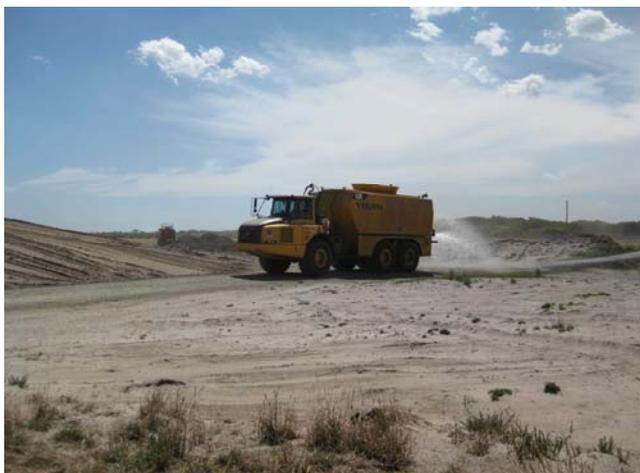
Views of dust control operations are shown in Figures 7 and 8.

Figure 7. Response to dust alert. Plant site February 2010.

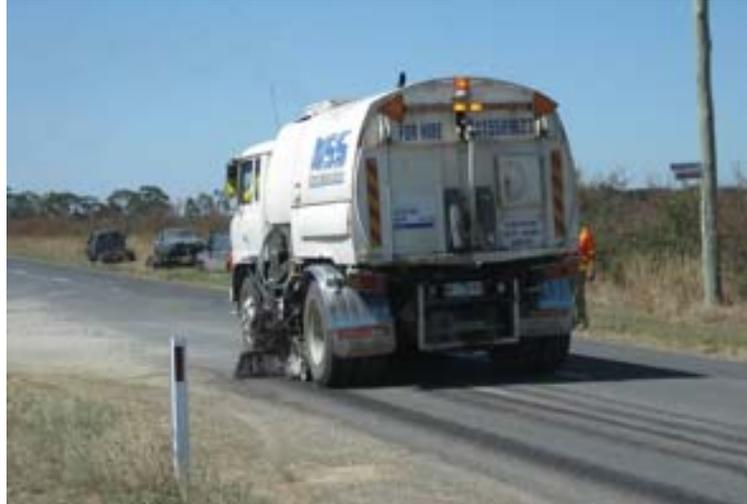
Figure 8. Road sweeper, utilities alignment, February 2010.

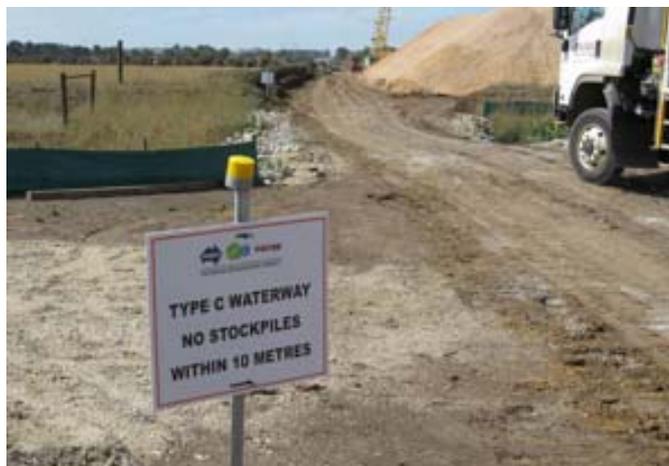
Figure 9. Waterway crossing, Utilities alignment, March 2010.

A view of signage installed at a waterway crossing in a utilities works area is shown in Figure 9.
