Achievement of environmental outcomes in Victoria's Murray-Darling Basin waterways

Summary report to the Murray-Darling Basin Authority to meet Basin Plan Schedule 12 Matter 8 obligations

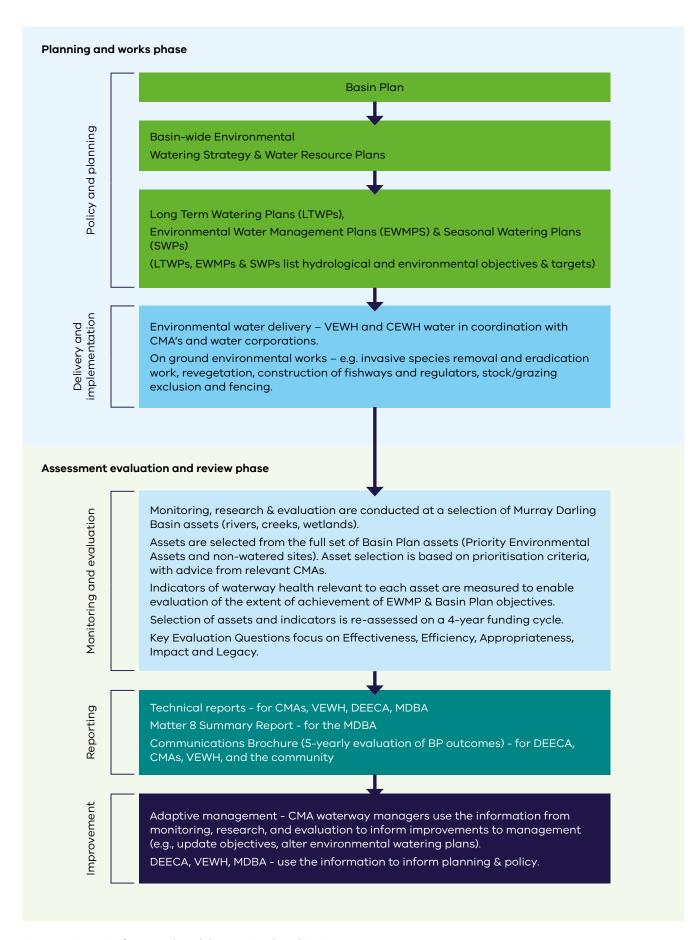
Figure 3. Victorian framework to deliver Basin Plan objectives.

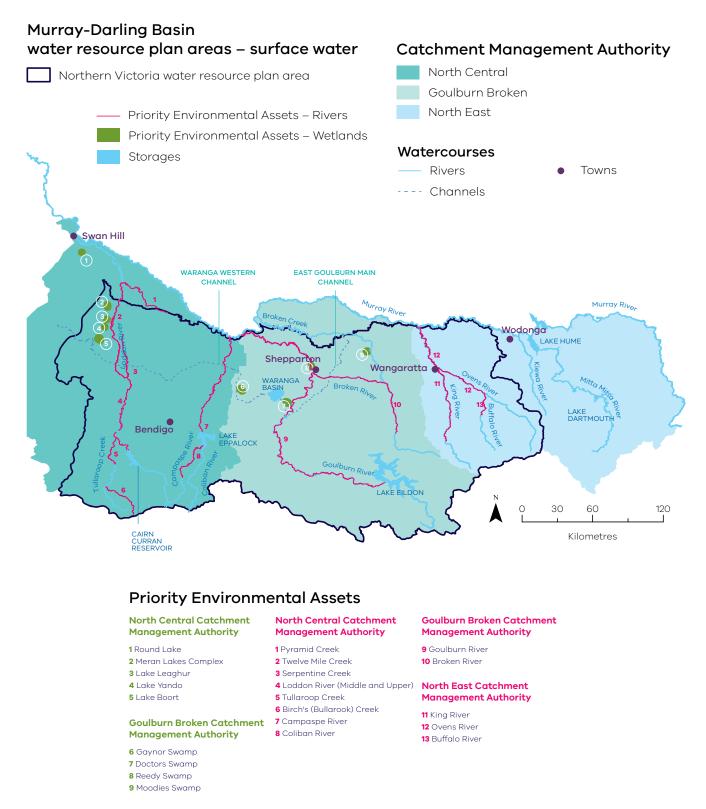
Figure 5. Priority environmental assets within the Northern Victorian WRP area (not all assets are monitored or assessed in this report).

The Northern Victoria WRP area (Figure 5) is dominated by northerly flowing river systems connected to the Murray River downstream of the junction with the Kiewa River. It includes the Ovens, Goulburn, Broken, Campaspe and Loddon Rivers,

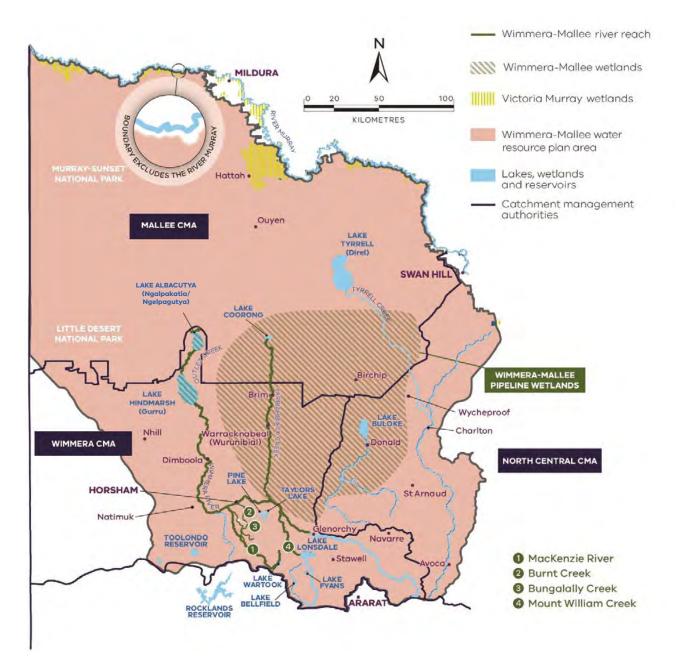
Figure 7. Priority environmental assets within the Wimmera-Mallee WRP area (note not all assets are monitored or reported on in this report).

The Wimmera-Mallee WRP area (Figure 7) is located in north-west Victoria. It extends from the Grampians (Gariwerd) and the Pyrenees Ranges in the south, to Ouyen and Kerang in the north, and it extends west to the South Australian border and east to meet the Northern Victoria WRP area. The Wimmera-Mallee WRP area is dominated by the Wimmera, Avon-Richardson and Avoca River systems. The three

waterway systems flow inland to the north, terminating in large lake systems. Major wetlands in the Wimmera-Mallee WRP area include Lake Albacutya and Lake Hindmarsh (terminal lakes of the Wimmera system), and the Wimmera Mallee Pipeline wetlands – a large collection of wetlands located east of the terminal lakes. Only a few waterways in the region can receive water for the environment.

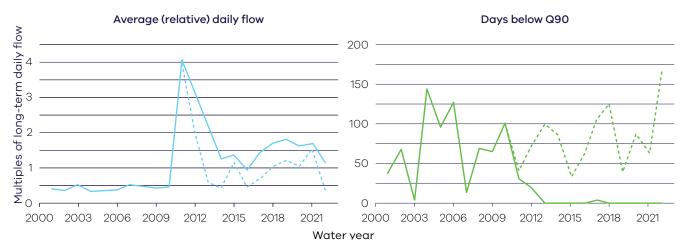
Figure 8. Flow in the lower Goulburn River from 2000 to 2023 showing flow with environmental water (solid line) and without (dotted line) (Tonkin et al. 2024). Note: Q90 is the discharge level that is exceeded 90% of the time. Flows below this level represent the driest 10% of days (hence Q90 is used to represent low flow).

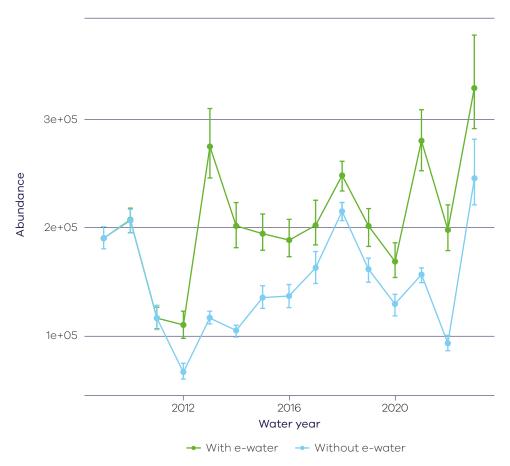
Figure 9. Modelled Murray Cod population abundances in the lower Goulburn River with environmental water and under a counterfactual scenario in which no environmental water was delivered. Points display median values and bars bound 90% credible intervals. All modelled values are subject to uncertainty (Tonkin et al. 2024).

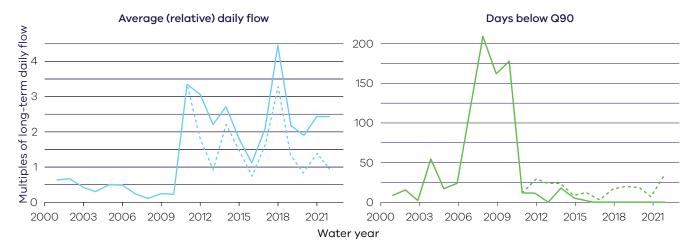
Figure 10. Flow (left) and number of low flow days (right) in the Campaspe River 2000 to 2023 showing with environmental water (solid line) and without (dotted line) (Tonkin et al. 2024).

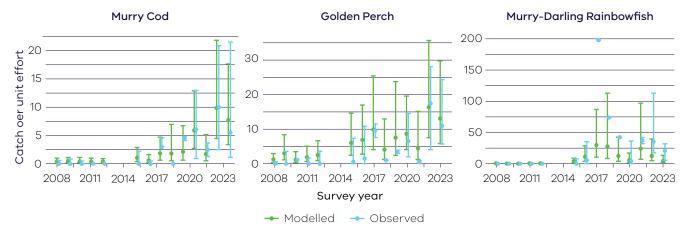
Figure 11. Observed (blue) and modelled (green) estimates of catch-per-unit-effort for three fish species in the Campaspe River (reaches 2–4) from 2008 to 2023. Points are median values and bars bound 10th and 90th percentiles (80% credible intervals) (Tonkin et al. 2024).

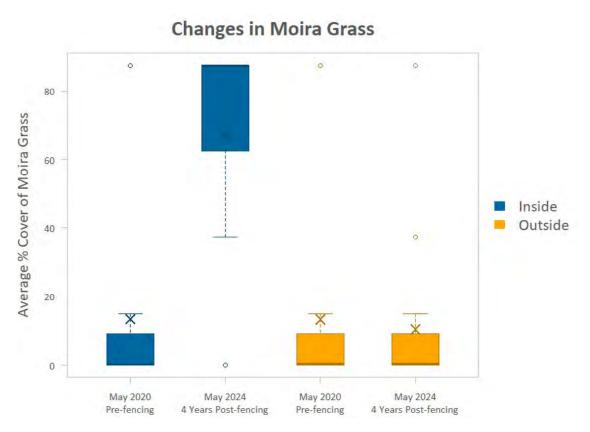
Figure 12. Summary of the change in cover of Moira grass inside and outside the grazing exclosures between May 2020 and May 2024 (Water Technology 2024).

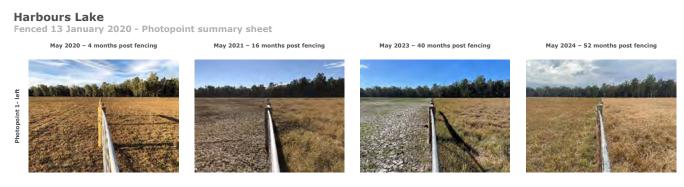
Figure 13. Photo-point monitoring at Harbours lake. Left of fence = grazing, right of fence = grazing excluded (Water Technology 2024).

by the use of fence corner photo points which show a substantial increase in plant biomass inside the exclosures compared with outside over the study (Figure 13).

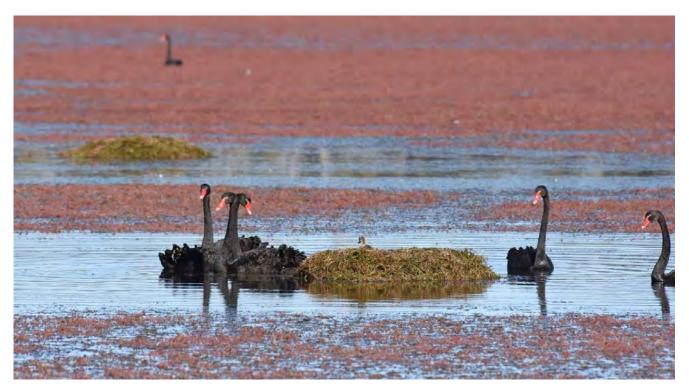
Figure 14. Black swans and swan nest with one cygnet at Lake Kramen in Hattah-Kulkyne National Park, 2021.

In autumn 2021, Mallee CMA project officers observed black swans nesting at the lake and noted the aquatic vegetation present was providing abundant feeding habitat and nest-building materials (Figure 14). Monitoring in June 2021 indicated at least 45 active swan nests and over 2,200 birds were identified, with hatching in many nests commencing at that time (GHD 2021). Black swan fledging is known to take 150–170 days from hatching and it is vital that inundation is maintained to provide suitable foraging and predator-free habitat to support successful recruitment. Given this, Mallee CMA worked collaboratively with Parks Victoria and VEWH to monitor the situation and deliver water when required to maintain water depths at a minimum of 0.5-1.0 m in Lake Kramen to support fledging.

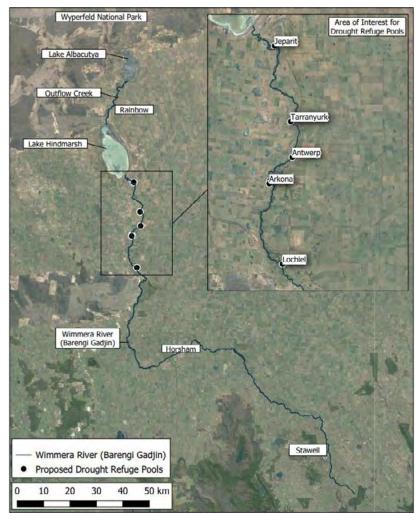
Figure 15. Wimmera River (Barengi Gadjin) showing the location of major drought refuge waterholes in the lower reaches (Houghton et al. 2021).

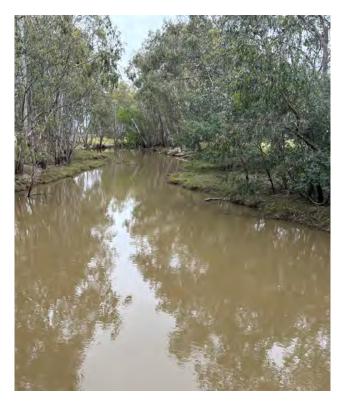
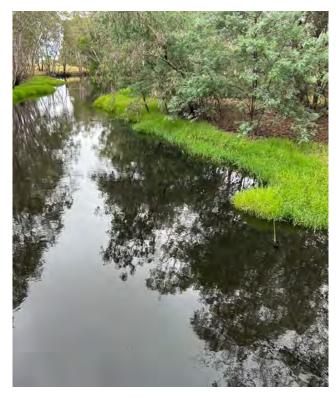
Figure 17. Broken Creek at Larissa Road on January 3 2024, with dissolved oxygen levels approximately 5 mg/L (left) and on January 6 2024 with obvious blackwater and dissolved oxygen levels of 1.5 mg/L (right) (source GB CMA).

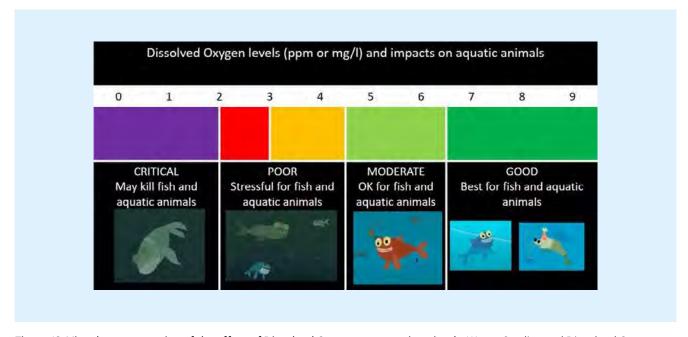
Figure 18. Visual representation of the effect of Dissolved Oxygen on aquatic animals. <u>Water Quality and Dissolved Oxygen – GB CMA – Goulburn Broken CMA</u>.

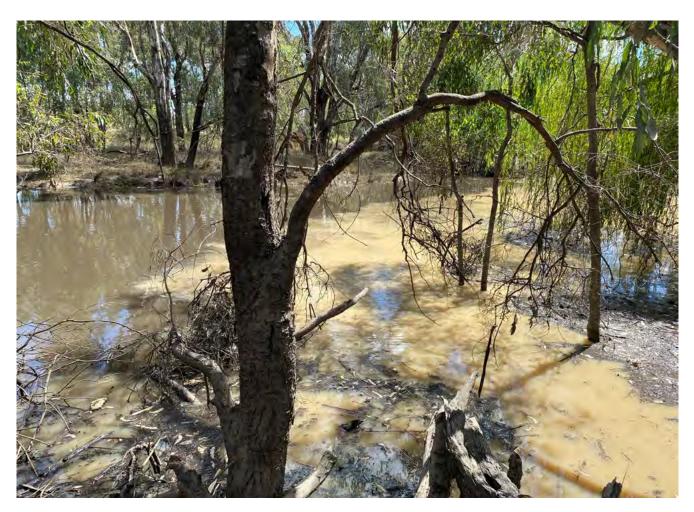
Figure 19. Irrigation outfalls into Seven Creeks in water backed up from the Goulburn River at Shepparton on the 16 January 2024 (source GB CMA).

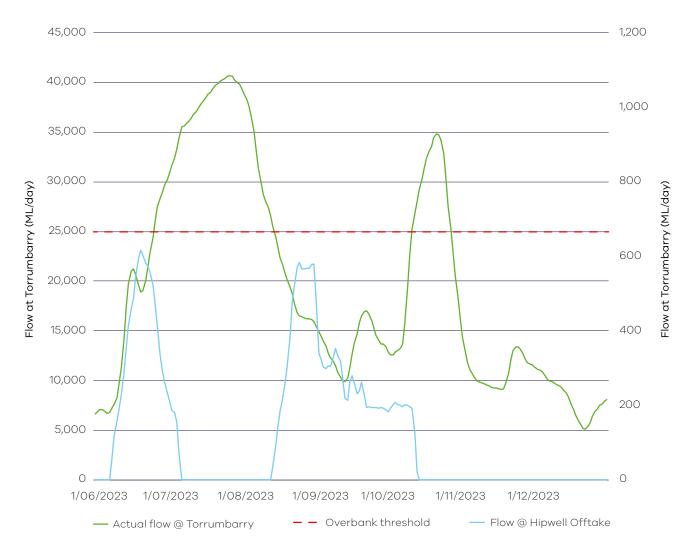
Figure 21. Flow rates at Hipwell Channel offtake compared with the Murray River at Torrumbarry Weir 2023-24. The dashed line denotes the approximate overbank threshold of 25,000 ML/d downstream of Torrumbarry Weir (Source: GMW 2024, MDBA 2024a)

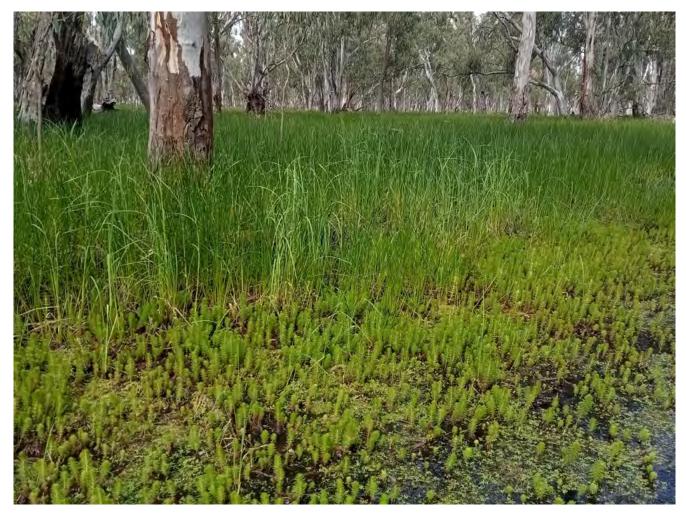
Figure 22: Vegetation response along Nursery Track in September 2023. Aquatics include water milfoil and starwort, with amphibious species such as swamp wallaby grass, blown grass and spike rush in shallower areas. (Photo: NCCMA)

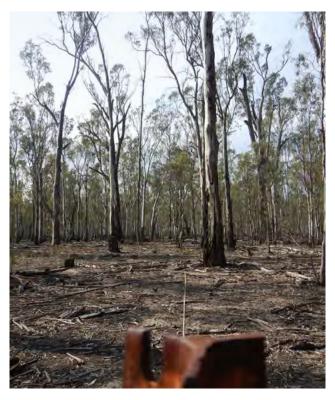
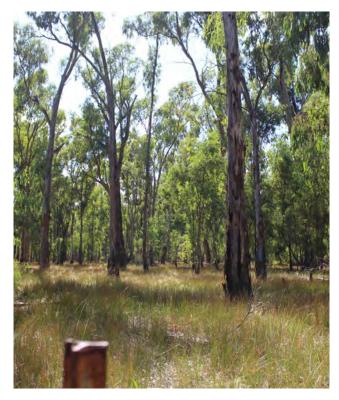
Figure 23. Canopy and understorey condition in Gunbower Forest in March 2022 (left) prior to the natural flooding showing minimal understorey and thinning red gum canopies compared to December 2023 (right) following two years of consecutive flooding created by both unregulated flows and water for the environment. (Photos: NCCMA).
