# Burra Environmental Water Management Plan

Sunraysia Environmental (2015) *Burra Environmental Water Management Plan*, Mildura: Report for the Mallee Catchment Management Authority.

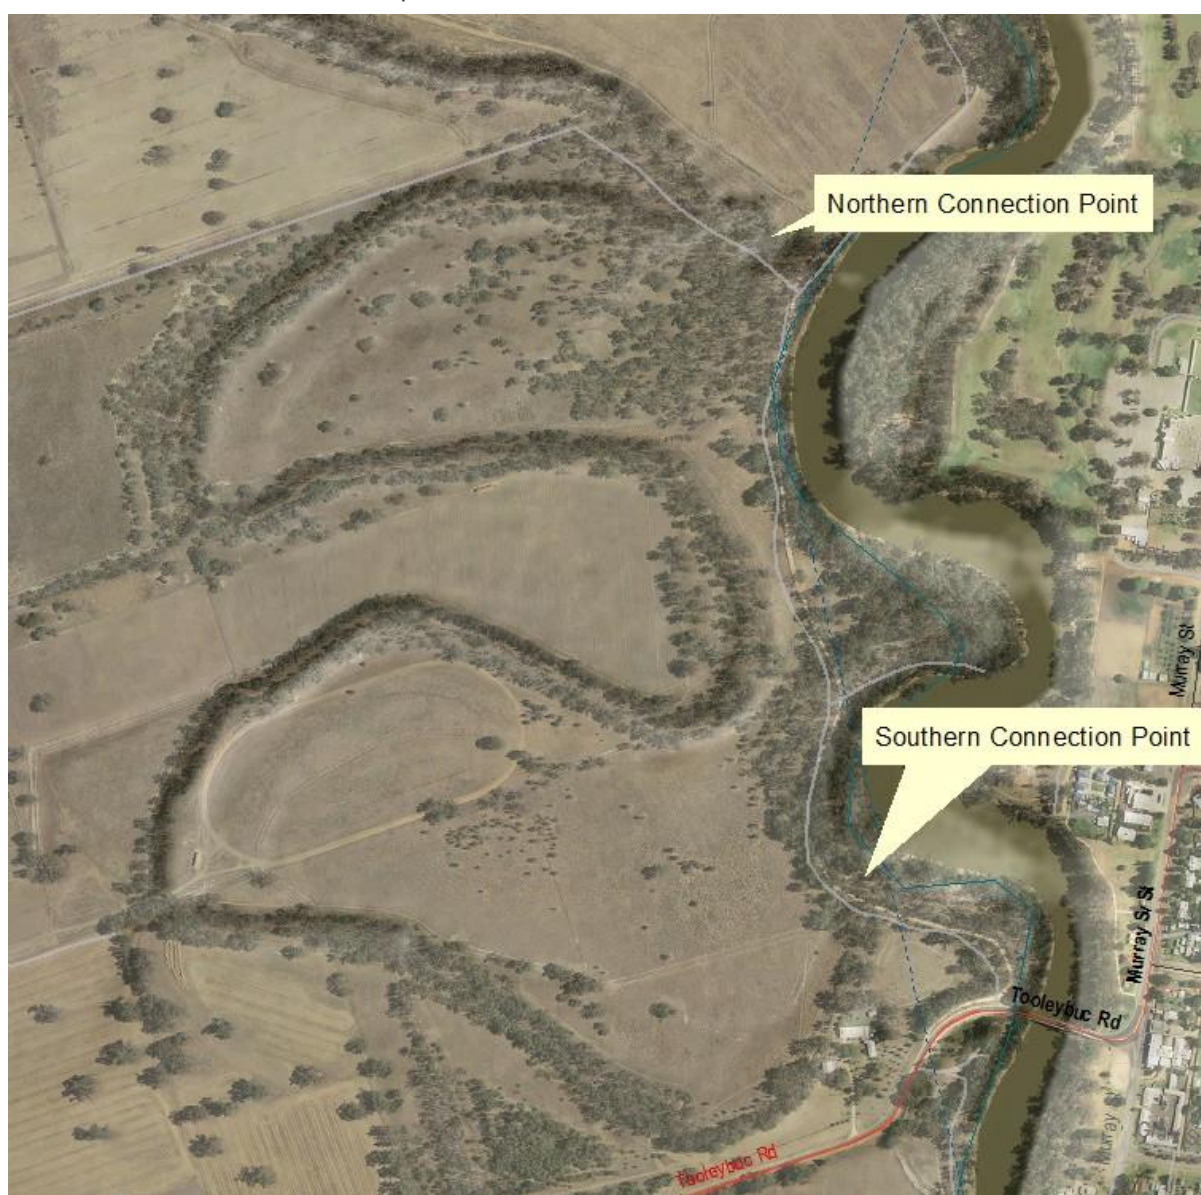
Figure 4 - Southern and northern connection points for Burra Creek South Proper

The southernmost section of Burra Creek, known as Burra Creek South Proper was once connected to the Murray River at two connection points (Figure 4). Since European settlement the original southern connection point of the creek has been 'lost'. The northern connection point has been impeded by a road crossing, Connection Point C (Figure 3).

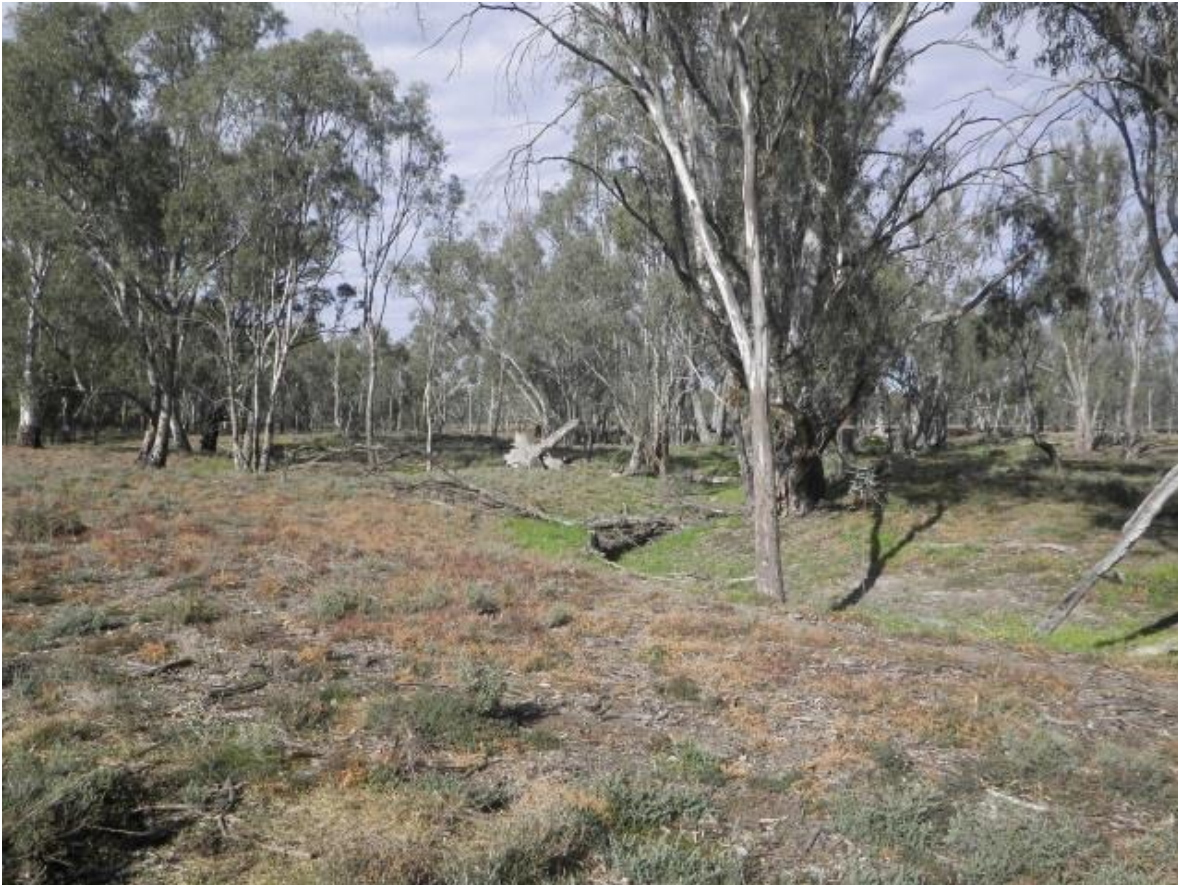
Figure 5 - Burra Creek through Burra Creek South Proper

Burra Creek South Proper is a shallow and wide creek bed (Figure 5) approximately 3 km in length. Burra Creek South Proper is dominated by Lignum Swamp and Lignum Swampy Woodland vegetation communities. Tangled Lignum, provides valuable habitat for waterbirds, fish and macro-invertebrates, and can be an important feeding area for raptors, owls and predatory reptiles (Ecological Associates, 2007).

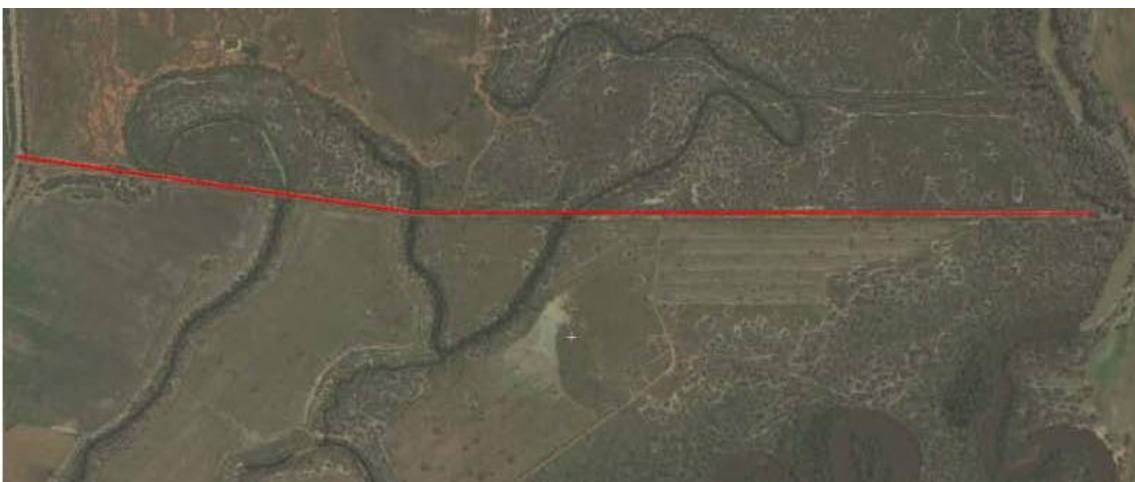
Figure 6 - Irrigation channel crossing Burra Creek

Burra Creek South is a stretch of creek line measuring approximately 27 km in length. It commences as a narrow (5 m) and relatively deep (3 m) channel, and changes into a wider (17 m) and flatter (2 m deep) channel by the time it reaches an impediment upstream of the irrigation channel (Figure 6). Burra Creek South is connected to the Murray River at the southern end of Burra Creek South (~1319), Connection point C and at another site around river km 1307.5, Connection Point B (Figure 3). Burra Creek South and Burra Creek North are physically separated by a large irrigation channel (Figure 6 and Figure 7).

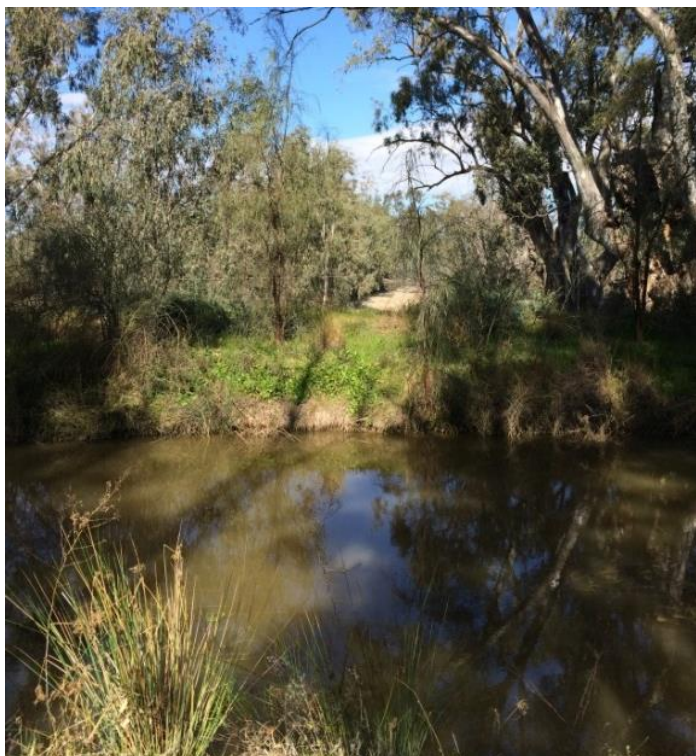
**Figure 7 - The irrigation channel (foreground) that separates Burra Creek North and South, crossing Burra Creek (background).**

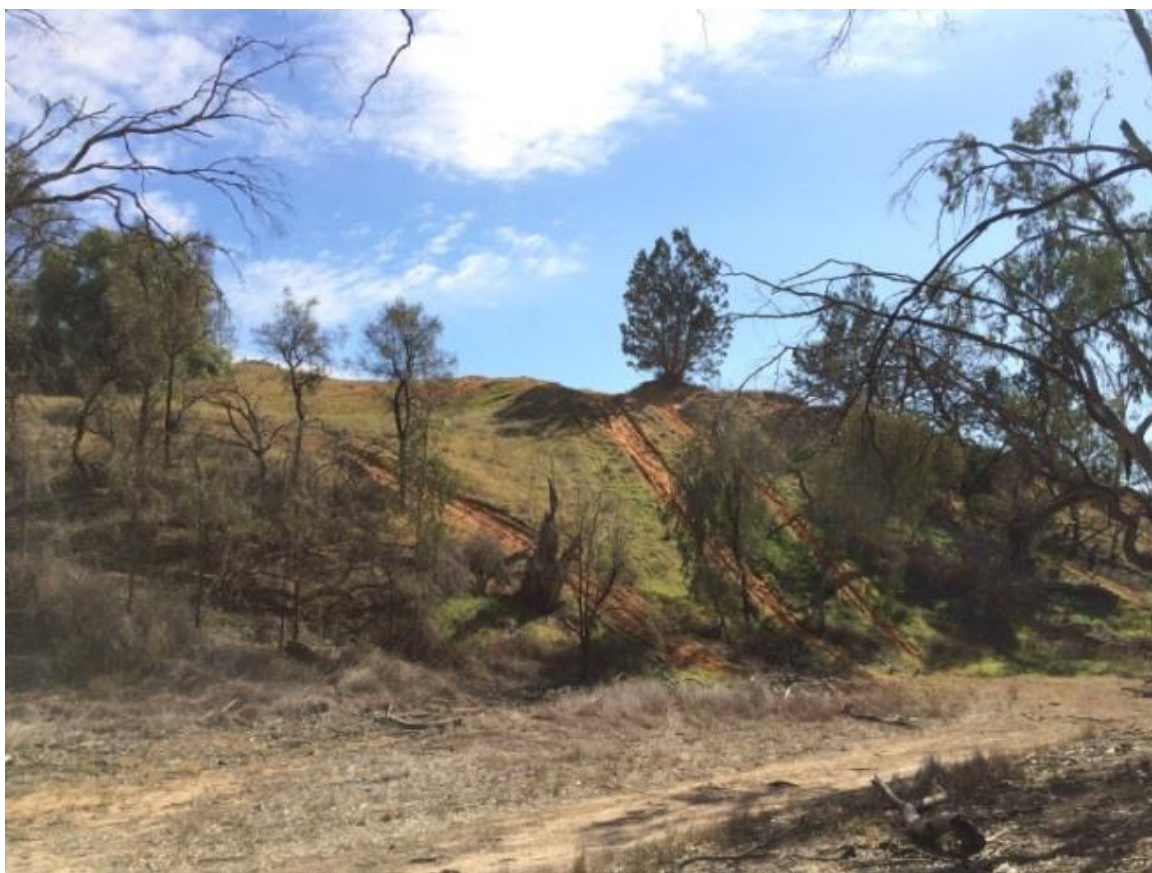
**Figure 15 - An area of semi-arid woodland on a sand dune adjacent to the creek (Deadmans Hill). The creek bed is shown in the foreground. Erosion and loss of native vegetation on Deadmans Hill from motorbike activity is notable.**

- Semi-arid Chenopod Woodland occurs alongside Burra Creek, near Impediment Site 5. At this location, the eastern bank of the creek is formed by a sand dune, which is likely to be of very high Aboriginal Cultural Heritage significance. It is subject to disturbance by recreational motorbikes (Figure 15), with several tracks crossing both the dune and the creek bed.
- Semi-arid Woodland occurs adjacent to Burra Creek at Impediment Site 1 (where road raising has been conducted to retain water within the creek).

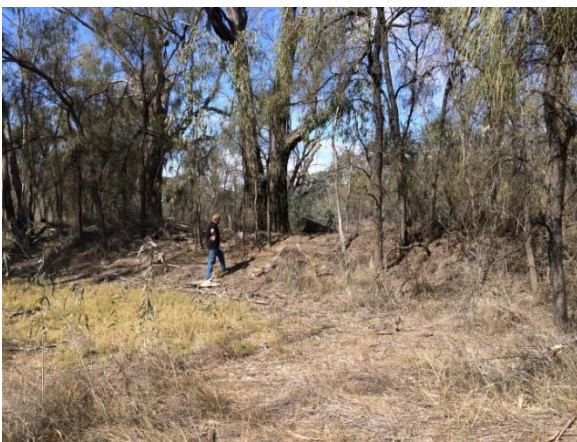
**Figure 17 - Levee across Burra Creek at Impediment Site 5**

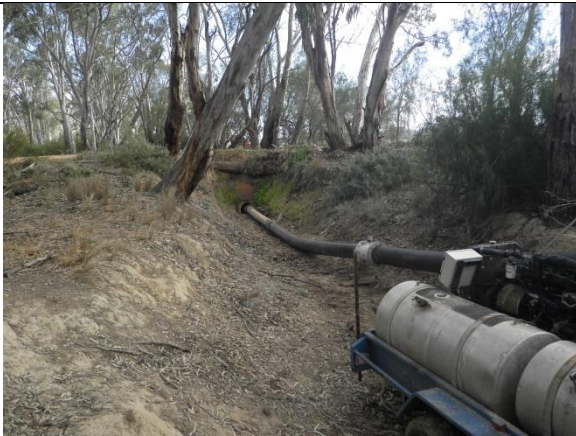
Pump Site C, showing temporary pump in foreground and pipe through Impediment 22. This is also River Connection Point C, looking away from river.

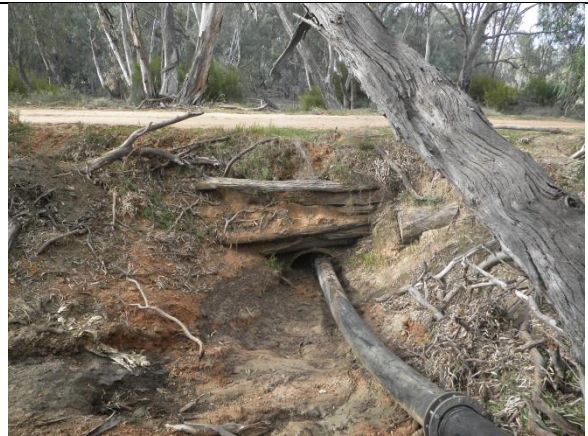
The downstream side of Impediment 22, looking back towards river, (visible in the background).

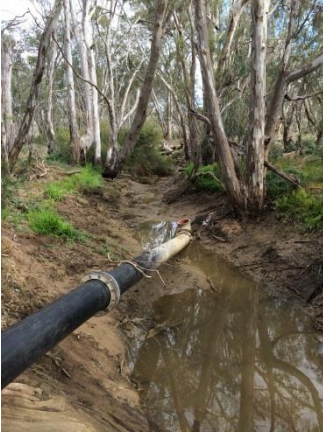
The outlet to the pump at Pump Site C, (downstream of Impediment 22) showing recession of water; pumping can soon recommence.

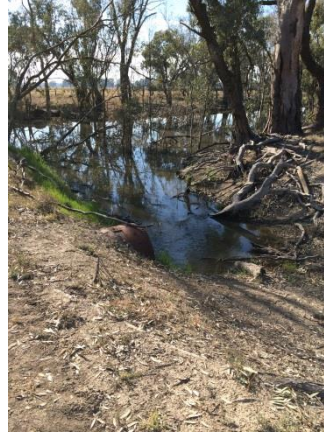
Impediment 19 (left of image) is an access track used by a private landholder. Pipe culvert and altered creek course is shown in the foreground.

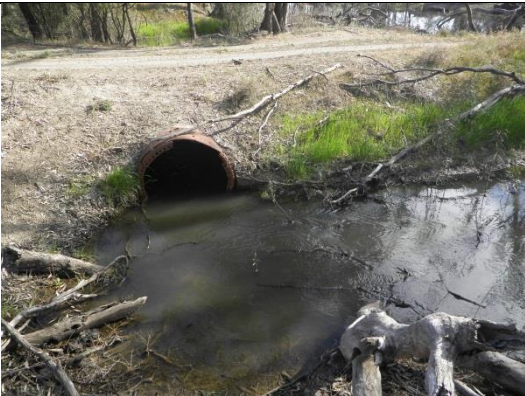
The culvert at Impediment 19, looking downstream.

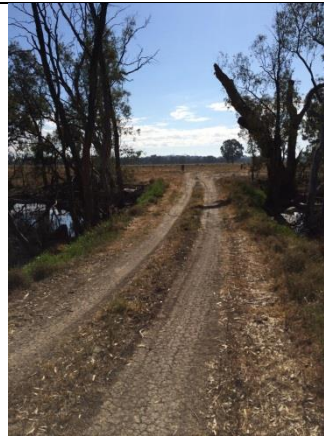
The private access track that forms Impediment 19).

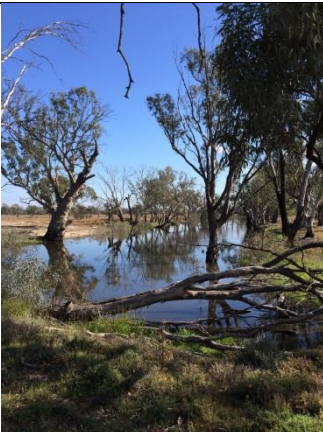
Impediment 18. Fallen timber often accumulates at the upstream entrance to culverts. In this image, on the left bank of the creek, intensive disturbance is evident from agricultural uses.

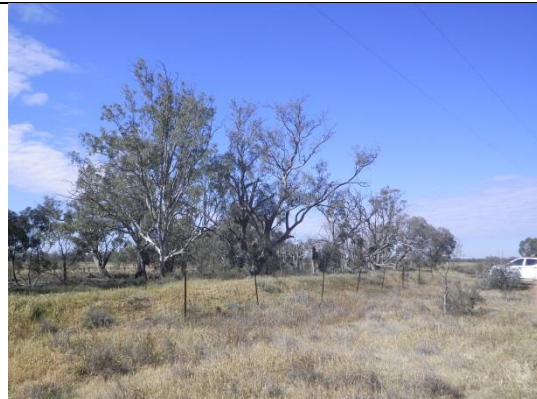
A levee has been constructed in places along the creek line, presumably to prevent inundation of private land, but also reducing rainfall runoff to the creek. Tree canopy health is noticeably poor, but regenerating.

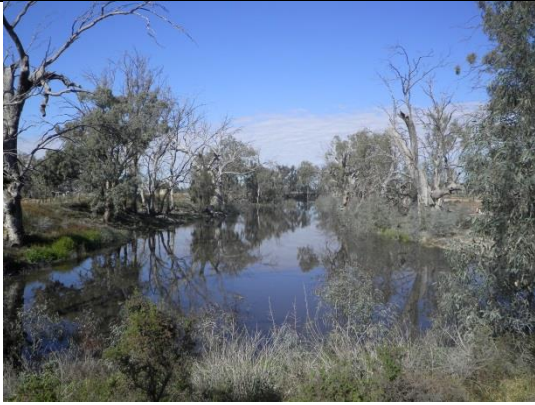
This image captured from an access track that crosses the creek at Impediment 18, vegetation growing on the edges of this track can be seen in the foreground.

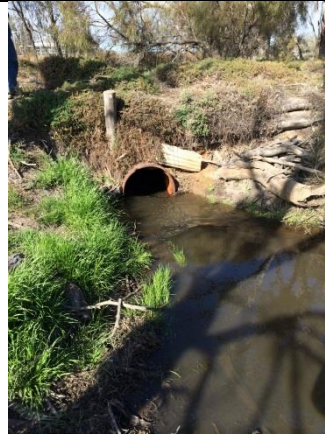
The culvert at Impediment 18, again diverting the creek flow to just outside the natural bank. Fast-flowing water can be seen entering the pipe, and evidence of logs removed from the entrance on right of picture.

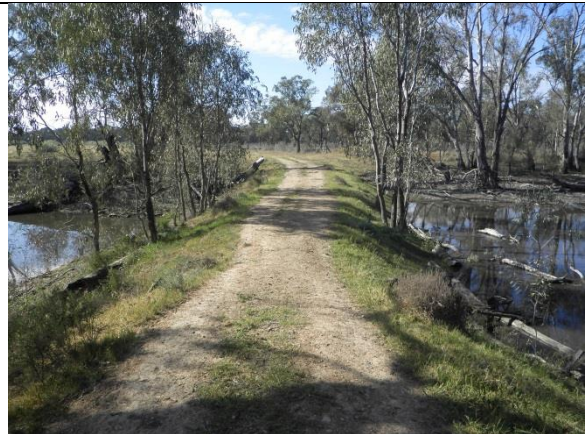
The private access track at Impediment 16. Note the difference in water levels from upstream (right) to downstream via the culvert (left).

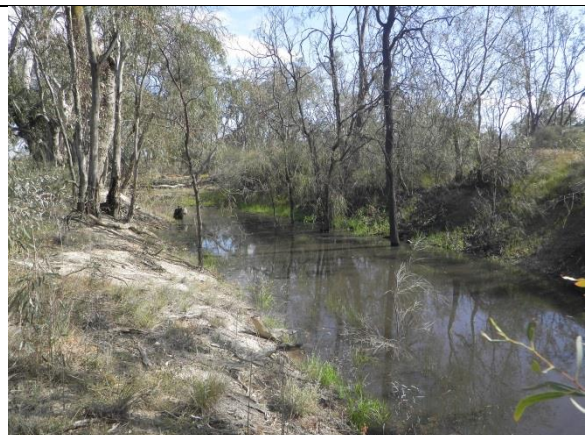
A narrow cutting has been excavated around Impediment 17. The impediment at this location is no longer serves any obvious purpose.

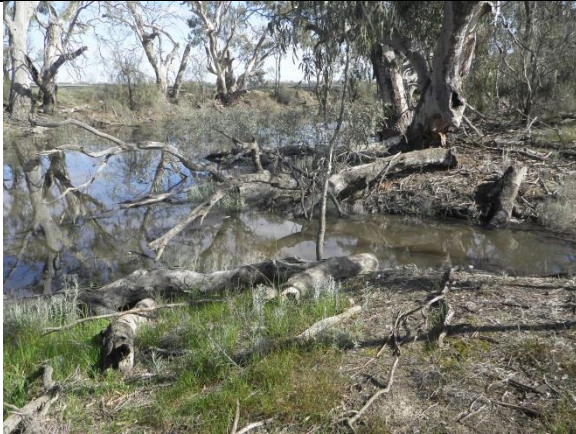
The downstream cutting exit to the creek at Impediment 17. Note the fallen timber at this point, which, if allowed to accumulate would further impede flow.

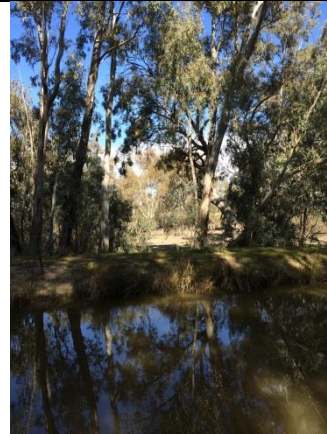
A large irrigation channel (foreground) crosses the creek (dry, in the background) at three locations. This site is Impediment 9.

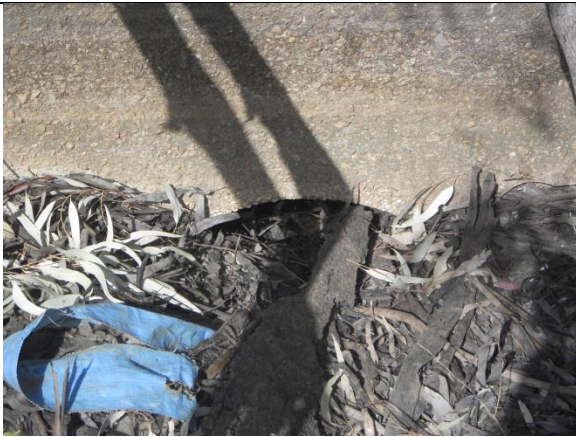
The downstream side of the pipe culvert at Impediment 9 under the channel. The culvert is of comparatively good size (~900 mm diameter), however a large volume of debris almost completely blocks flow.

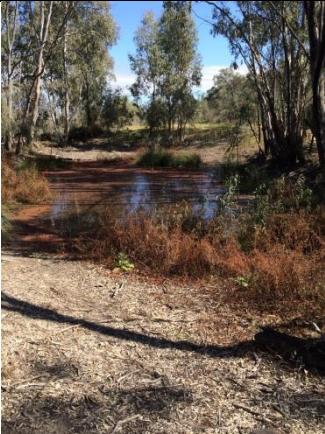
At Impediment 7, the irrigation channel enters a pipe and flows under the creek bed, reemerging once more into open channel. There is evidence of a leak in this wetland shown.

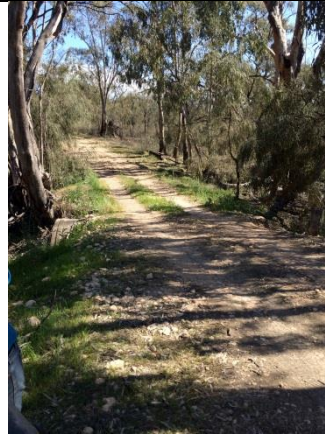
The roadway at Impediment 7 crossing the creek line. The pipe culvert is visible left of picture.

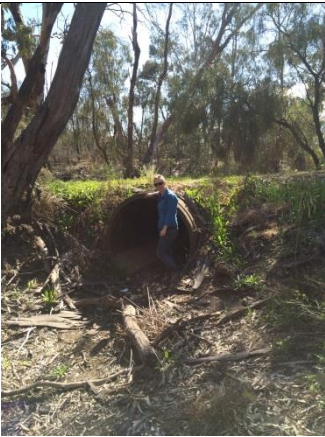
At Impediment 7, the road parallel to the channel and pipeline crosses the creek, with a large culvert enabling passage of creek water.

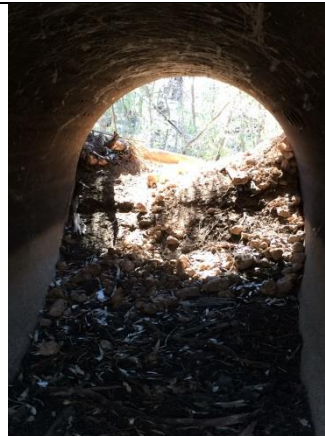
The downstream end of the culvert at Impediment 7, however, is partially blocked by soil and rubble.

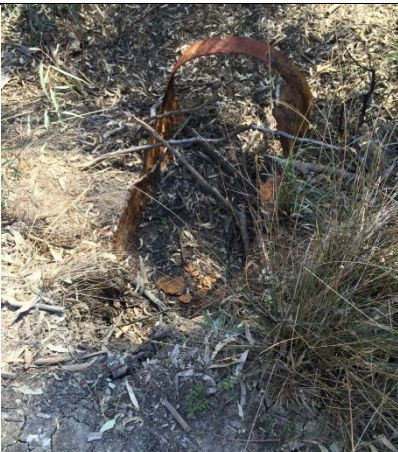
The aged pipe culvert at Impediment 6 is in worrying need of attention.

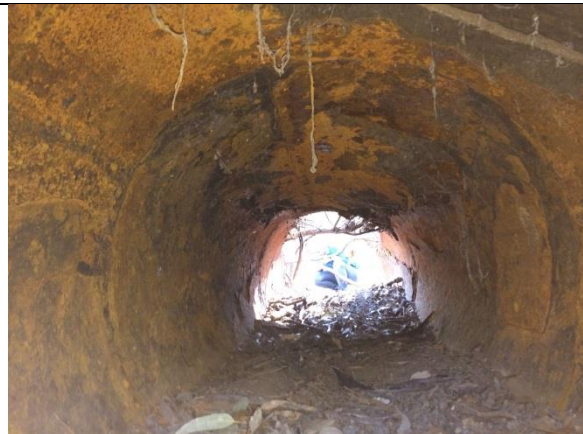
An internal view of the pipe culvert at Impediment 6.

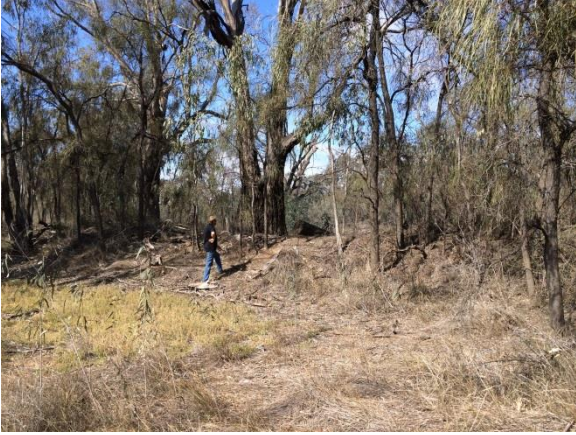
Impediment 5 is a long levee completely crossing the creek bed. A narrow cutting and culvert has been constructed to the east of this levee.

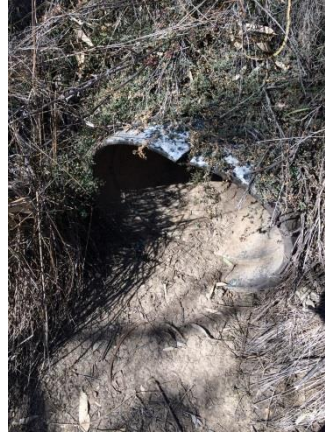
The ~600 mm diameter pipe culvert at the cutting at Impediment 5. This view is the downstream end.

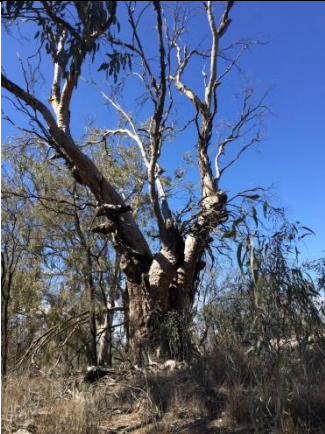
Impediment 5. Several large old River Red Gums have suffered dramatically in the past, however regeneration of saplings has occurred in recent years.

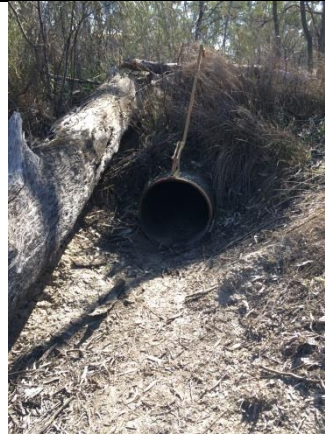
The upstream end of the pipe culvert at the cutting at Impediment 5. Evidence exists of past ability to close off the culvert.

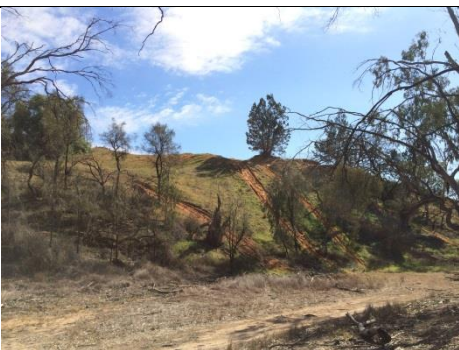
The sand dune immediately downstream of Impediment 5. Note significant disturbance by motorbike access.

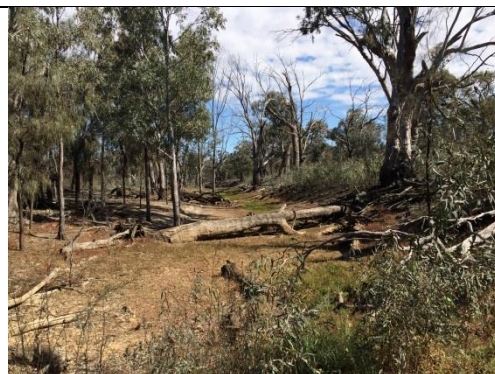
Upstream of Impediment 1, showing dead trees and healthy regeneration.

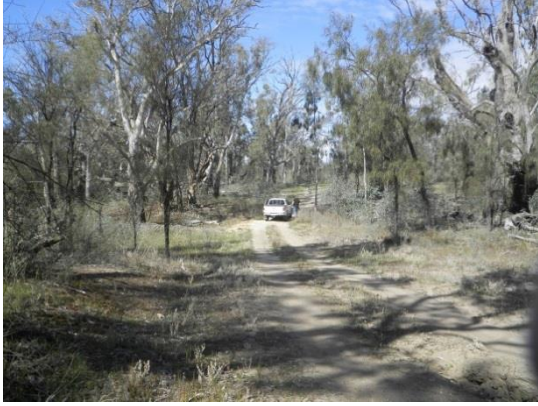
The low bank constructed at Impediment 1 traverses the creek bed and enables water to be held in the creek rather than returning to the Murray River.

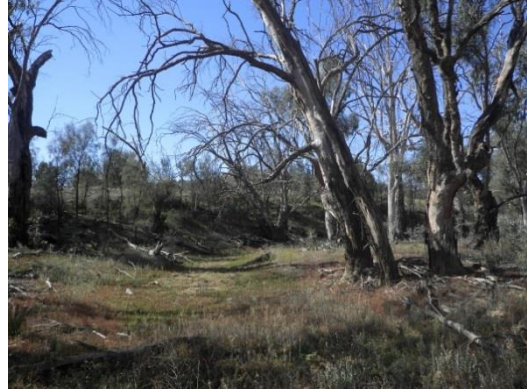
Downstream of Impediment 1, with sand dune in background, and several dead River Red Gums in middle distance.

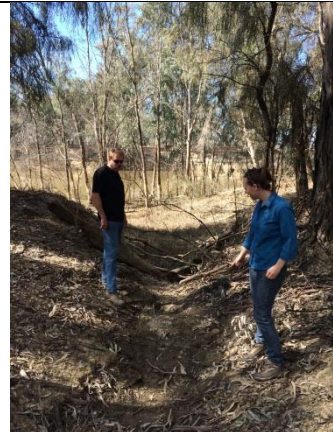
The downstream Connection Point A for Burra Creek and the Murray River (shown in background).
