Victorian Desalination Project | Independent Reviewer & Environmental Auditor

IR&EA REPORT

COMPLIANCE WITH ENVIRONMENTAL PERFORMANCE
REQUIREMENTS QUARTER 2 2011

QUARTERLY REPORT TO THE MINISTER FOR ENVIRONMENT AND
CLIMATE CHANGE

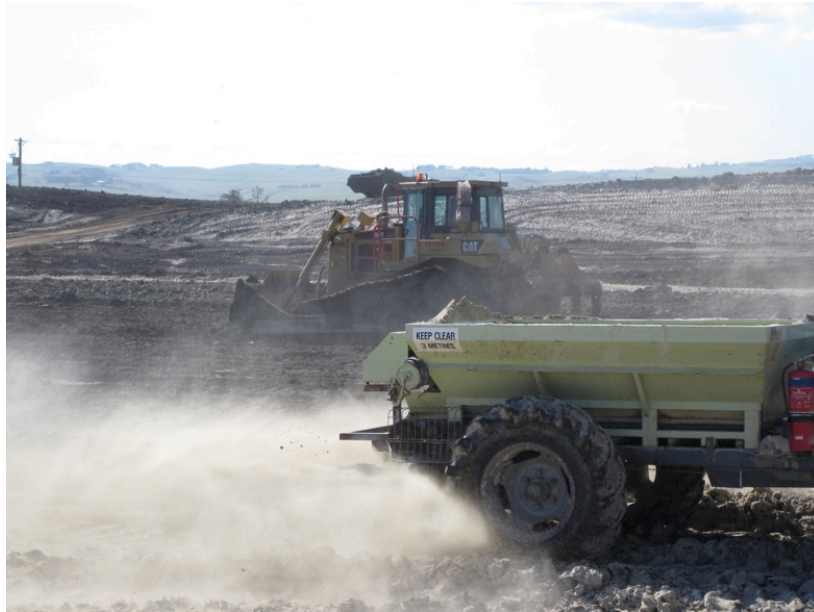
Figure 6. Acid sulphate soils treatment, May 2011

As the works at the plant site move from earthworks towards primarily civil construction activities, the associated environmental risks reduce. The treatment of Acid Sulphate Soils (ASS) has continued successfully (see Figure 6), and investigations into the location of any additional ASS material in stockpiles and the constructed dunes on site are continuing. The required management of any ASS located will be developed with the overview of the EPA appointed environmental auditor. The annual migration of shearwaters was the subject of a mitigation plan to rescue any birds which landed on the plant site. The plan was developed in conjunction with the Phillip Island Nature Park, and successfully guided the relocation of about a dozen birds from the plant site (see Figure 7).

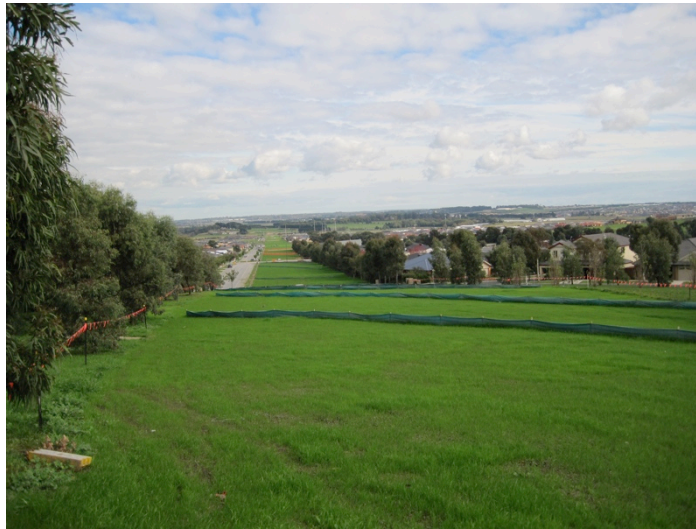
Figure 8. Reinstatement of the utilities alignment at Berwick, May 2011.

Works along the utilities alignment during the reporting period were almost complete. Some minor sections of pipe and power cable remain to be laid, and several waterway crossings are still to be completed. The length of the alignment and the wet weather experienced combined to keep sediment control as an on-going challenge. When
