Victorian Desalination Project | Independent Reviewer & Environmental Auditor

IR&EA REPORT

COMPLIANCE WITH ENVIRONMENTAL PERFORMANCE
REQUIREMENTS QUARTER 3 2010

QUARTERLY REPORT TO THE MINISTER FOR ENVIRONMENT AND
CLIMATE CHANGE

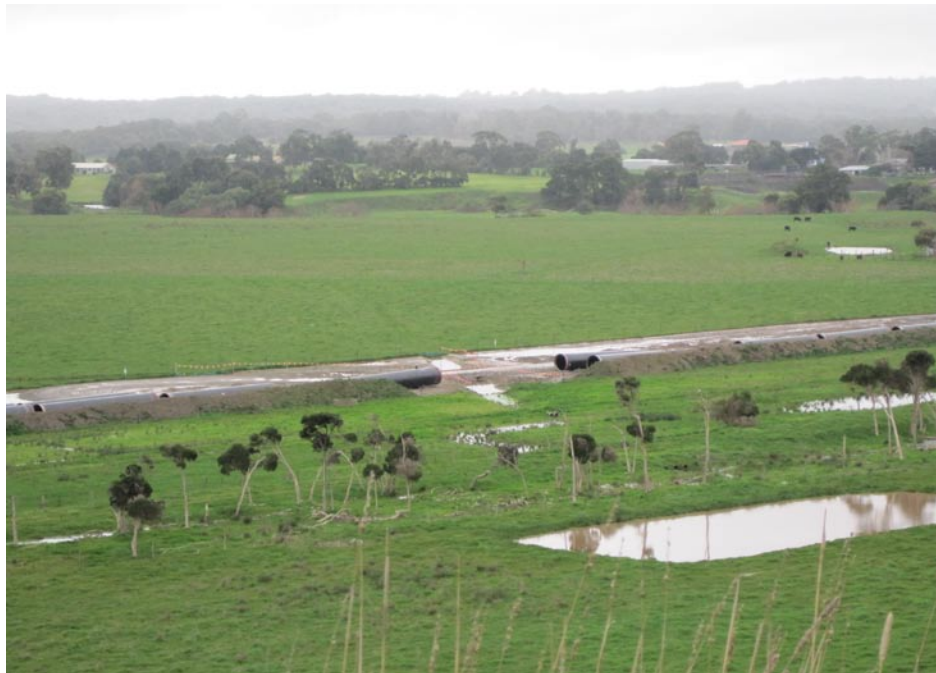
Figure 5. Utilities alignment near The Gurdies, August 2010.

42	4-Aug-2010	42/02	Afl	<p>Utilities alignment: At approximately KP 28 – 30 in The Gurdies inadequate sediment controls were evident.</p>	September 2010: The site environmental inspections have been revised to be more detailed, and a formal process established to escalate issues with subcontractors. There is a current focus on erosion and sediment controls.	Finding closed Audit No 47, September 2010
42	4-Aug-2010	42/03	Obs	<p>Utilities Area EMP, Water Quality and Erosion management sub plan: The Dewatering / Discharge Procedure, in particular sections 4.3 and 4.4, do not reflect recent changes to landowner consent and authority notification requirements.</p>	September 2010: the requests of landowners relating to notification requirements are to be documented.	Finding closed Audit No 47, September 2010
42	4-Aug-2010	42/04	Afl	<p>Utilities Area EMP, Water Quality and Erosion management sub plan. The management of water disposal activities could be improved by maintenance of a register in which the disposal site along with the source of the water, volume discharged and date of disposal were recorded. The general condition of the land or dam before and after discharge could also be recorded. This would assist with subsequent review of water disposal practices and facilitate investigation of any issues that might be attributed to water disposal practices.</p>	September 2010: a process to track loads of water from source to discharge point is being established. Remaining actions are still to be addressed.	Remains open

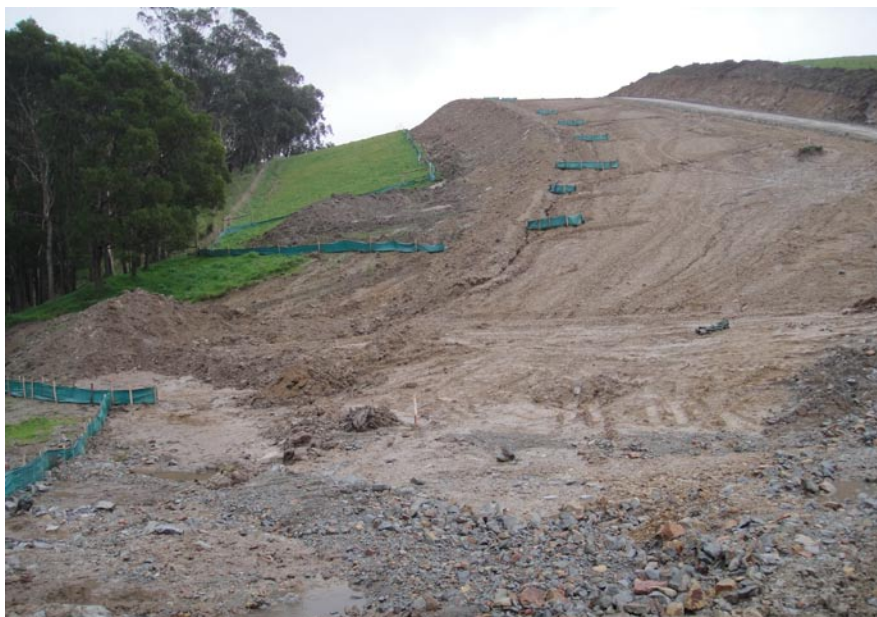
Figure 6 Drainage and sediment controls, August 2010

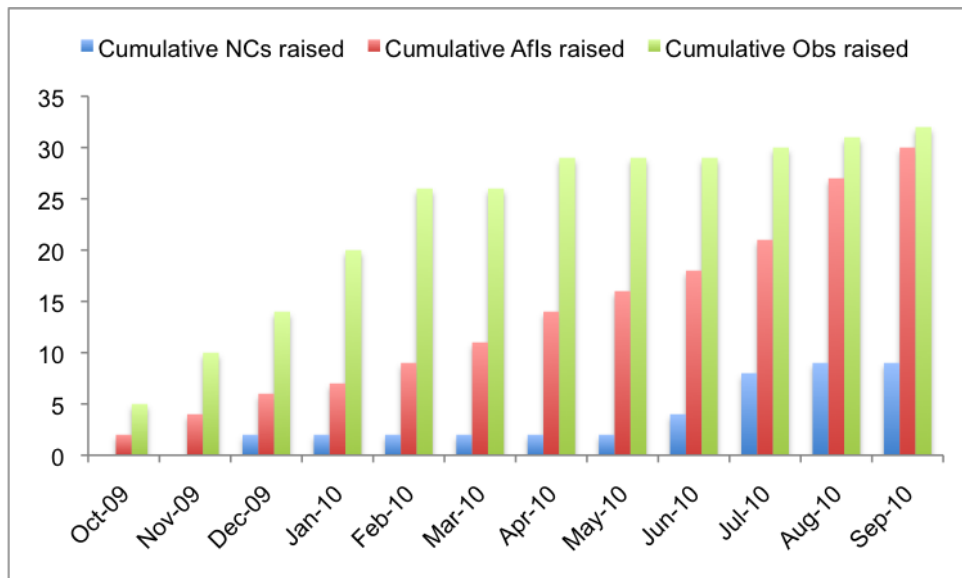
The cumulative number of each type of audit finding raised since project inception is given in Figure 7 below.

Figure 7. Cumulative audit findings by category.

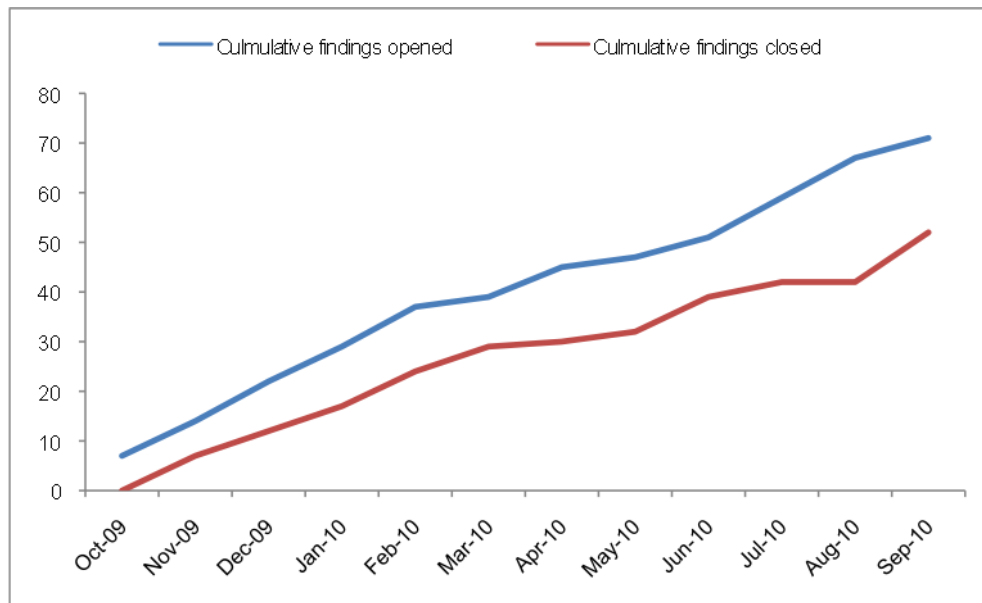
The overall number of audit findings raised (and closed) since the project started is given in Figure 8 below.

Figure 8. Cumulative number of audit findings, Project inception to date.

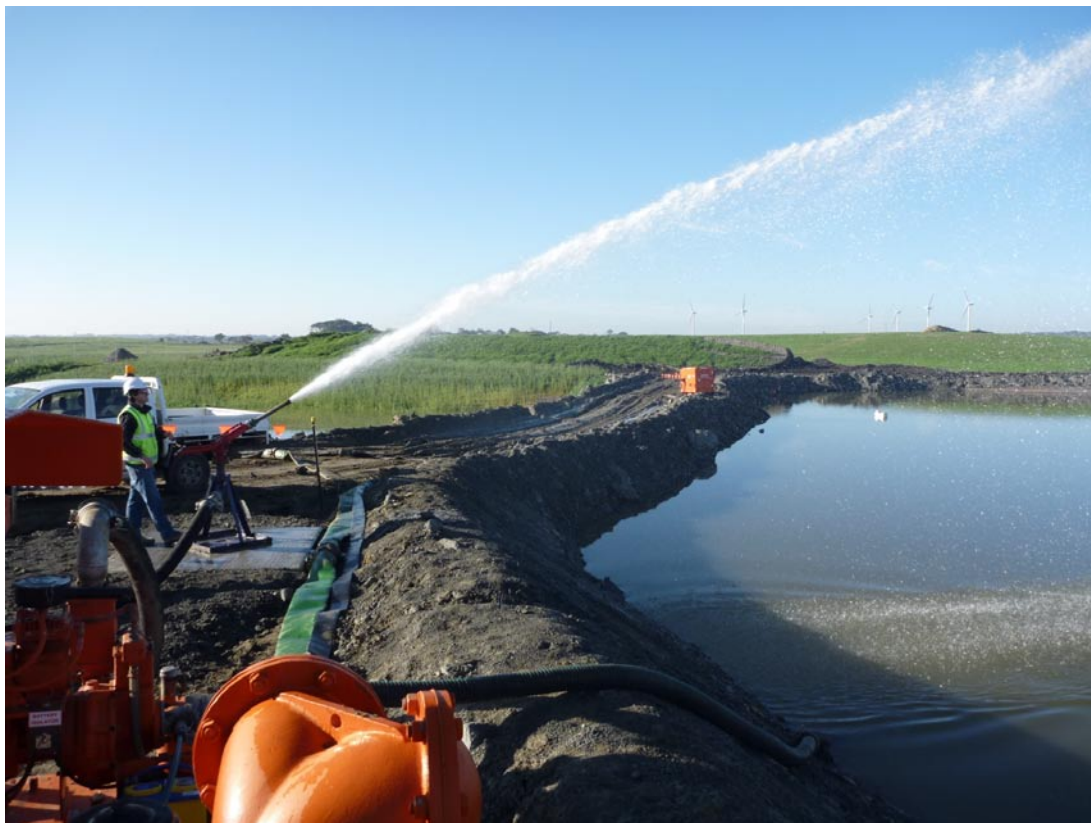
Construction water management at the plant site was effectively managed (see the photos below) during the reporting period. In mid-August water was observed to be piping through the levee being constructed at the plant site sediment pond. In order to empty the pond and discharge water from the site a revised Section 30A Emergency Discharge permit was issued by the EPA. The pond was emptied in accordance with the conditions of the permit, enabling the levee to be successfully reinstated.

Figures 9 and 10 below show the sediment pond being dosed with flocculent to reduce turbidity, and the automatic water quality monitoring station on the Powlett River.

Figure 9. Dosing the plant site construction water sediment pond, August 2010

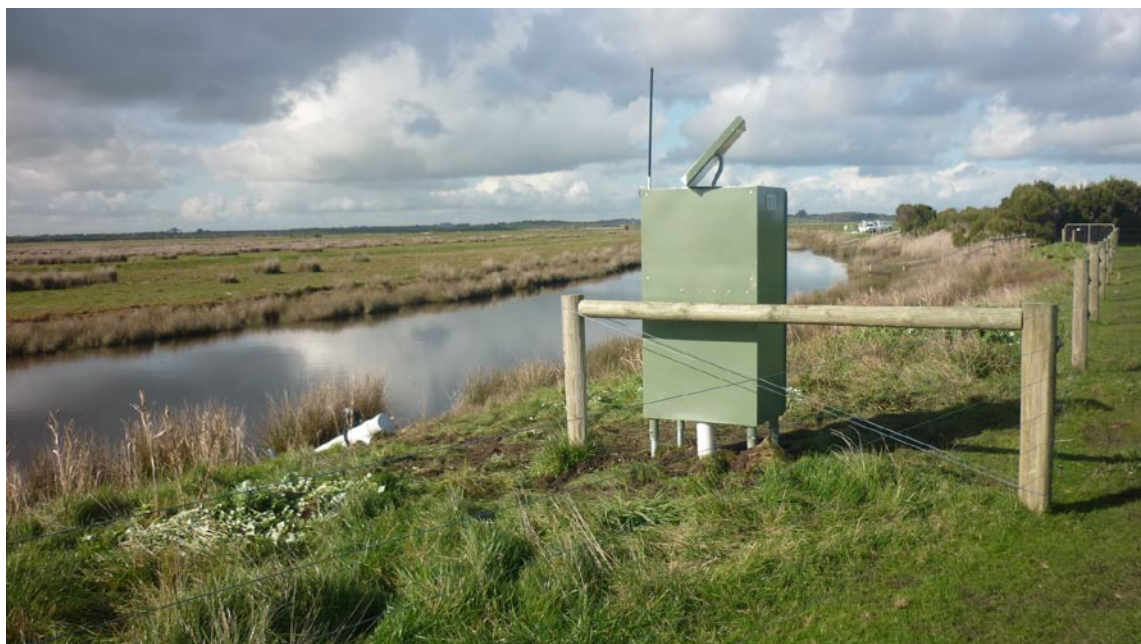
Figure 10. Automatic water quality monitoring, Powlett River.

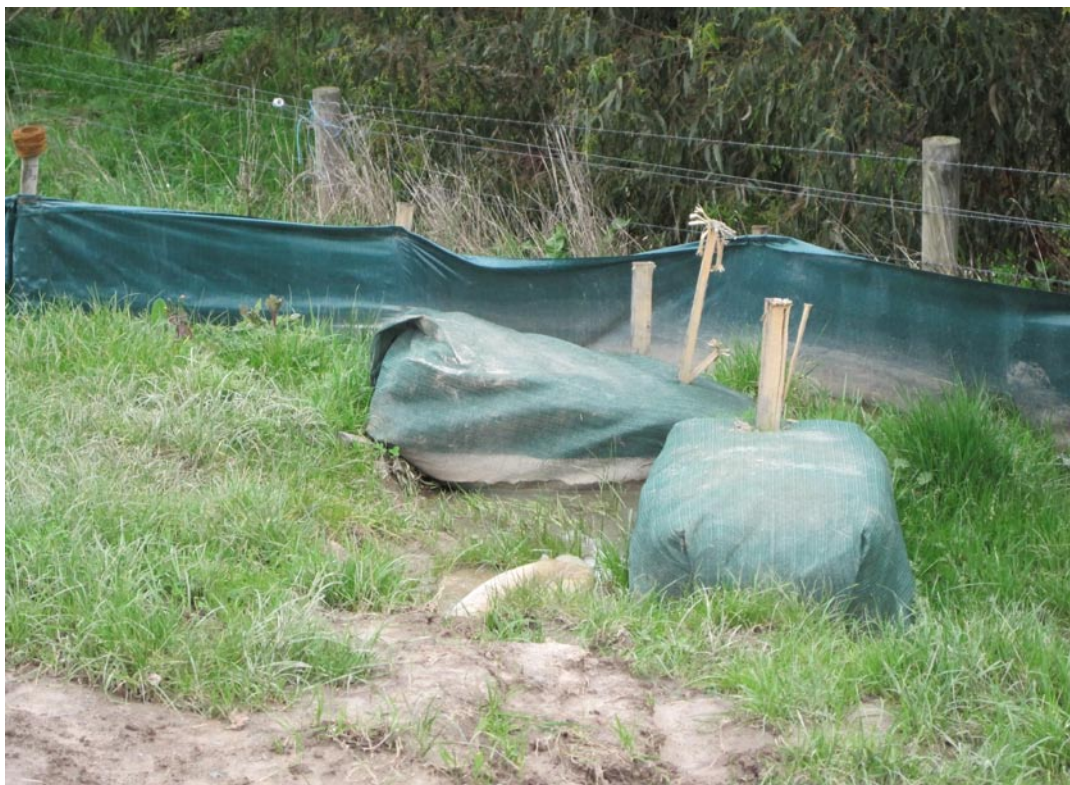
Other findings related to the timely installation and maintenance of sediment control structures, particularly along the utilities alignment. The wet period, coinciding with the increasing construction tempo and the length of the alignment which had been cleared, increased the importance of adequate sediment control.

Figures 10 and 11 below show an example of sediment controls installed along the utilities corridor, and protective fencing around sensitive vegetation.

Figure 11. Sediment control structure, Utilities alignment, September 2010.

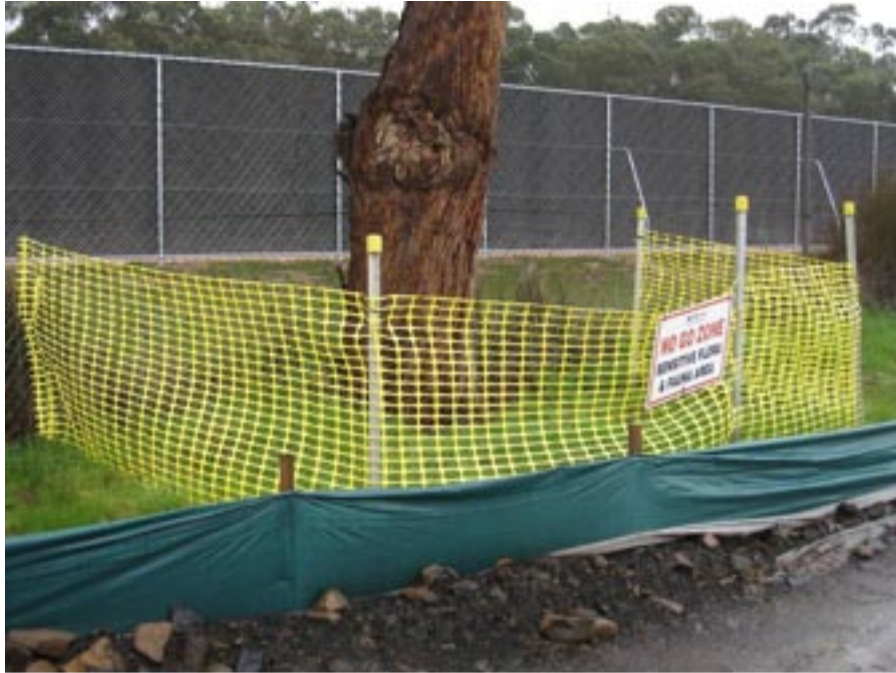
Figure 12. Protecting sensitive vegetation, Utilities alignment, September 2010
