FINAL REPORT:

An assessment of the impact of riparian revegetation on stream erosion during floods in Victoria

December 2011

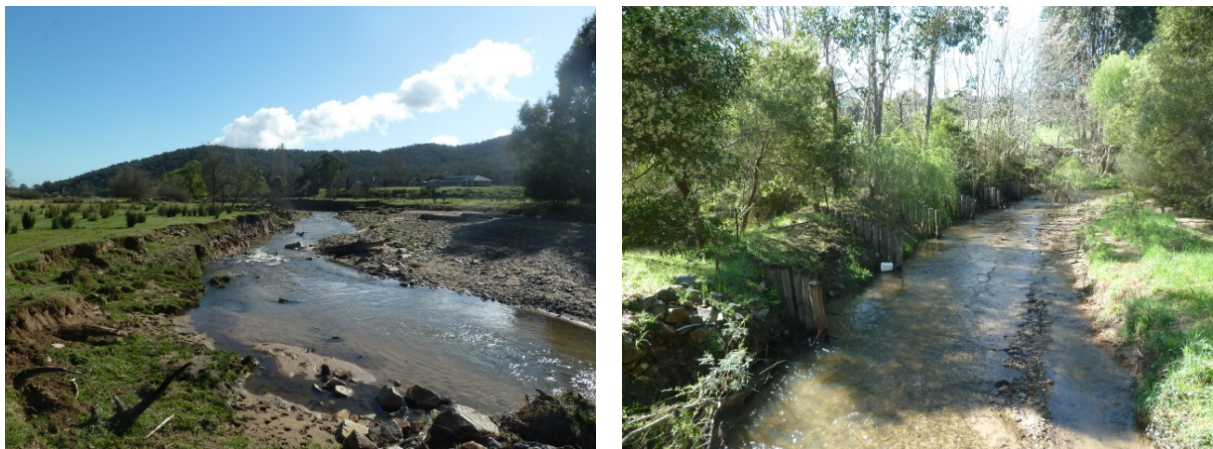
Figure 1. Paired site assessment for Black Range Creek, north east Victoria (the site with bare banks (left) experienced widespread erosion while the revegetated site (right) incurred only minor channel change in the same flood event

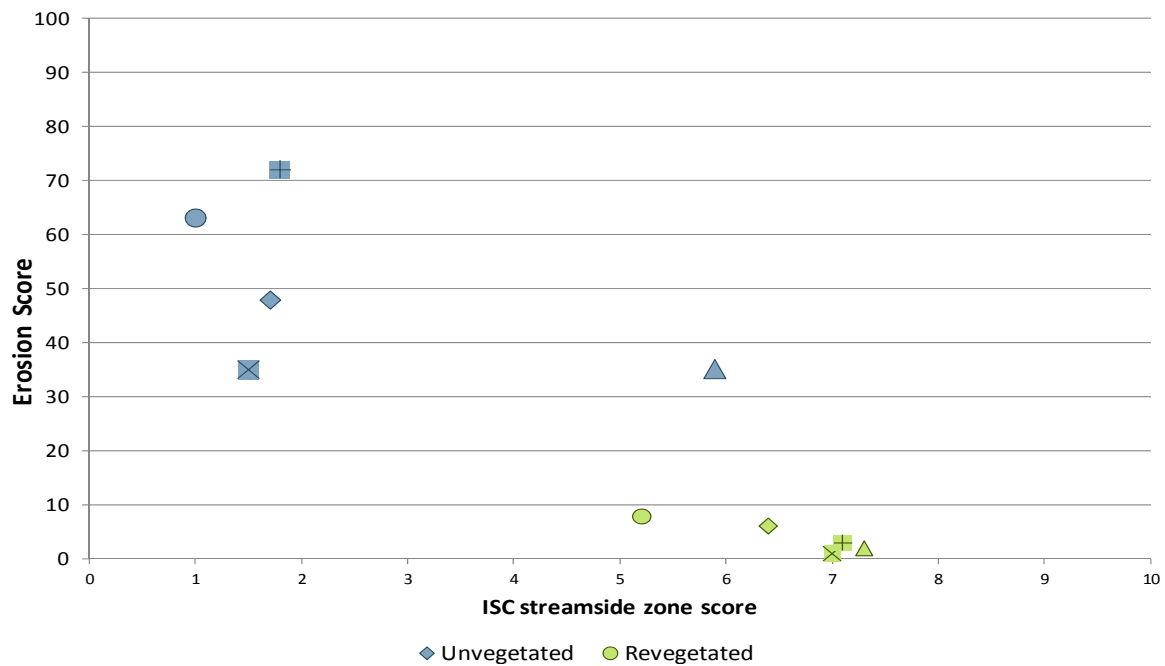
Figure 2. Results showing the relationship between erosion score and the ISC streamside zone score for all five of paired sites analysed in this study

The paired site assessments revealed a strong inverse relationship between erosion and the presence of high quality, structurally diverse native vegetation, established from a revegetation program (Figure 2). The results of the paired site assessment support the hypothesis that riparian vegetation established through a revegetation program can be the controlling factor that limits flood related channel change. At the paired sites, we found negligible channel change at sites that had been the subject of revegetation programs resulting in the establishment of high quality, structurally diverse native riparian vegetation. We found high rates of flood related channel change at sites that did not have high quality, structurally diverse native riparian vegetation.

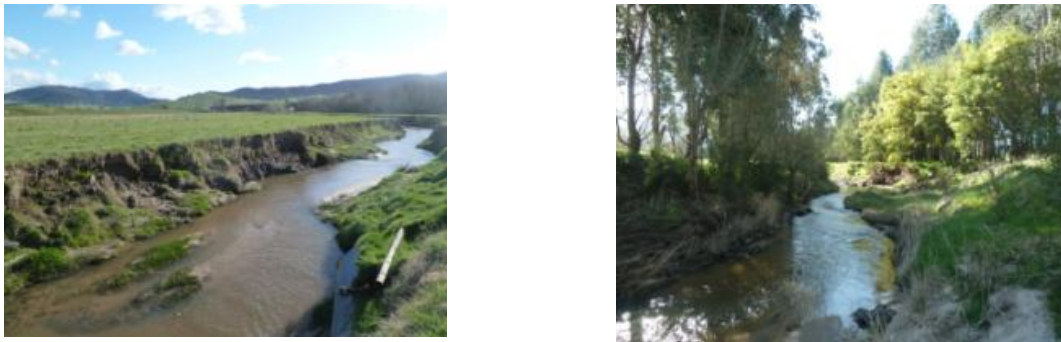
Figure 3. Paired site assessment for Barwidgee Creek, north east Victoria (the site with bare banks (left) experienced widespread erosion while the revegetated site (right) incurred only minor channel change in the same flood event

Some of these characteristics are shown in the right hand panel of Figure below.

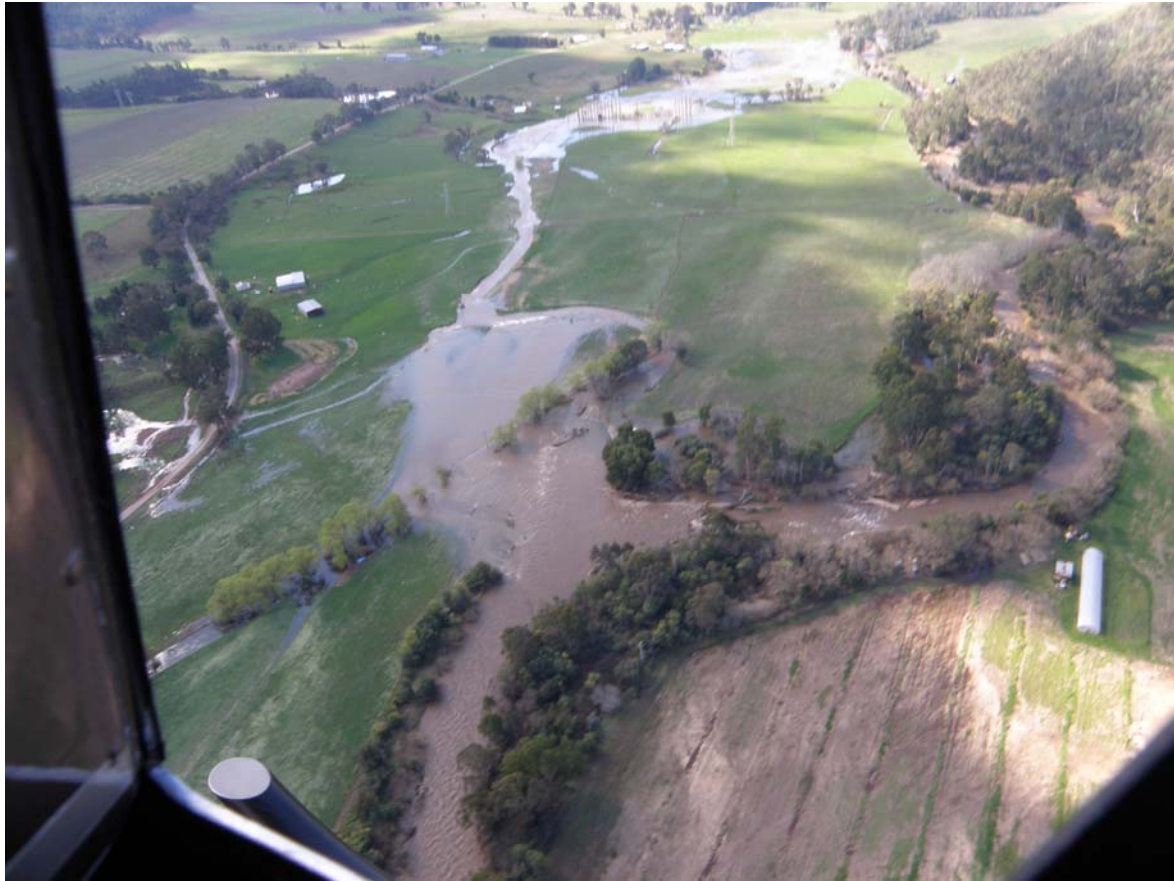
Figure 5. Floodplain flow and site of potential avulsion of King River in north east Victoria (View looking downstream, King River is on the right, floodplain scour path is in centre of image)

The damage associated with flood related channel change includes erosion that leads to loss of private and public infrastructure such as bridges, culverts, roads, water supply systems and power and telecommunications systems. Flood related channel change causes the loss of agricultural land through erosion of stream beds and banks. In addition, large floods can produce meander cut-offs and avulsions where the river abandons one channel and occupies a new one across a floodplain. This causes major disruption to communities and infrastructure (Figure 5).

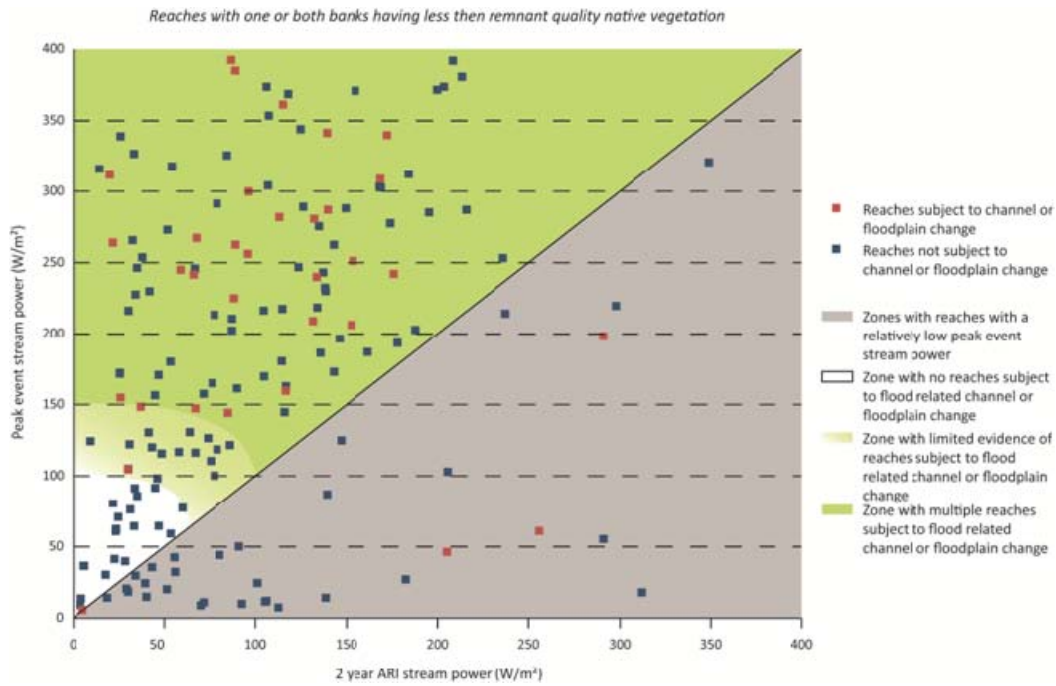
Figure 8. Scatter plot showing the relationship between predisposition to channel change, flood hydraulics and erosion in reaches with less than remnant quality vegetation.

Channel change did not occur in reaches with less than remnant quality vegetation for events with specific stream power less than 100 W/m^2 . Channel change occurred in reaches with less than remnant quality native riparian vegetation when these values were exceeded.

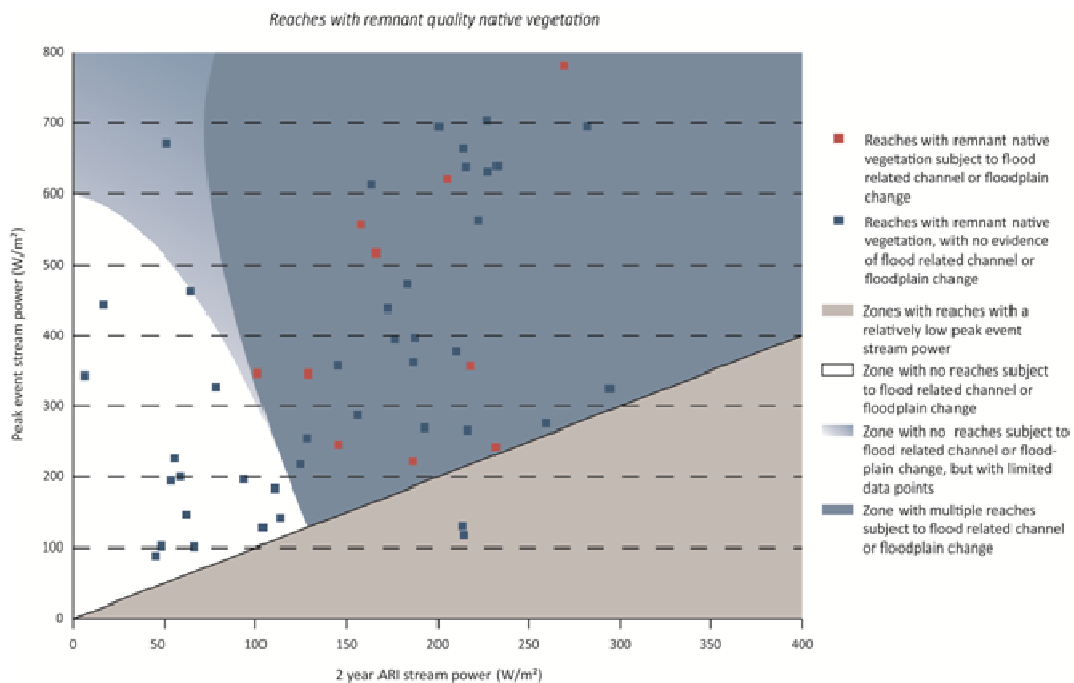
Figure 9. Scatter plot showing the relationship between predisposition to channel change, flood hydraulics and erosion in reaches with remnant quality vegetation

Figure 9 provides a plot of reaches subject to different flood factors, and predisposition to channel change for sites with remnant quality riparian vegetation. Channel change did not occur in reaches with remnant quality vegetation where the predisposition to channel change (the 2 year ARI specific stream power) was less than $100 W/m^2$.

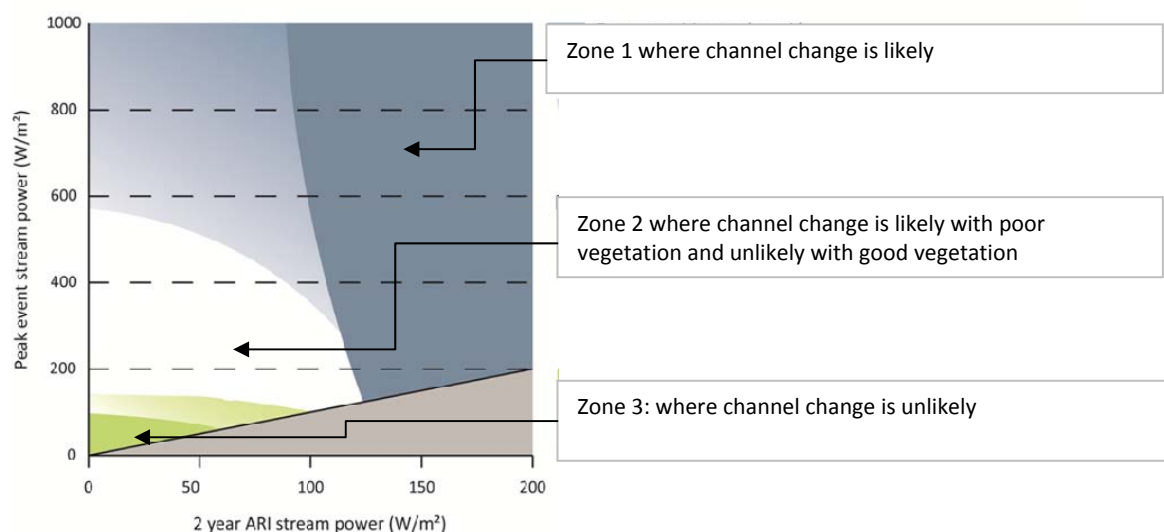
Figure 10. Zones of erosion resistance based on predisposition to channel change, scale of event and vegetation type

From these two graphs a third figure can be developed that identifies a set of zones where remnant quality vegetation does and does not have an influence on flood related channel change. The zones represent a combination of flood and channel factors. Figure 10 illustrates a critical zone where remnant quality vegetation provides the additional resisting power to oppose channel change. This figure also illustrates a zone (or set of circumstances) where the combination of the flood event and the channel characteristics create circumstances that flood related channel change is unlikely even in the absence of riparian vegetation. These circumstances occur when the stream power in the flood event and or the predisposition to channel change is very low. Similarly there is a zone (or set of circumstances) where channels are so predisposed to erosion, or the flood event is so large, that channel change will occur even with remnant quality vegetation.

We found 80% of cross sections assessed on the Cann River to be currently within Zone 2 (Figure 10) with most having stabilising vegetation i.e. most of the Cann River was found to be within a zone that would erode if there was no vegetation. The remainder of cross sections were in Zone 3 and unlikely to undergo channel change in the subject flood event with or without native riparian vegetation. Based on the assessment, and subject to the continuing presence of high quality, structurally diverse native vegetation, the system is now effectively protected from gross channel change in major flood events. At the time of the 1998 flood event, we found over 90% of the system to be within Zone 2 and in the absence of effective stabilising vegetation was subject to gross channel change.

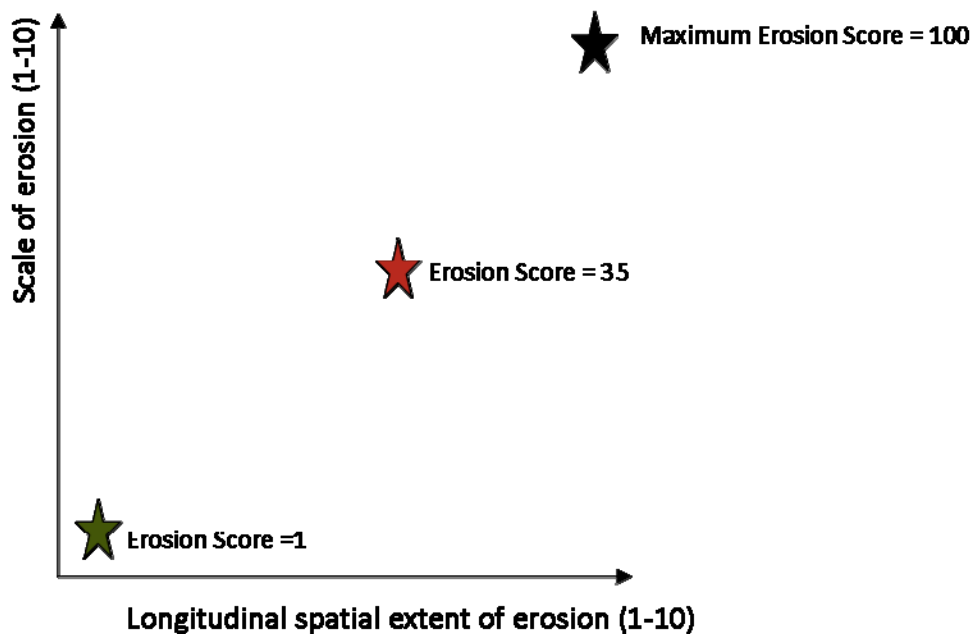
Figure 11. Hypothetical example of the Erosion Score developed to assess the extent of erosion at each of the sites

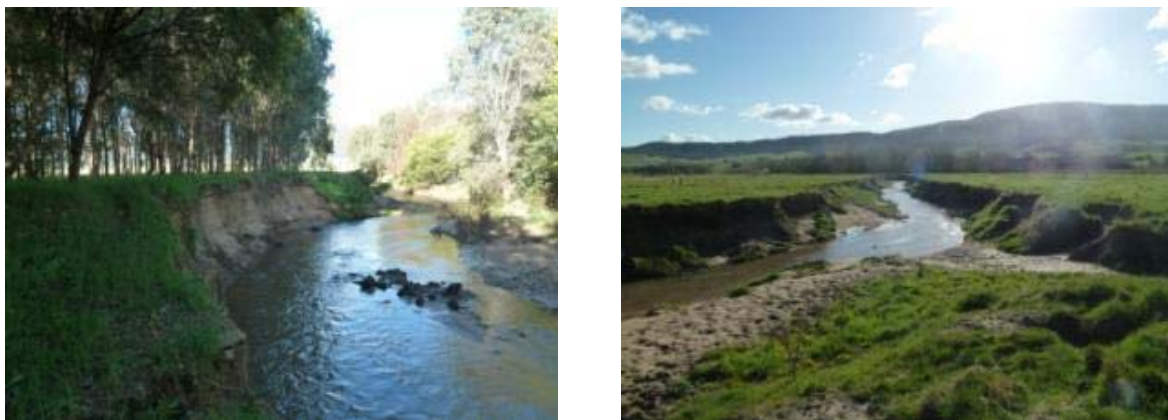
Figure 12. Examples of two sites with differing longitudinal spatial extent of erosion scores. The site on the left received a low score as erosion is localised and limited to one bank on the outside of a meander, the site on the right received a high score as erosion occurred through the reach on both banks

erosion was defined as the percentage of bank length that was impacted on by erosion. Two examples are provided in Figure 12. It is important to remember that under pre-disturbed conditions some erosion would be expected, similar to that in the photo on the left.

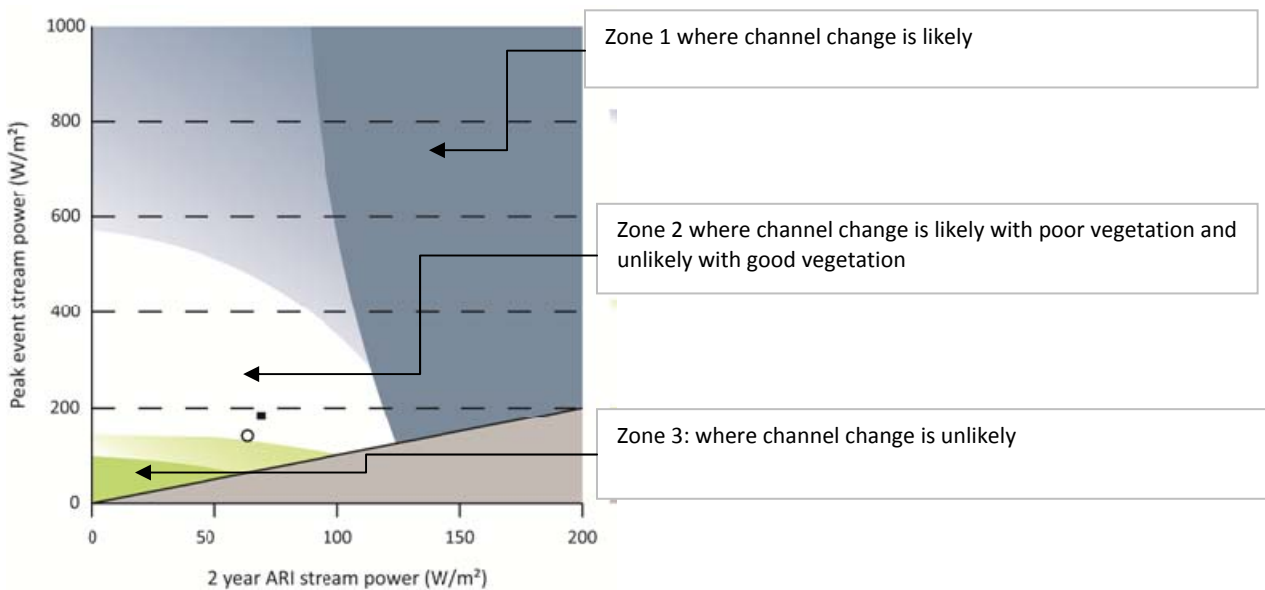
Figure 13. Results from the hydraulic modelling for the Cann River paired sites

Further, we found each of the sites for which a quantitative analysis was undertaken to be within the zone where vegetation was expected to play the critical role in the presence or absence of flood related channel change. The Cann River paired sites are illustrated graphically in Figure 13.

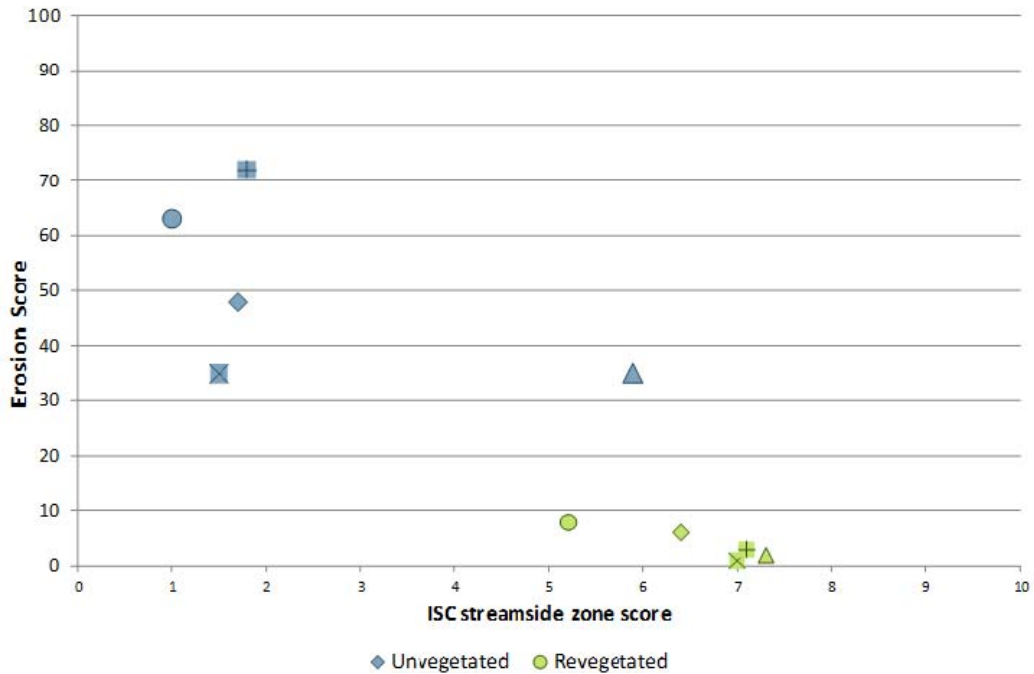
Figure 14. Results showing the relationship between erosion score and the ISC streamside zone score for all five paired sites

The paired site assessment revealed a strong inverse relationship between the presence of revegetation works resulting in high quality, structurally diverse native riparian vegetation and erosion at all five case study sites (Figure 14). We found a low rate of erosion at sites that had been the subject of revegetation programs resulting in the presence of high quality, structurally diverse native riparian vegetation. We found high rates of flood related channel change at sites that did not have high quality, structurally diverse, native riparian vegetation.

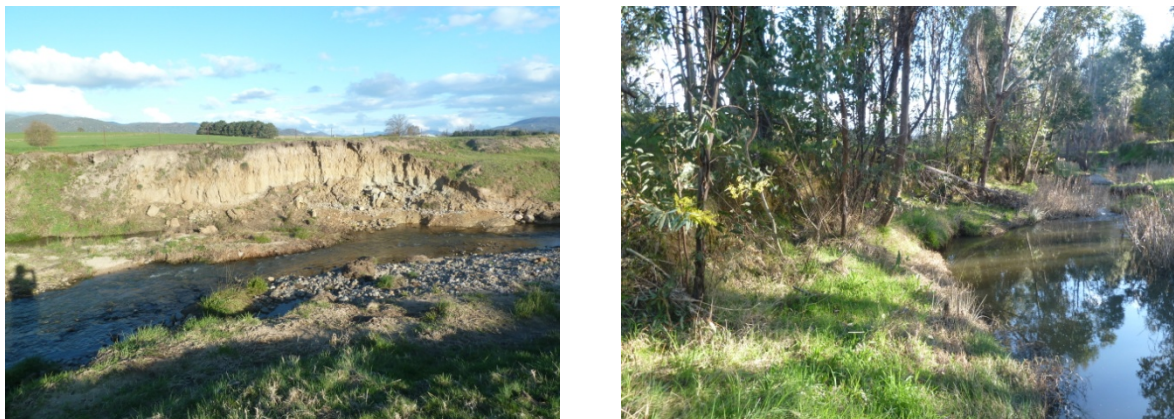
Figure 15. Paired site assessment for tributary of Barwidgee Creek, north east Victoria (the site with bare banks (left) experienced widespread erosion while the revegetated site (right) incurred only minor channel change in the same flood event

The difference in the scale and extent of channel change at a pair of sites on a tributary of Barwidgee Creek in north east Victoria is illustrated in Figure 15.

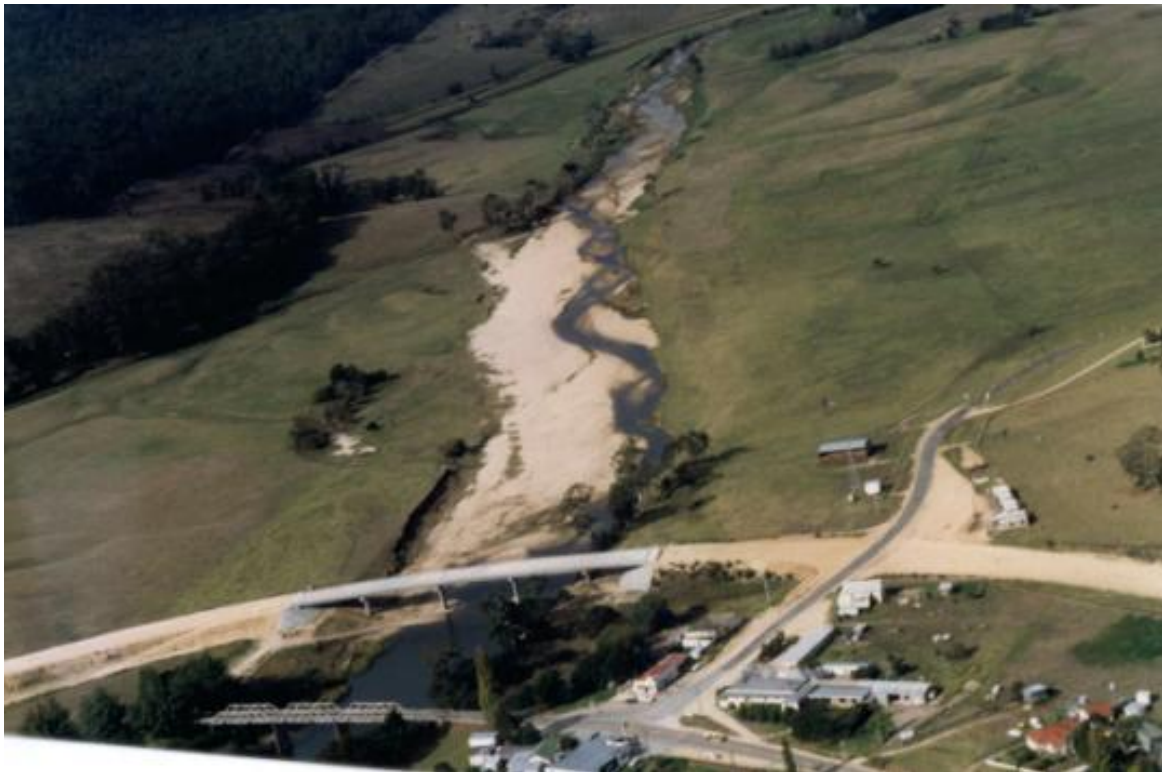
Figure 17. *Genoa River following major flooding in 1985 (Photos courtesy of EGCMA)*

The Genoa River rises in the alpine region of New South Wales before flowing into far eastern Victoria. The lower reach, which flows through the township of Genoa, is an unconfined sand bed stream. The floodplain and riparian zone was largely cleared of vegetation during the twentieth century for agricultural pursuits. Major flooding in 1976 and 1985 resulted in substantial channel widening in the floodplain reach which was largely devoid of riparian vegetation (Figure 17).

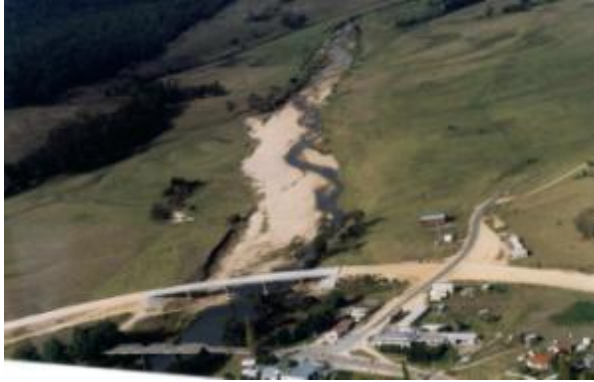
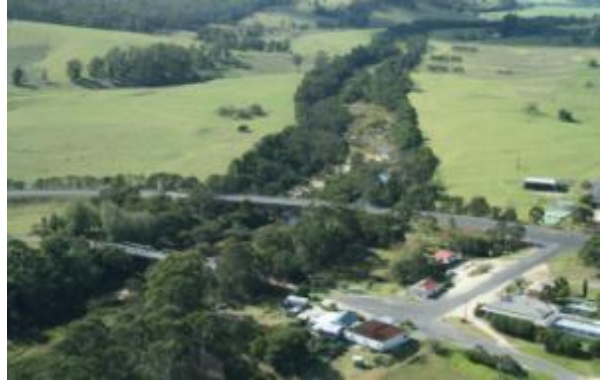
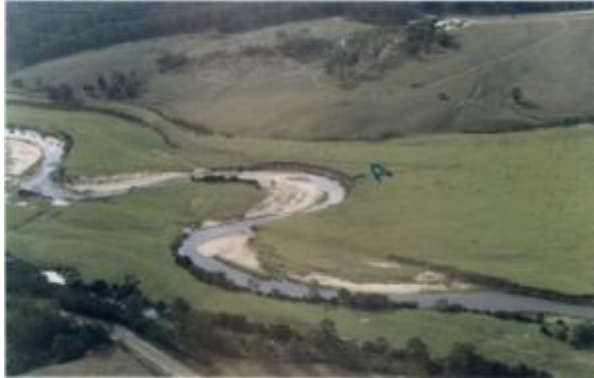
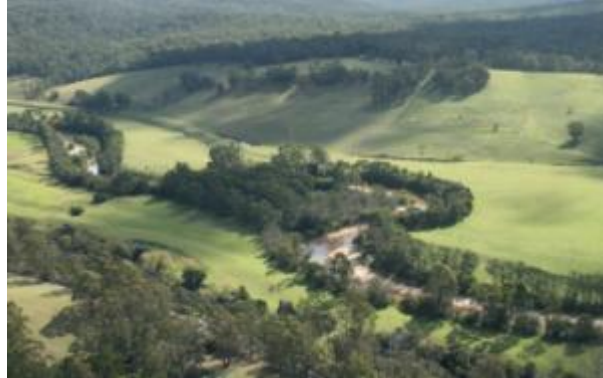
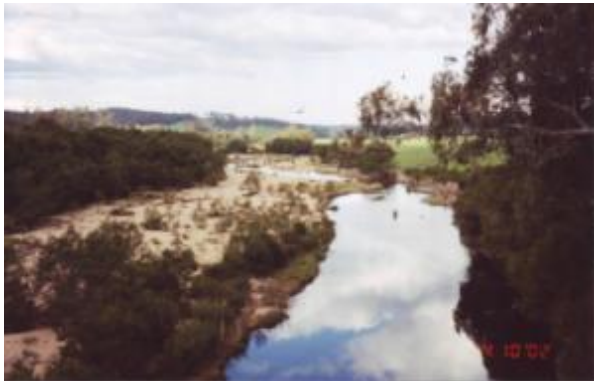
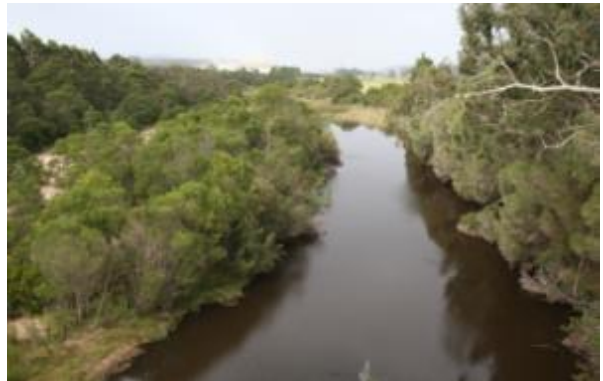
Figure 18. The Lower Genoa River before and after an extensive rehabilitation project downstream of the Princes Highway in Genoa (Photos courtesy of EGCMA)

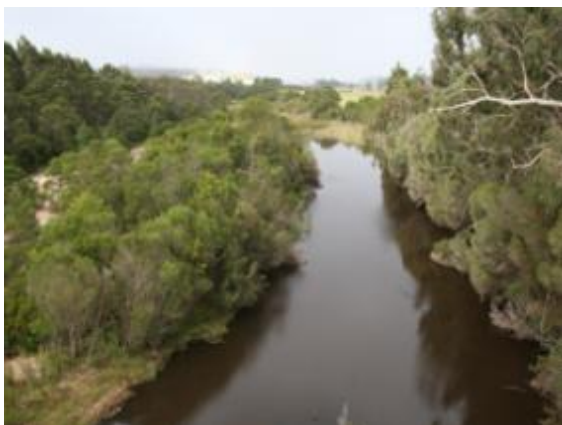
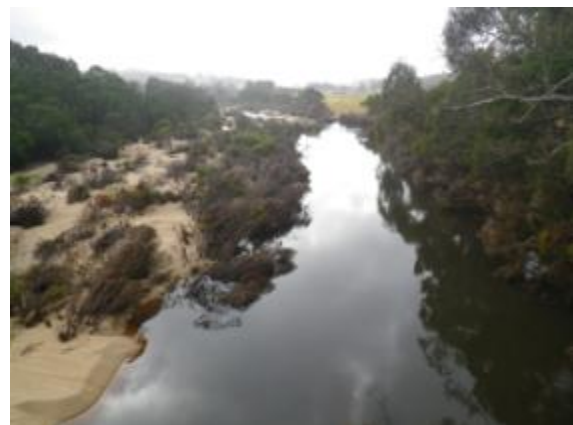
Figure 19. Looking downstream from the Princes Highway before and after the March 2011 flood. Note the same alignment of the low flow channel and the recent deposition on the bar (Photos courtesy of EGCMA)

The reach was for the most part, highly resistant to the March flood event. Prior to the flood, the system had developed a well-defined low flow channel within the over widened macro channel. The alternate sand bars were well vegetated with a range of terrestrial species. Following the flood there was no major realignment, or infilling, observed in the low flow channel. A large amount of deposition, up to 2m, had occurred on some of the sand bars. In certain locations, the sand bar elevation was now approaching the floodplain elevation. The deposition on the sand bars is consistent with the narrowing observed during the recovery from stream incision and should not be seen as negative outcome, but a positive contribution to system recovery. The vegetation on the sand bars provided favourable conditions for deposition and helped maintain the alignment of the low flow channel (Figure 19).

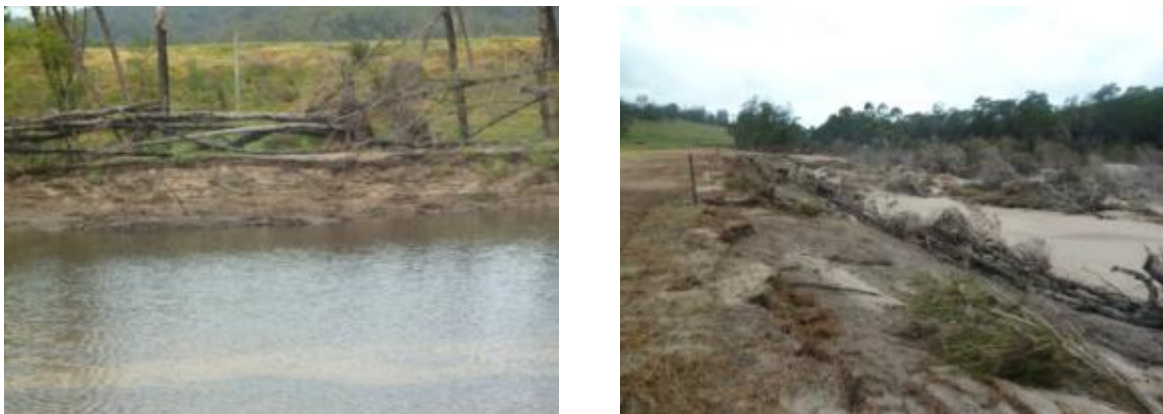
Figure 21. Banks that exhibited localised erosion were limited to areas cleared for stock watering access.

At two locations, localised minor bank erosion had occurred. Both these locations had limited riparian vegetation as the banks were used for stock watering access (Figure 21). The dense riparian vegetation upstream and downstream of the stock access point appeared to have reduced the near bank velocities sufficiently to limit fluvial scour at these locations.

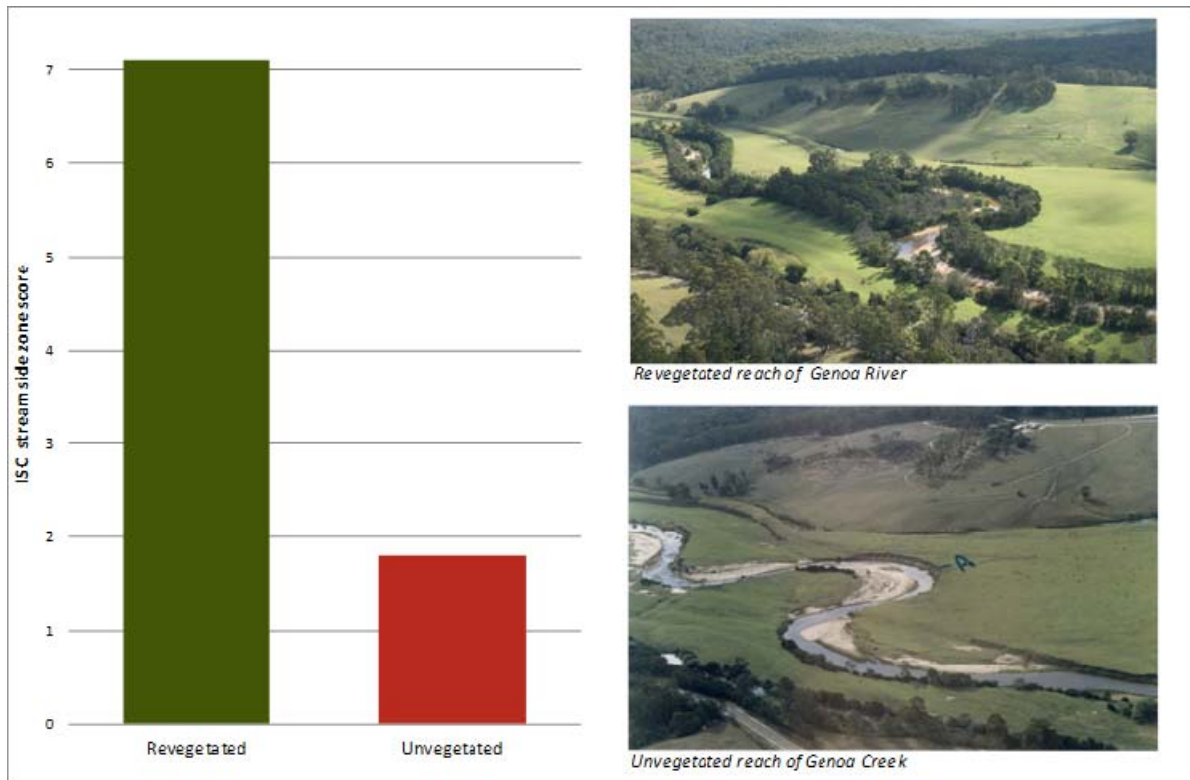
Figure 22. *ISC streamside zone scores for the paired sites of Genoa River*

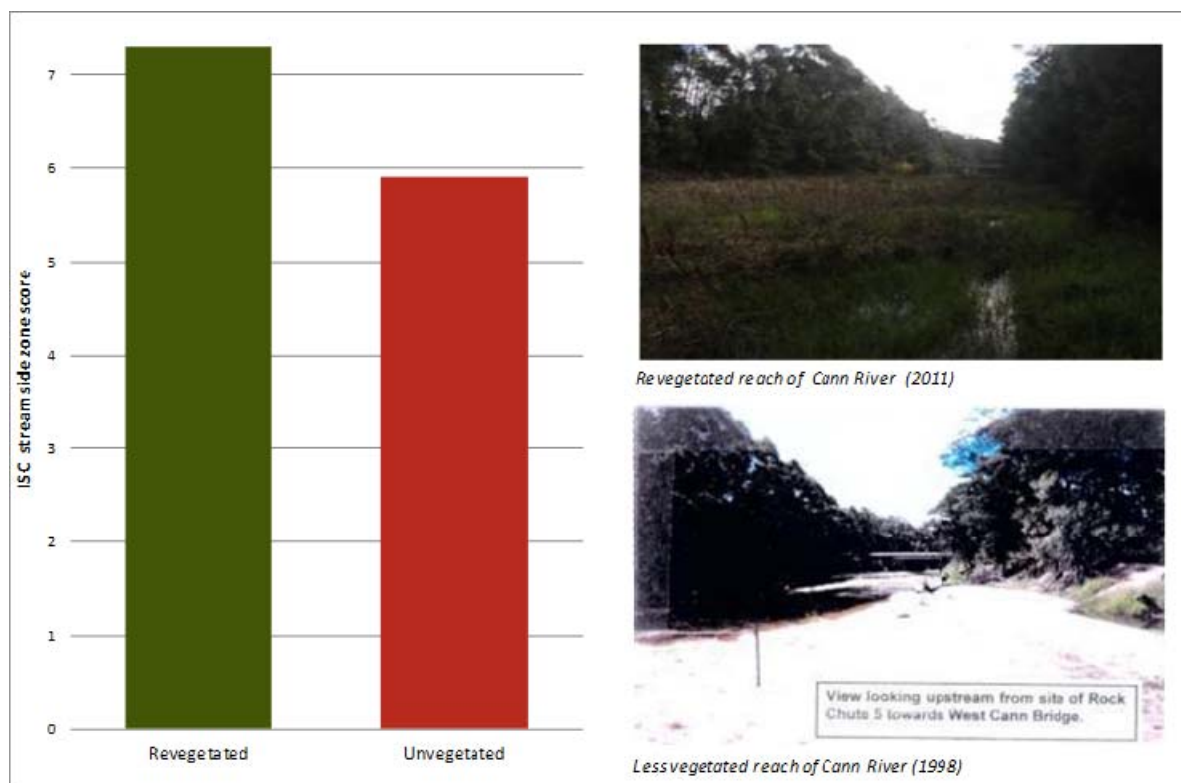
Figure 23. ISC streamside zone scores for the paired sites of the Cann River

Assessments undertaken following the 2011 flooding gave the system an erosion score of 2 (Table 6). The site was given an ISC streamside zone score of 7.2 (Figure 23).

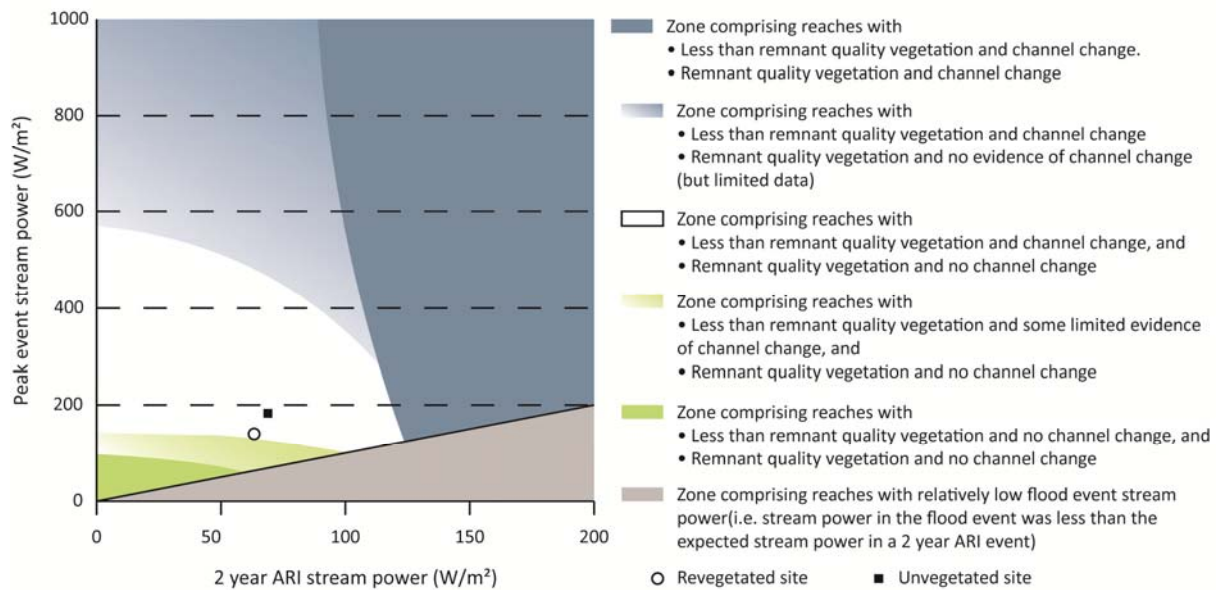
Figure 24. Results from the hydraulic modelling for the Cann River paired sites

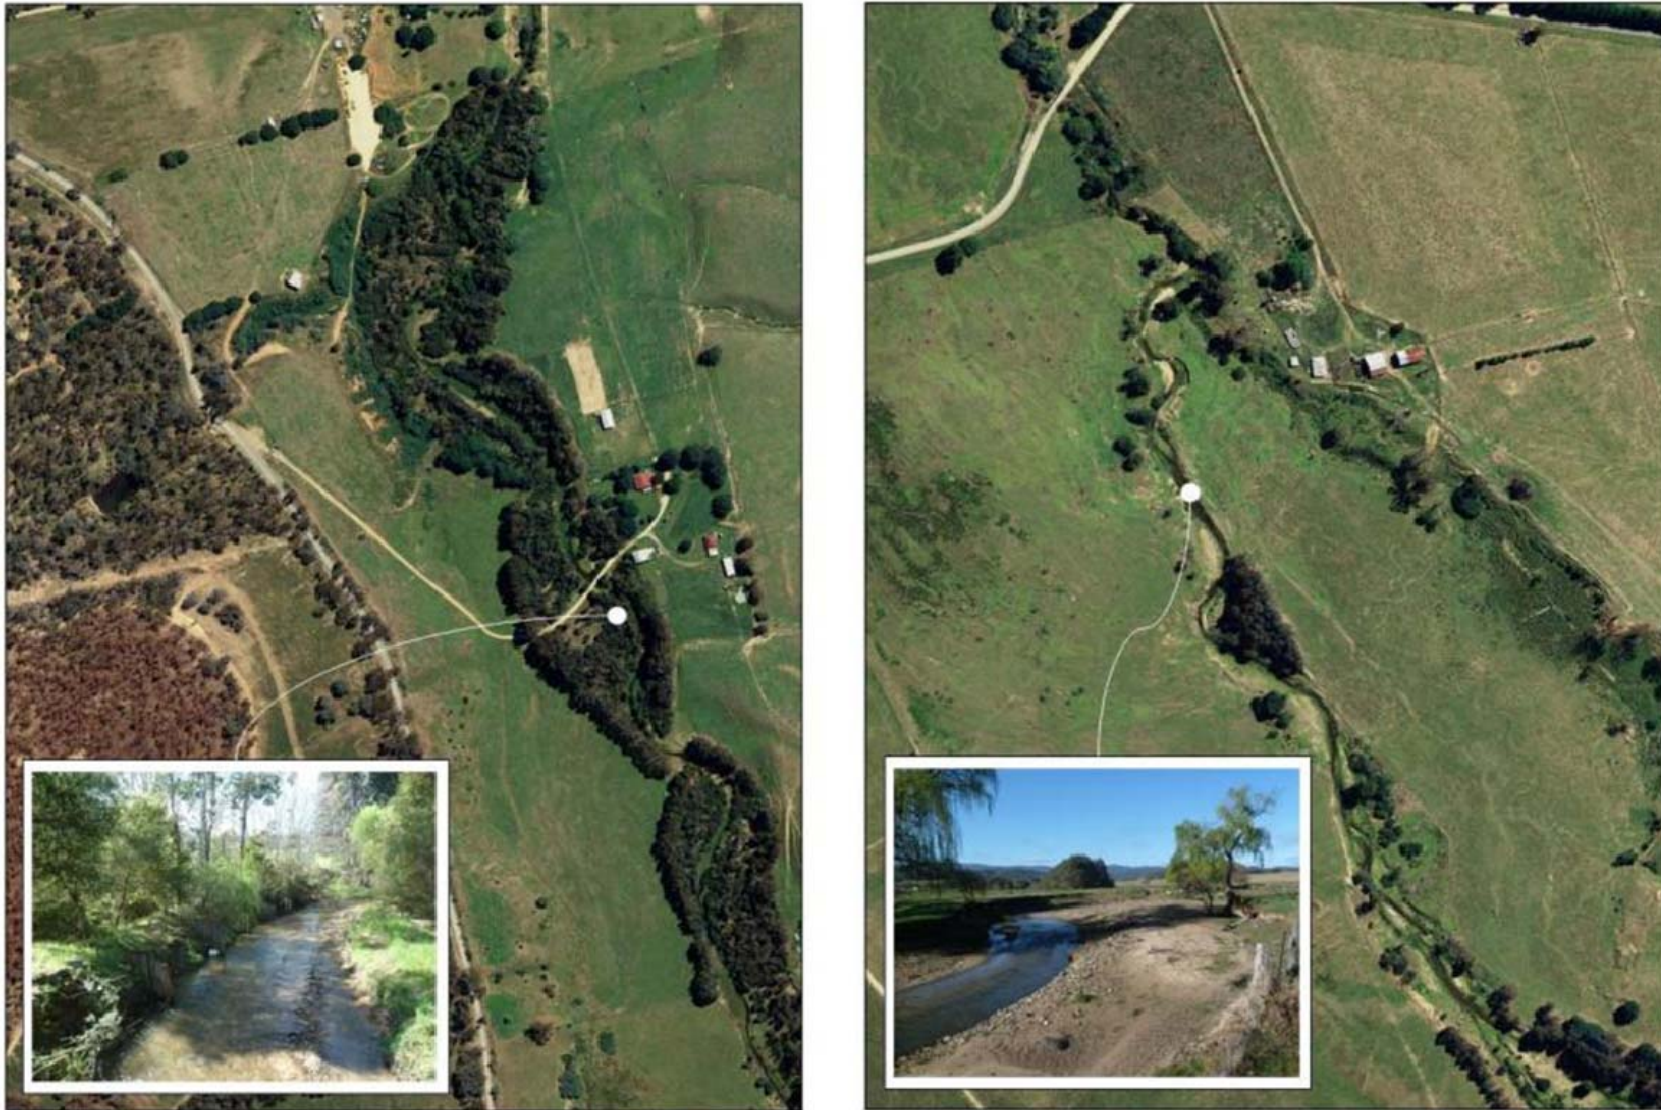
Figure 25. *The paired sites for Black Range Creek (The revegetated reach on the left, and the unvegetated reach on the right*

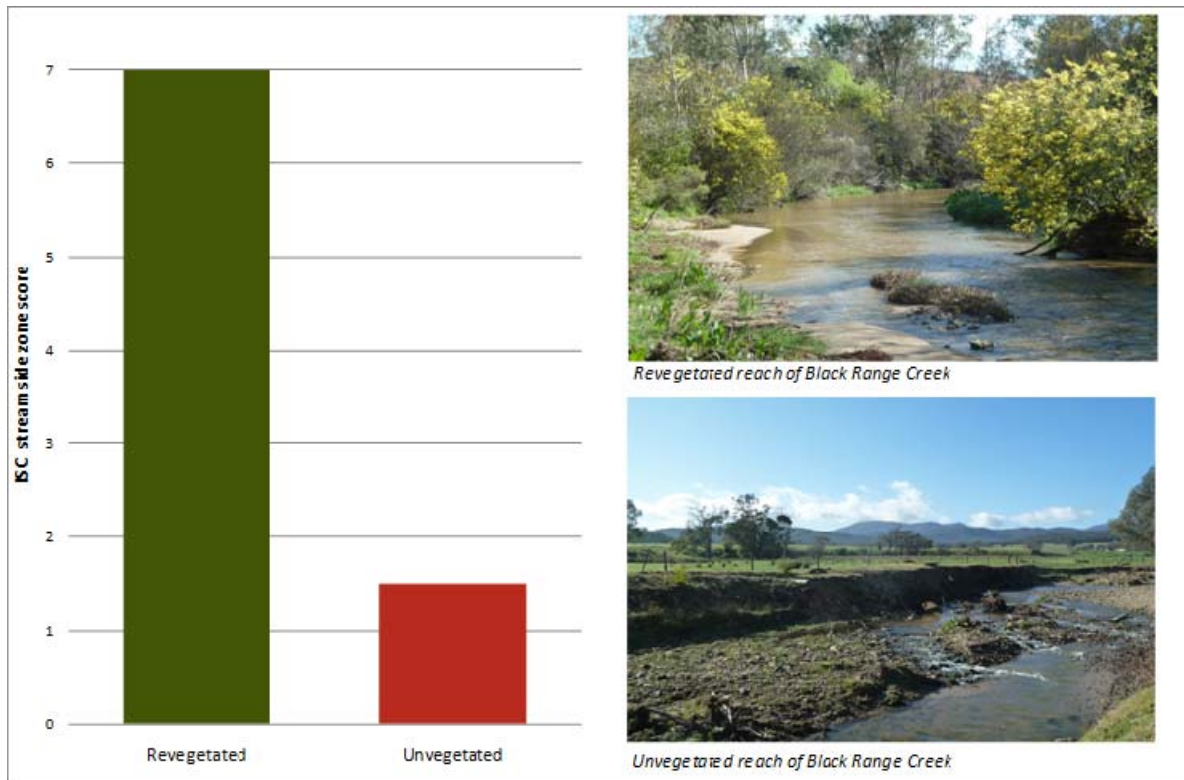
Figure 26. ISC streamside zone scores for the paired sites of Black Range Creek

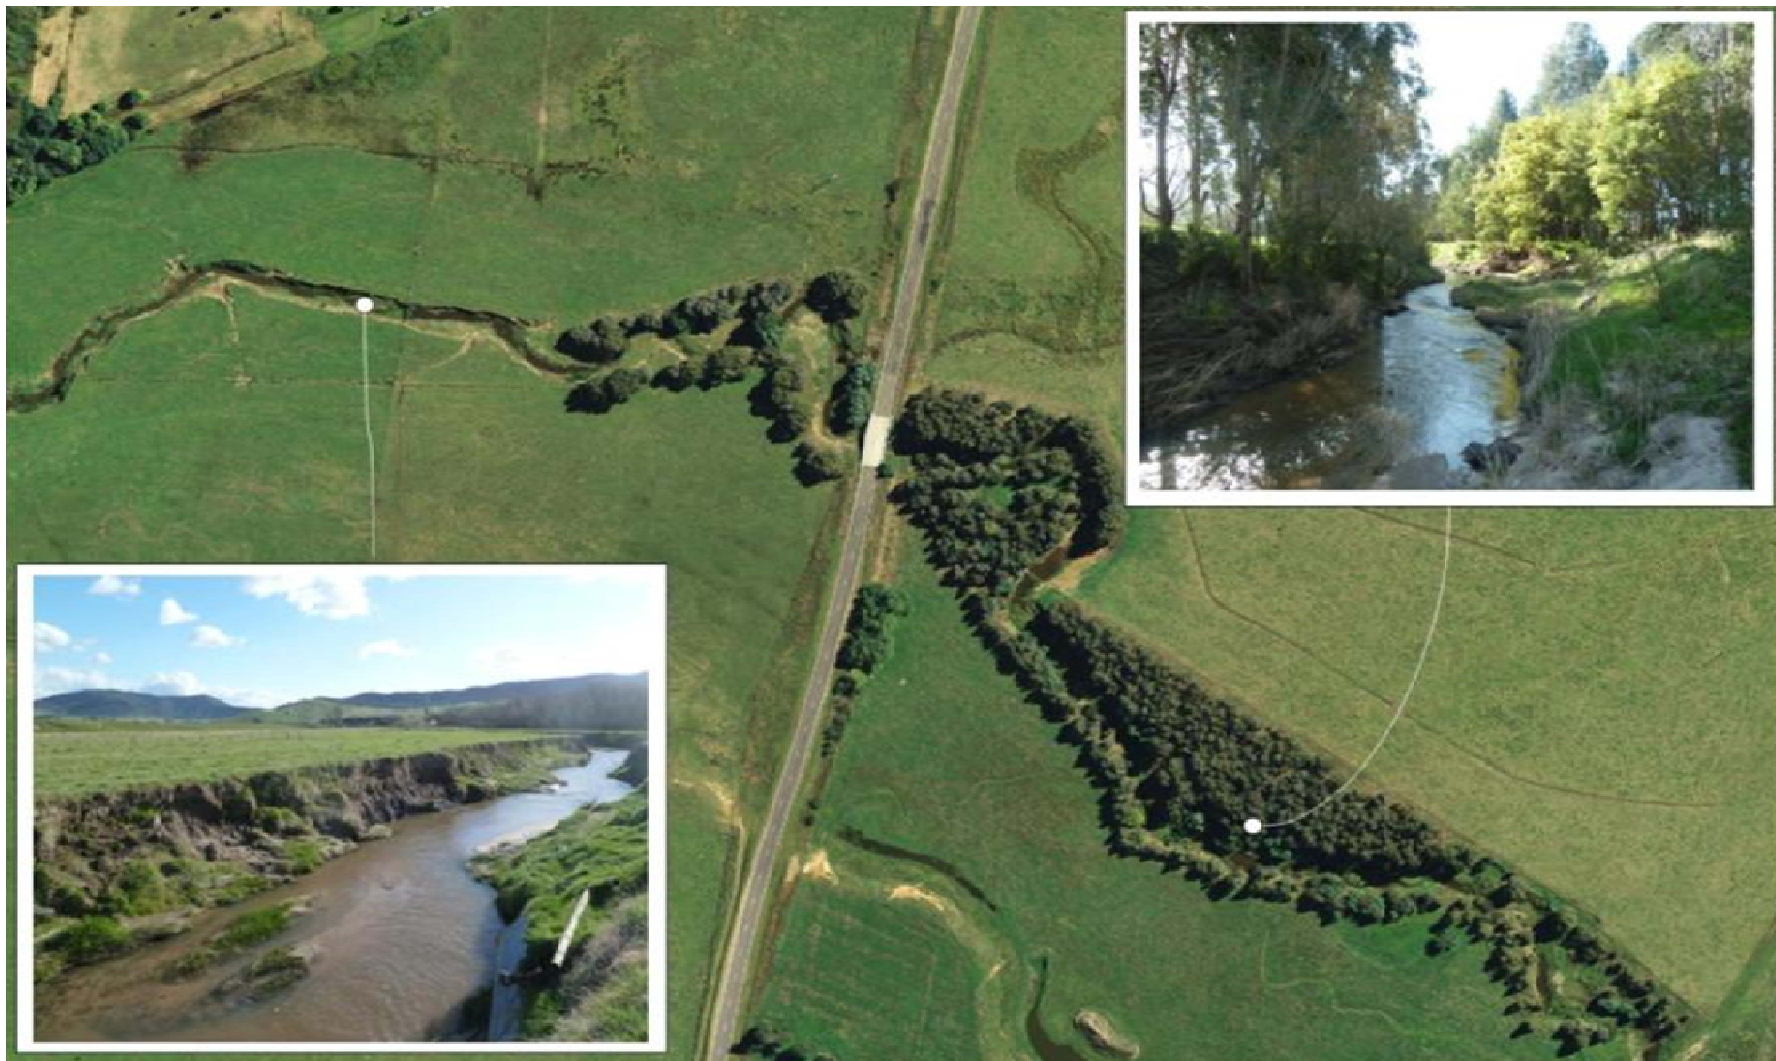
Figure 28. *The paired sites on the main stem of Barwidgee Creek (on the left is the unvegetated reach, while on the right is the revegetated reach*

Moderate erosion still occurred at this site with bank retreat and slumping observed for approximately 20 % of the reach length. The erosion was localised and confined to high energy zones such as the outside of meanders. The site received an erosion score of 8.

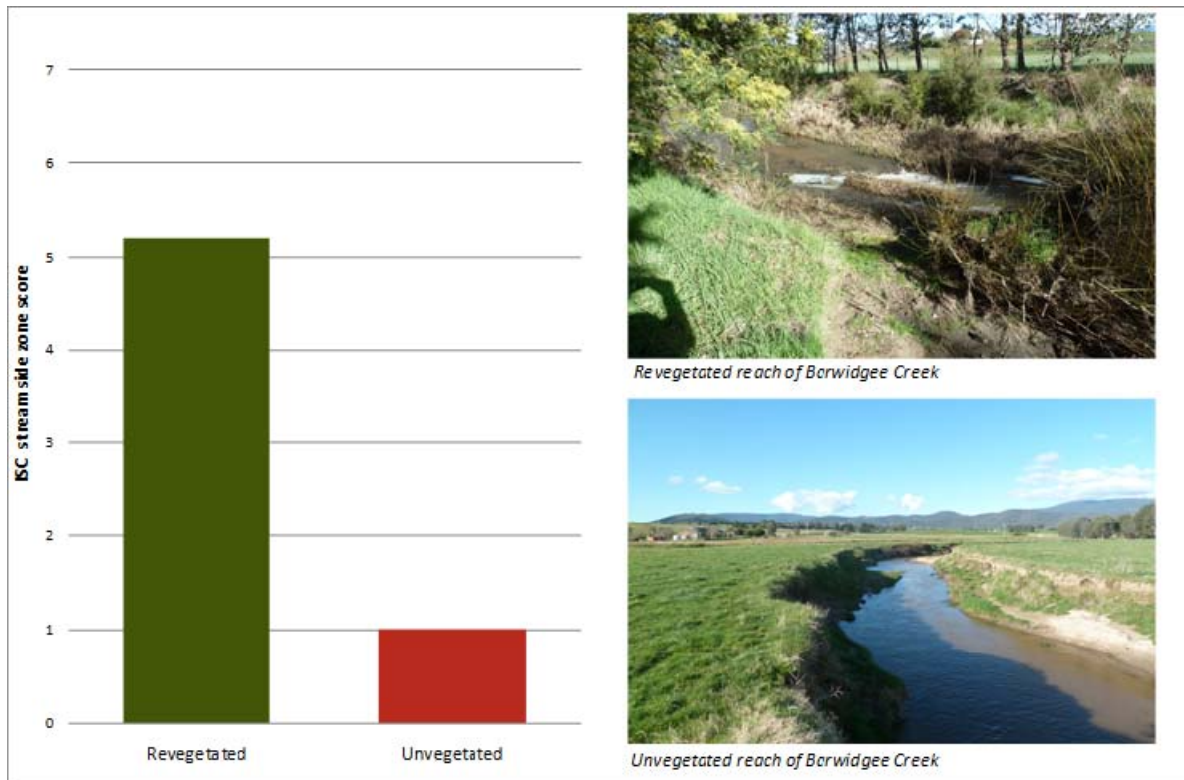
Figure 29. ISC streamside zone scores for the paired sites of Barwidgee Creek

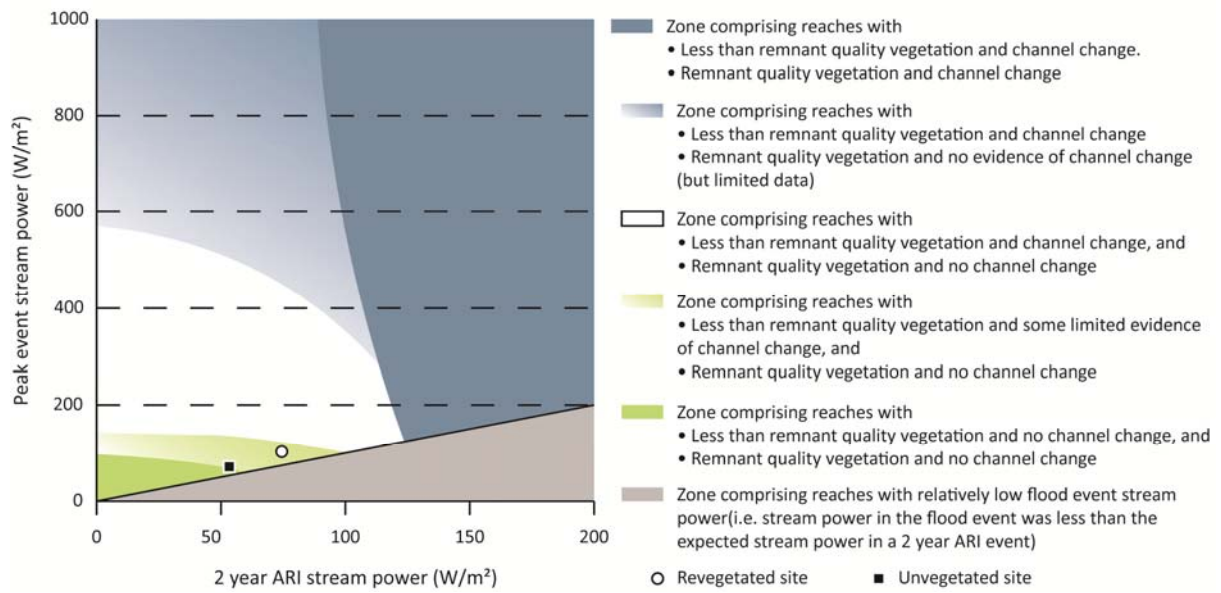
Figure 30. Results from the hydraulic modelling for the paired sites of Barwidgee Creek

The hydraulic modelling indicated that the revegetated reach experienced higher peak stream powers during the December flood event and had a much higher predisposition to channel change (Figure 30). Despite this, the revegetated site was found to be largely intact, with only moderate erosion observed in approximately 20% of the reach. In contrast, the unvegetated reach experienced widespread severe erosion. The critical difference in resisting power appeared to be the revegetation works.
