FINAL REPORT:

An assessment of the impact of riparian revegetation on stream erosion during floods in Victoria

December 2011

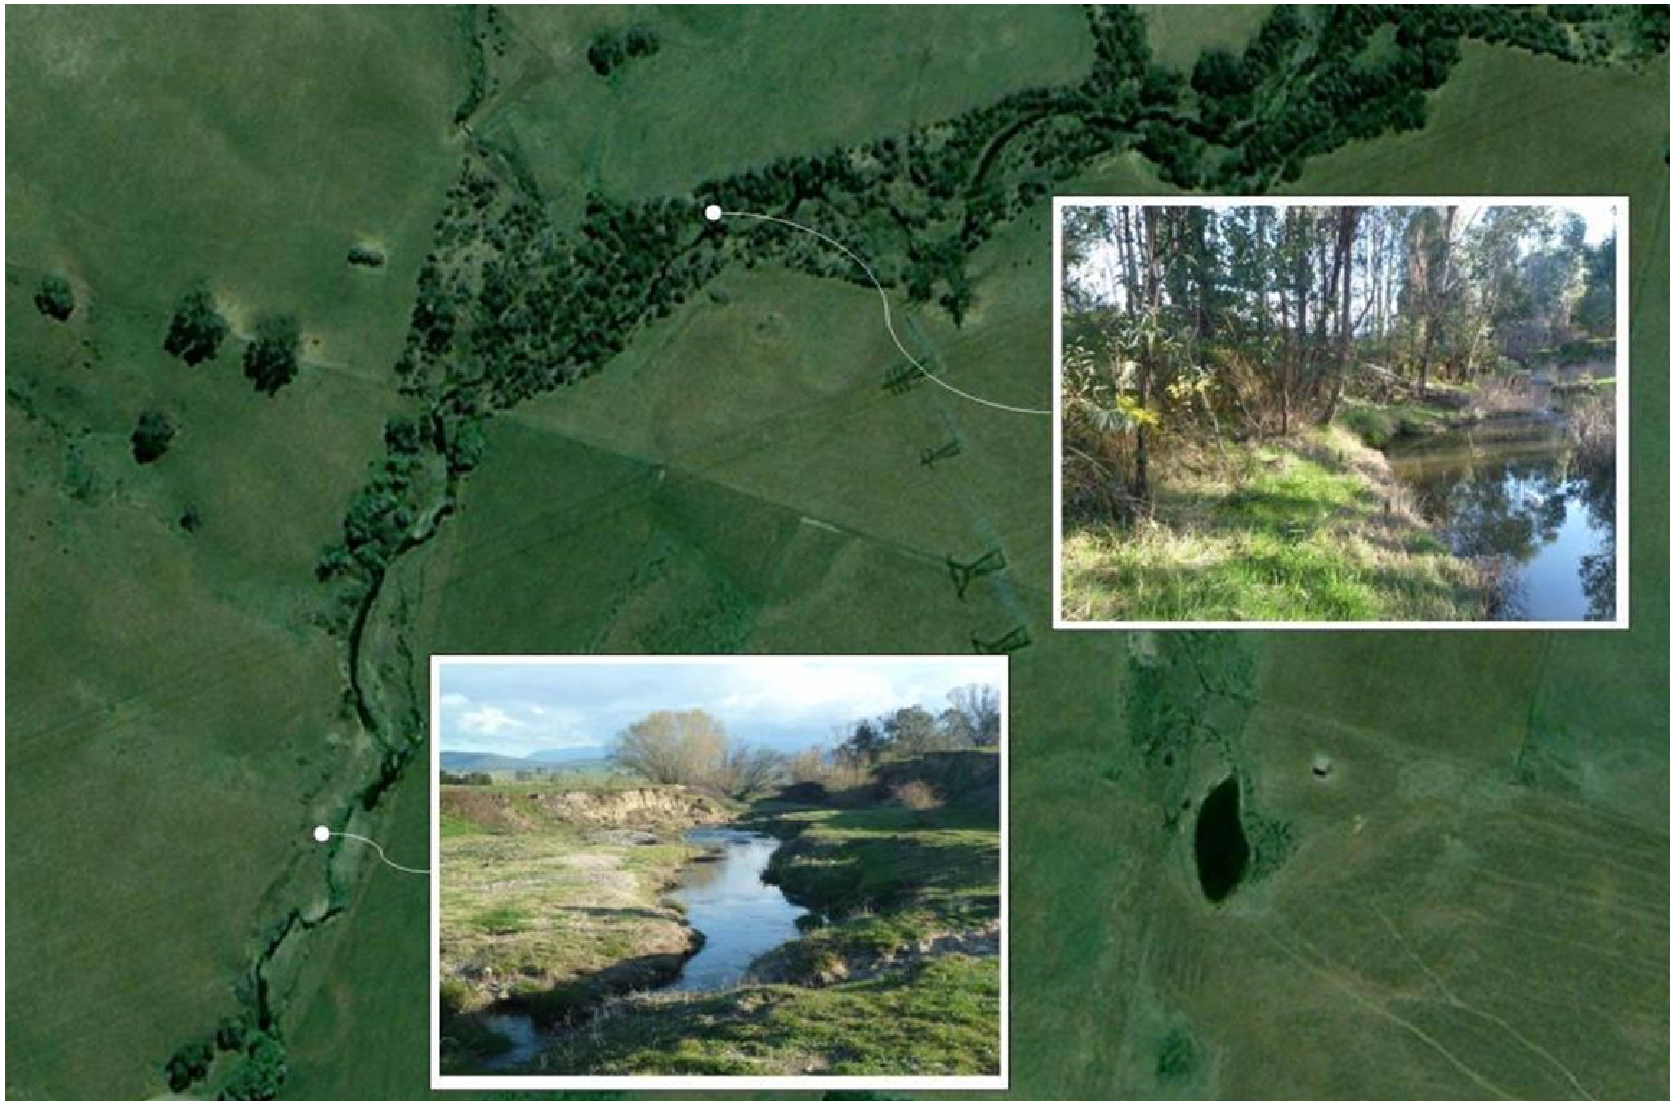
Figure 31. *The paired sites on the tributary of Barwidgee Creek (on the left is the unvegetated reach, while on the right is the revegetated reach)*

The reach had also previously incised (hence the upstream grade control), however the inset channel was narrower than downstream with only localised bank erosion observed. No erosion was observed in the macro channel which was well vegetated. Approximately 20% of the reach was assessed as having minor erosion.

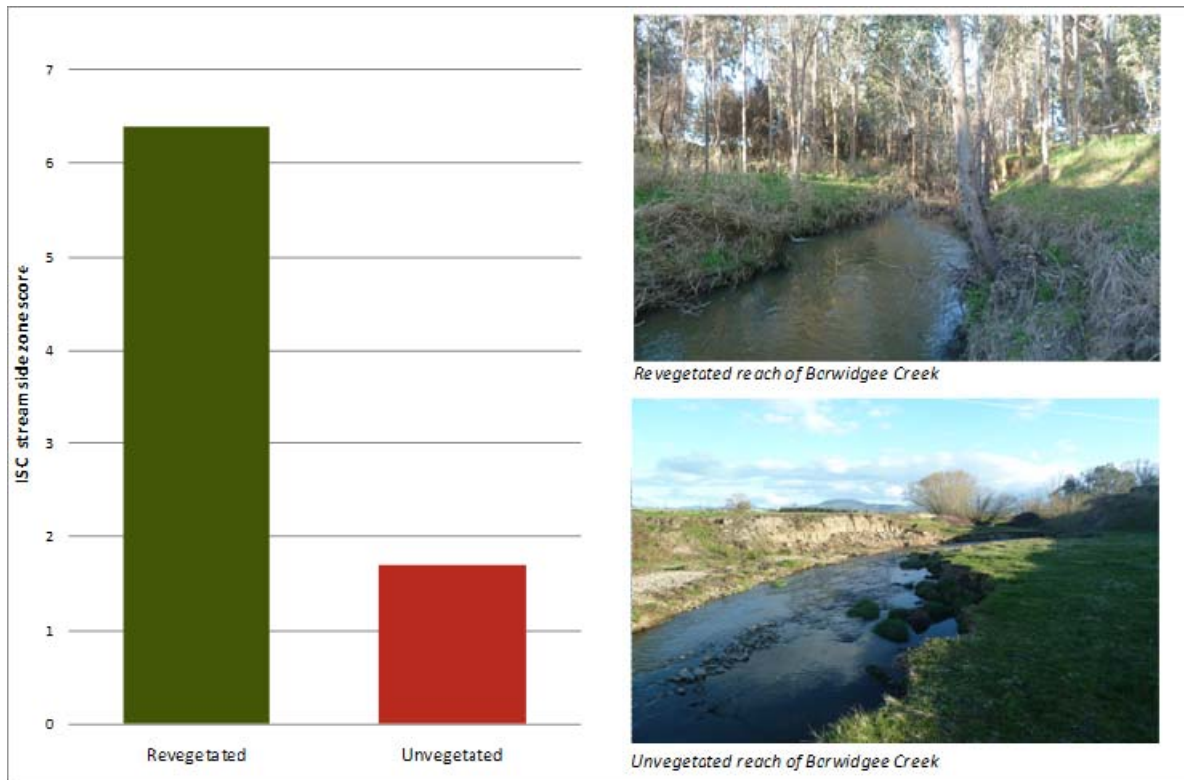
Figure 32. ISC streamside zone scores for the paired sites of the tributary of Barwidgee Creek
