Victorian Water Quality Analysis 2022

Summary Report

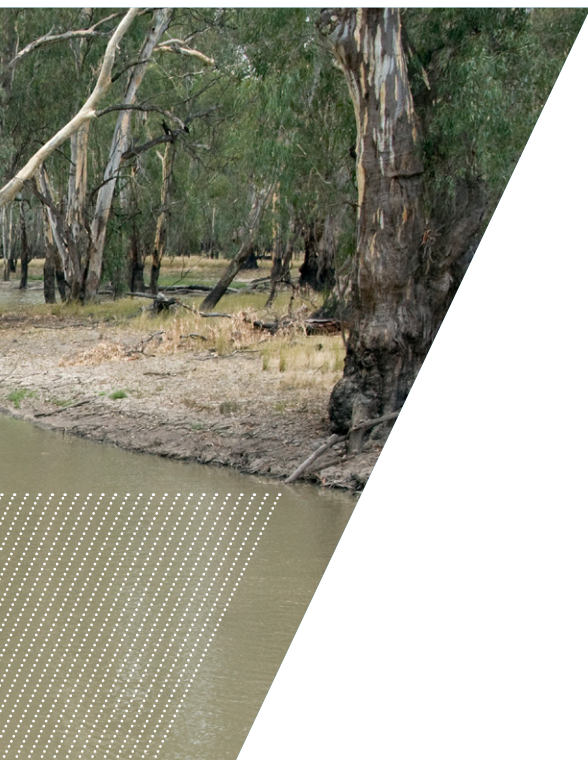
FIGURE 16: Per cent changes in water quality due to changes in streamflow during the Millennium Drought (1997-2009 inclusive) compared with non-drought periods. Positive values indicate an increase in concentration; negative values indicate a decrease.

The study investigated the impact of the Millennium Drought on water quality. Flow reductions led to reductions in total nitrogen, total phosphorus and turbidity, and increases in salinity, all of which were most pronounced in the Murray and Western Plains ERS segment due to larger reductions in streamflow (Figure 16, Figure 17).

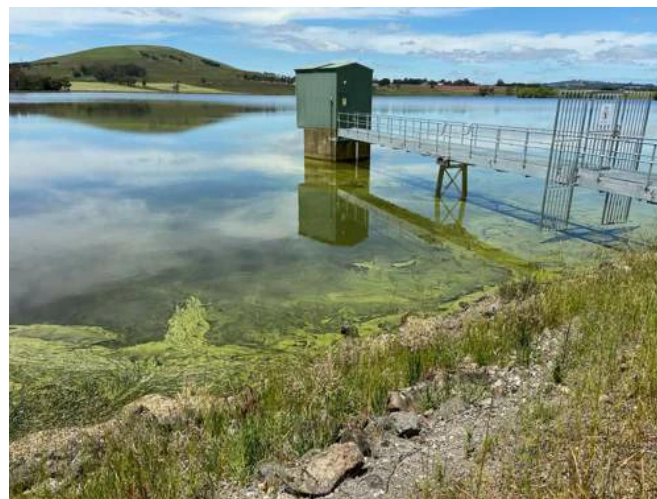
FIGURE 20: Blue-green algae at Newlyn Reservoir in central-western Victoria.

When blue-green algae exceed an accepted trigger level at a water body (e.g., reservoirs, lakes), water managers issue warning for recreational uses for this water body. Therefore, this analysis focuses on the periods of these recreational warnings as an indicator of blue-green algal bloom events.

The study identified 16 water bodies monitored regularly by Goulburn-Murray Water, Grampians Wimmera Mallee Water and Southern Rural Water and examined the data for changes in frequency, duration, and time of year of blue-green algal bloom events leading to recreational notifications. The study further investigated possible drivers of any patterns.

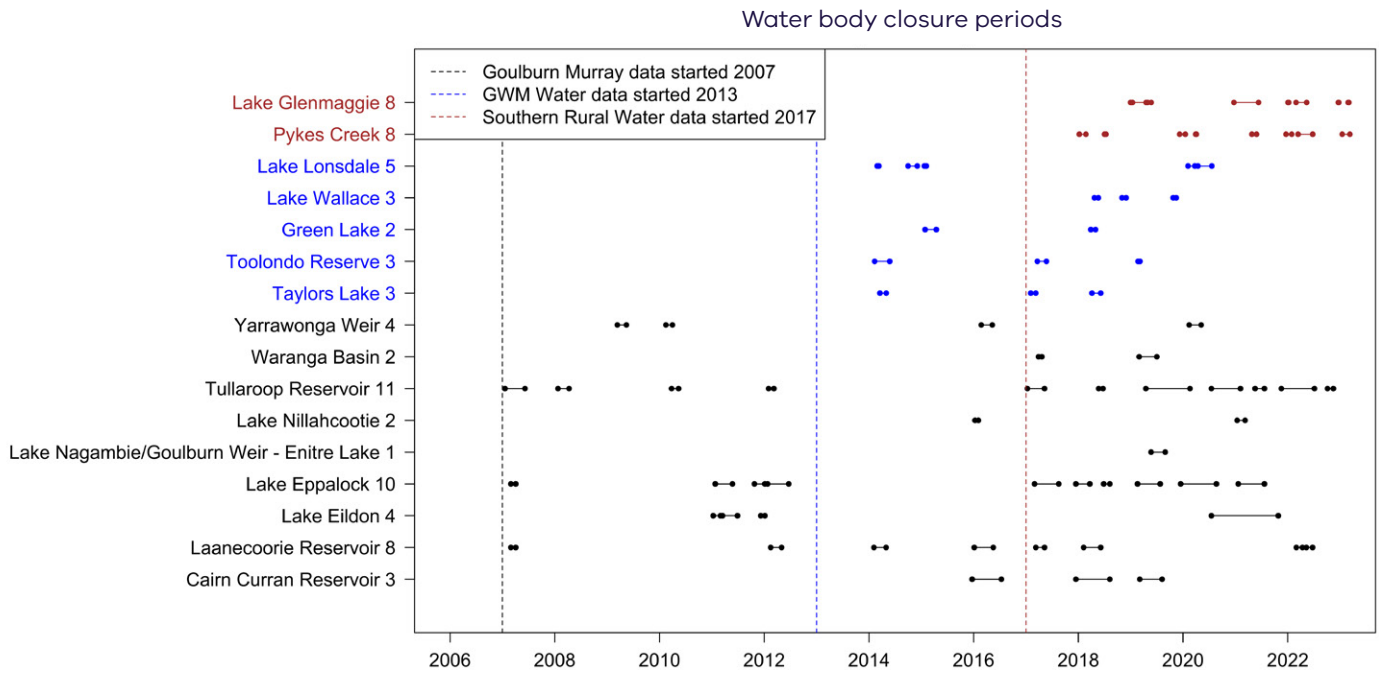
FIGURE 21: Summary of the periods of all blue-green algal bloom warnings issued across storages managed by Goulburn-Murray Water, Grampians Wimmera Mallee Water and Southern Rural Water. After the names of the water bodies is the total number of blue-green algal bloom warnings. The colours indicate the local water managers that issue warnings for each water body: Goulburn-Murray Water, Grampians Wimmera Mallee Water, and Southern Rural Water.

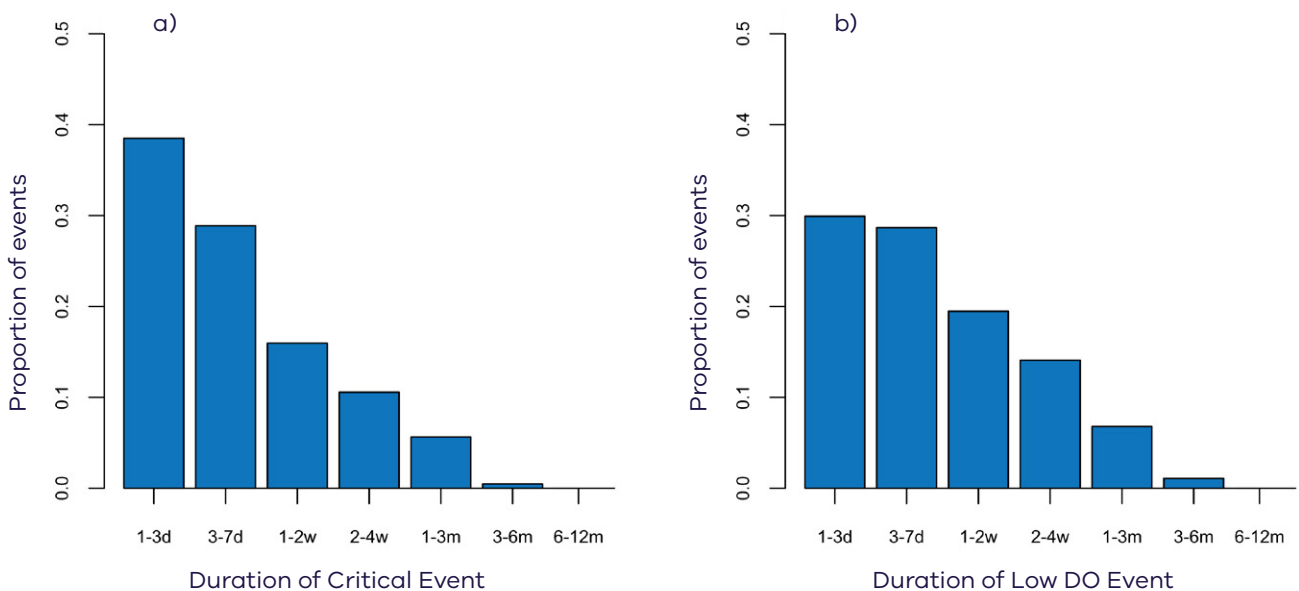
FIGURE 23: Duration of a) critical DO events and b) low DO events.

The typical duration of critical and low dissolved oxygen events was days to weeks, with approximately 67% of critical and 59% of low DO events lasting less than a week; and 94% of critical and 92% of low DO events lasting for less than a month (Figure 23).
