# Stream Change Assessment: detecting change in riparian woody vegetation using LiDAR derived data

The Stream Change Assessment project (SCA) re-sampled a subset of ISC river reaches using LiDAR from 2018 to 2020, to assess changes in woody vegetation since the 2010 ISC capture.

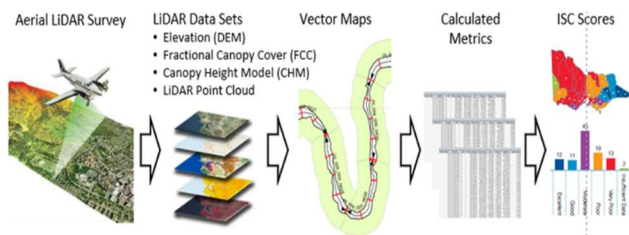
### Steps for using LiDAR to map and quantify riparian vegetation

Methods for LiDAR capture and processing are described in DELWP (2022), but involved five steps:

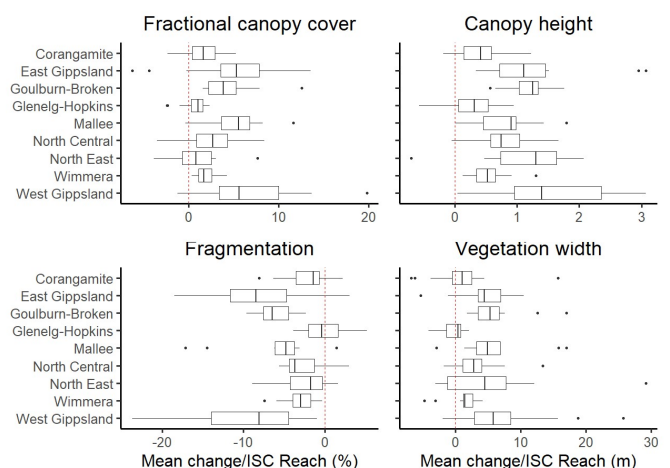
**Summary of changes in vegetation metrics. Boxplots show the mean change between times across all ISC reaches in each CMA region. The red dashed line designates no change between assessment periods.**

Changes in individual woody vegetation metrics were variable, but more pronounced than changes in ISC Streamside Zone scores:

- Increases were evident in fractional canopy cover, especially in areas with higher rainfall (Gippsland) or where flooding and/or water management had occurred (Mallee).
- Corresponding increases in vegetation width and canopy height were also apparent as were decreases in fragmentation.

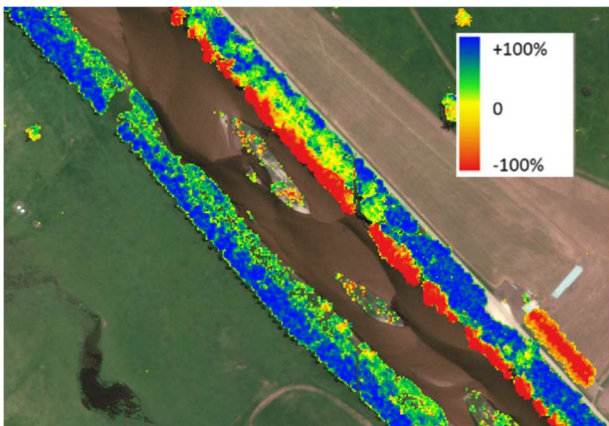
**Snowy River. Changes in fractional canopy cover between 2010-2018 are shown as a gradient from red (100% decrease – likely woody weed removal), yellow (no change), to blue (100% increase – due to revegetation).**

The largest changes were observed at smaller sections of stream within ISC reaches. These were usually several kilometres long and areas where substantial and/or sustained riparian management had been undertaken.

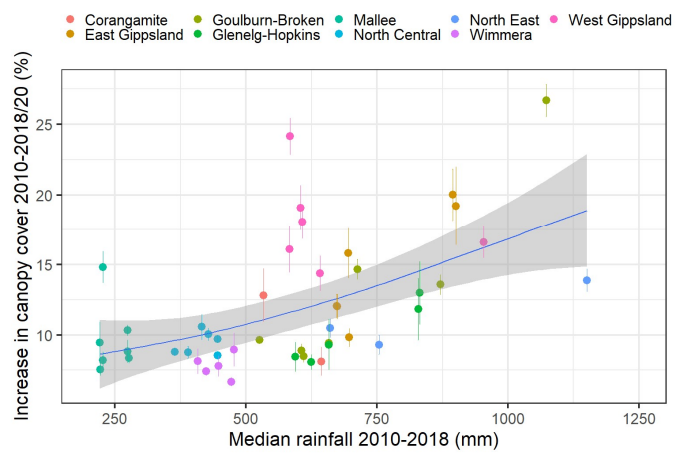
**Relationship between increases in fractional canopy cover and rainfall at ISC reaches. Each point represents the mean increase in canopy cover at an ISC reach, with 95% confidence intervals. Blue line is the average increase (grey shading 95% confidence interval) from a generalised additive model.**

Preliminary work suggests that rainfall is an important driver of variability in woody vegetation responses across the state, with canopy cover increasing by >10% at all ISC reaches with >800 mm median annual rainfall.
