Stream Change Assessment: detecting change in riparian woody vegetation using LiDAR derived data

April 2022

Catchments, Waterways, Cities and Towns, Waterway Programs Branch

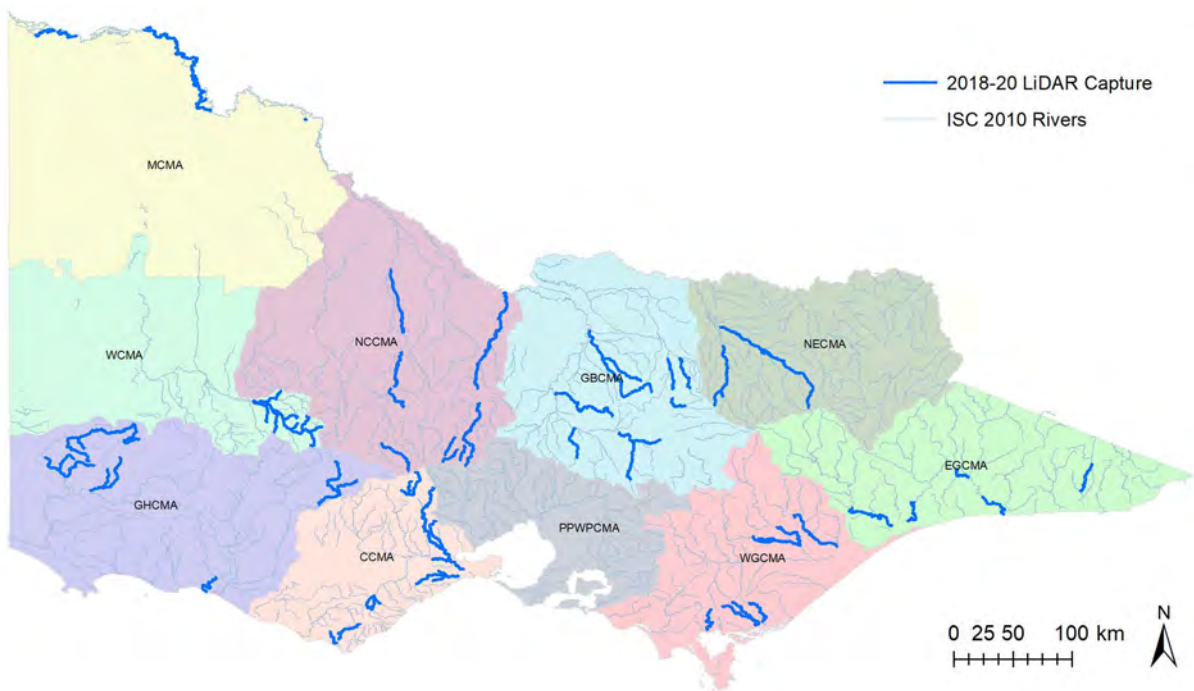
Figure 1 Subset of ISC streams resampled by LiDAR in 2018–2020

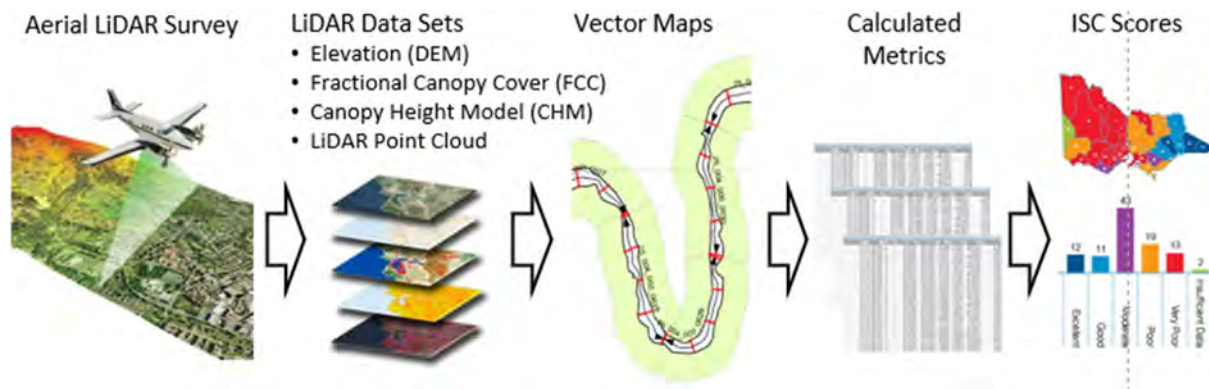
Figure 2 Steps for using LiDAR to map and quantify riparian vegetation

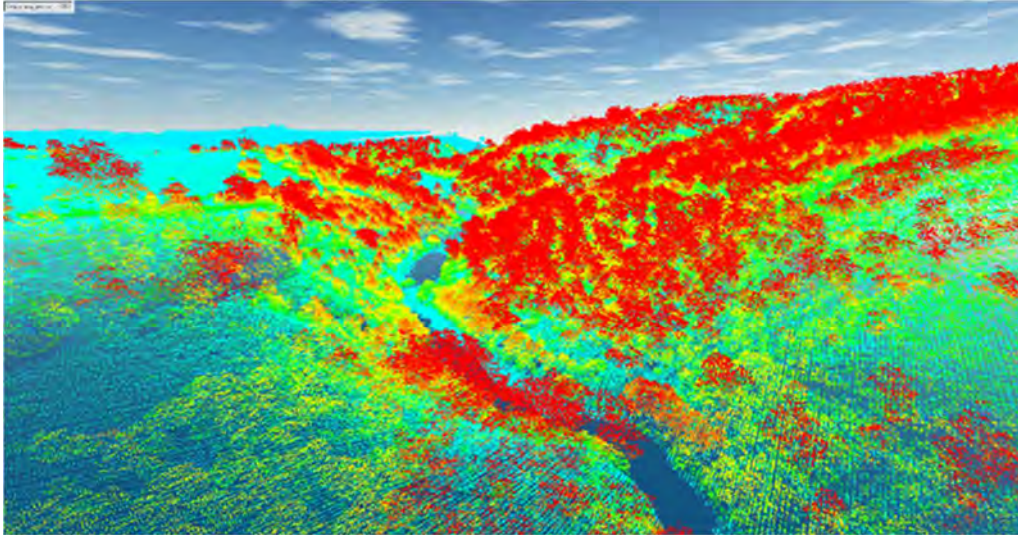
Figure 3 Example of LiDAR scan point cloud showing the stream channel and adjacent vegetation.

Airborne LiDAR uses reflected laser pulses from a light aircraft to measure the distance to the ground. Each laser pulse can also be reflected from other surfaces including vegetation and buildings but not from water which absorbs the laser light. For the 2010 ISC3 and this project, the scan density was a grid with approximately 4 laser pulses for every m² of land surface, with multiple heights being recorded from each pulse due to partial reflections from overlying vegetation. The height measurements are geo-referenced to create a “point cloud” that is a 3-dimensional computer representation of the landscape (Figure 3). Vertical and horizontal accuracy is supplied with associated metadata for each capture area but is approximately 0.3m and 0.2m, respectively.

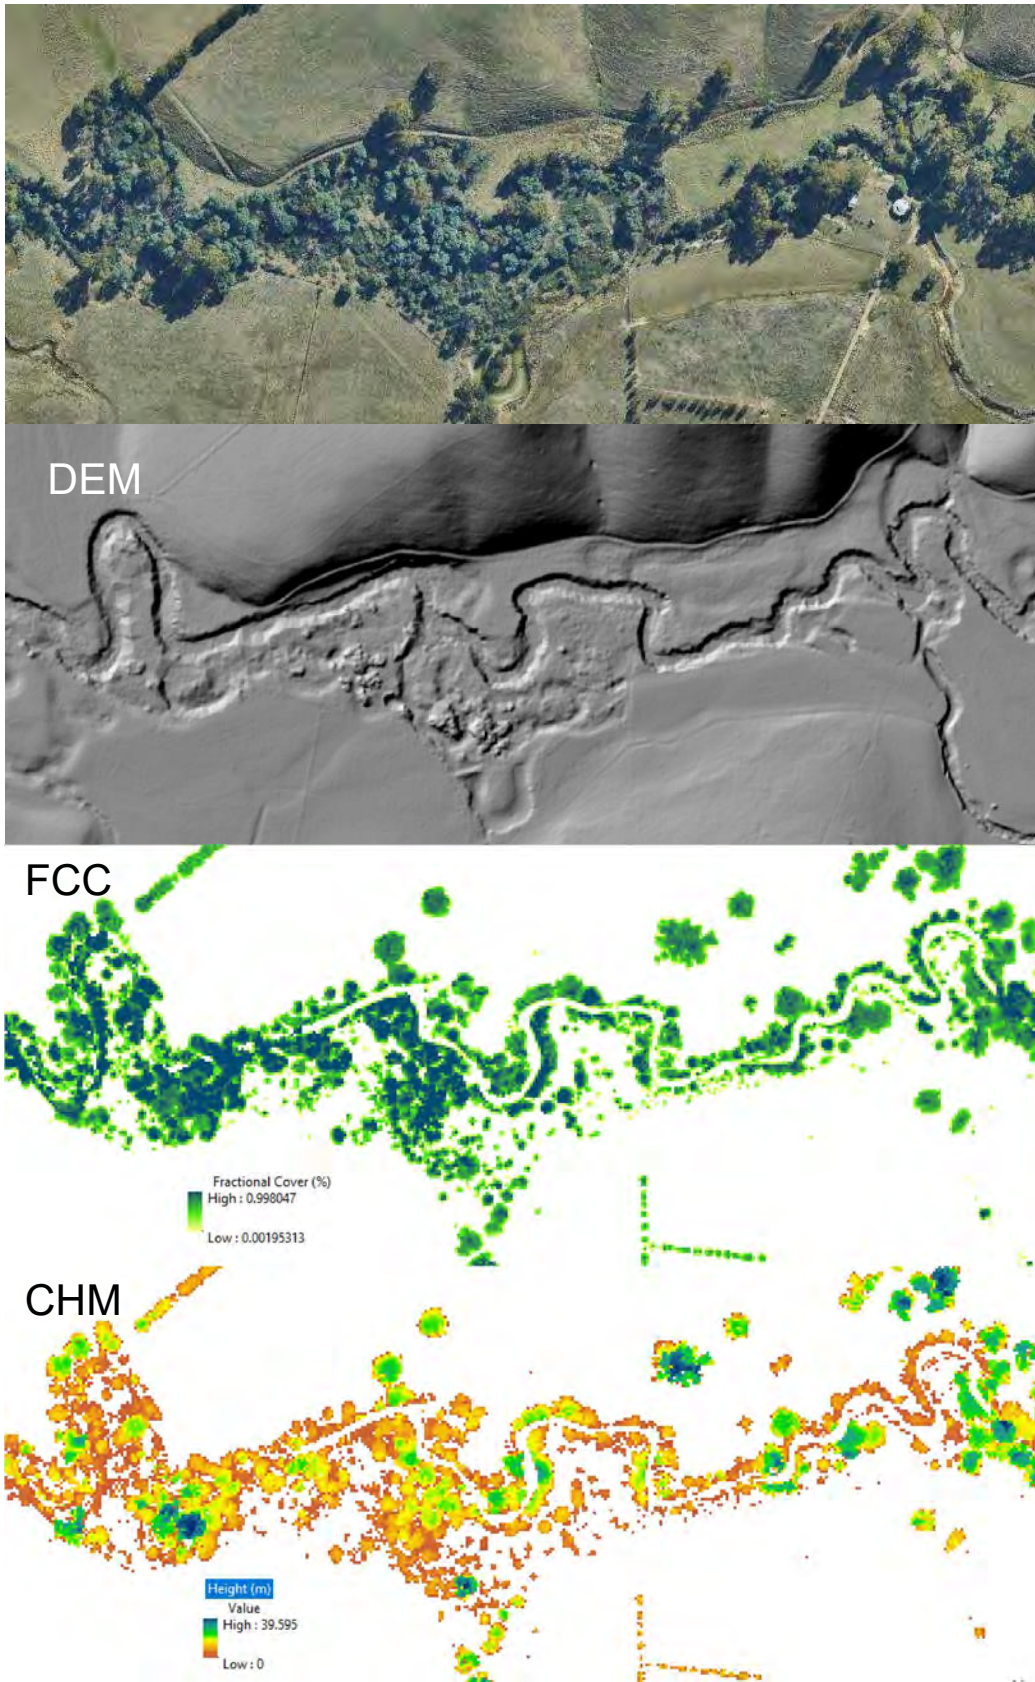
Figure 4 Example showing an aerial photo from a short section of King Parrot Creek (top) along with the associated 1m resolution Digital Elevation Model (DEM) and 2m resolution vegetation Fractional Canopy Cover model (FCC) and Canopy Height Model (CHM) that are derived from the LiDAR point cloud.

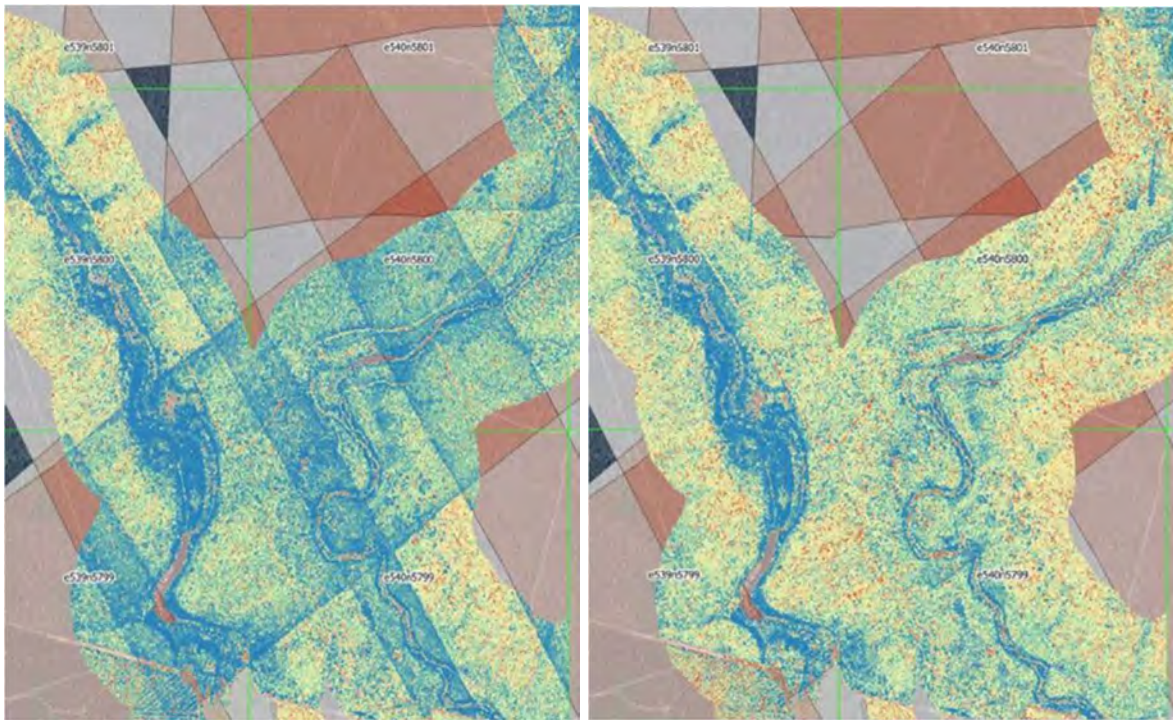
Figure 5 Duplicate counting of vegetation in overlapping passes of the aircraft (left) compared to corrected data (right). Higher vegetation cover is represented by blue colours and red rectangles in the background are the flight path of the aerial LiDAR aircraft.

Inspection of the 2010 ISC Fractional Cover data revealed banding of elevated vegetation cover associated with overlapping data collection flight paths in Glenelg-Hopkins and Mallee regions that were not visible in other CMA regions (Figure 5). The anomalies appear to be due to differential processing of ground reflections vs vegetation reflections with points from overlapping swathes removed from the ground layer thus inflating the FCC (and associated metrics). This was corrected by reprocessing the LiDAR point cloud data to remove the extra points in the overlap zones before regenerating the FCC outputs (Figure 5).

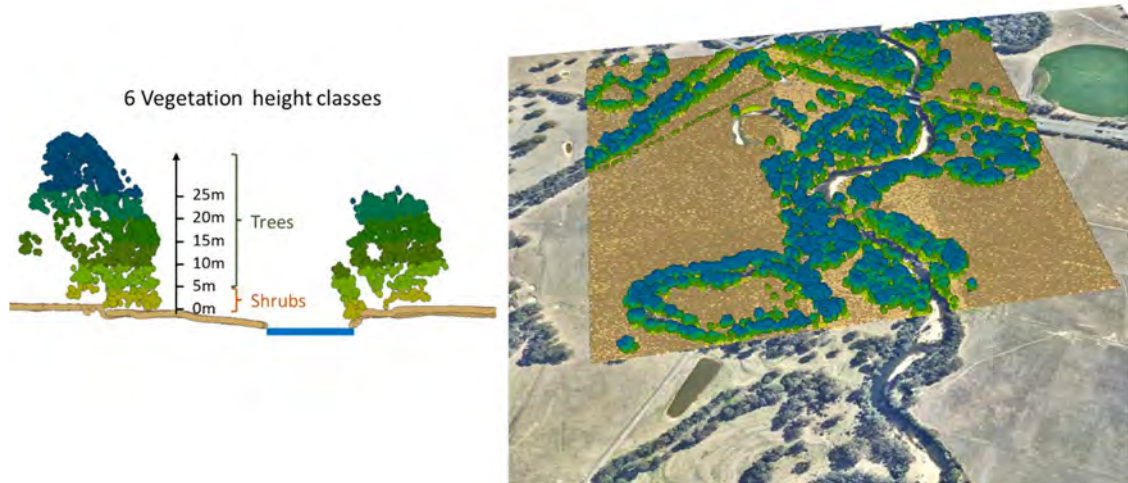
Figure 6 Illustration of fractional canopy cover in the six different height interval classes (left panel), and example showing the distribution of different height classes at the Owens River (right panel).

The revised formula for Height Interval FCC represents the industry standard for representing fractional canopy cover and the 2018-20 data was supplied using this approach. To facilitate a reliable assessment of change between the 2010 and 2018-20 data it was necessary to recalculate the FCC for 2010 using this new formula so that both time periods represented vegetation cover in the same way.

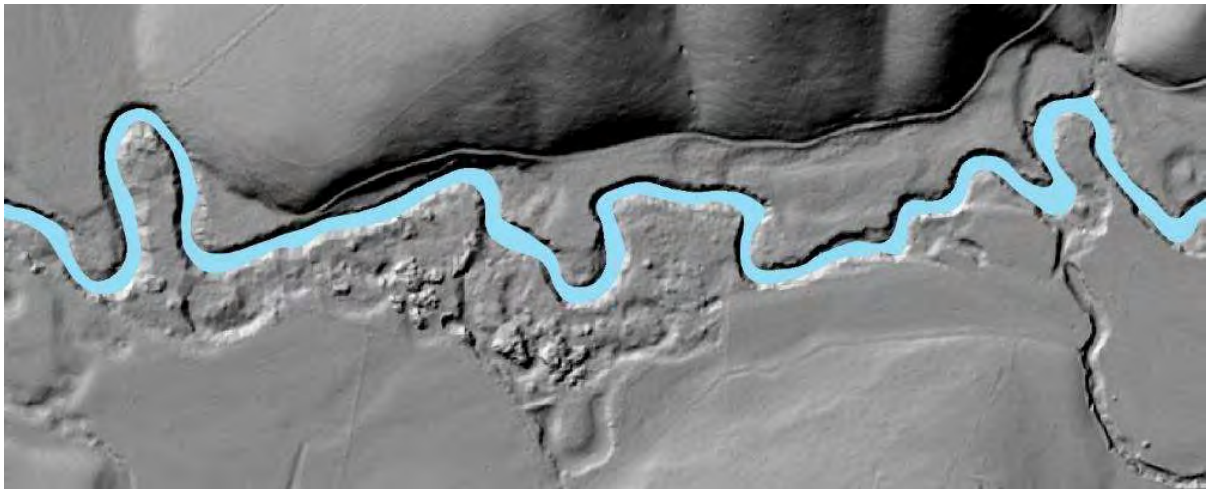
Figure 7 Example showing the river bed mapped from the DEM (photo shown in Figure 4).

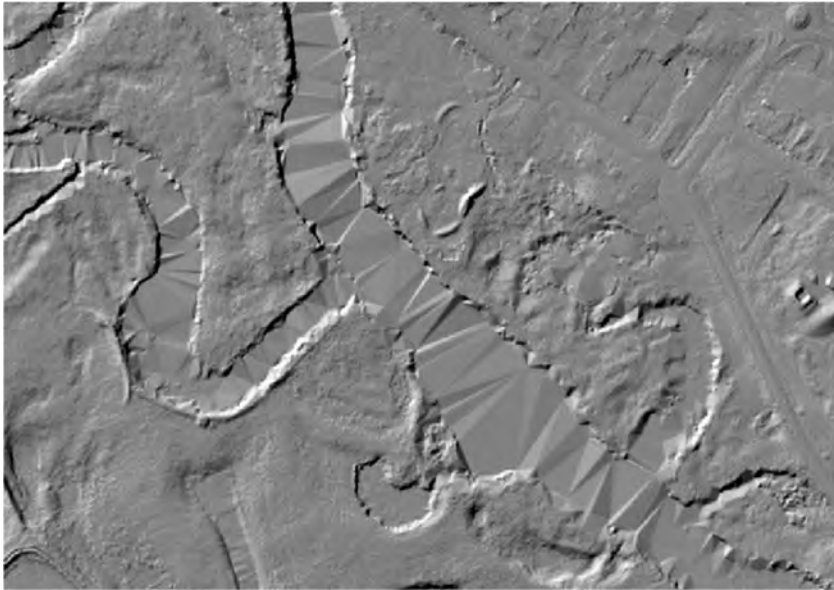
Figure 8 Triangular artefacts in the river channel in the DEM are caused by interpolation across the water from artificially high points on the bank where LiDAR is measuring the canopy of dense vegetation and not the ground.

The difficulty in automating the streambed mapping was related to artefacts in the DEM caused by artificially high points along the bank. These high points occur where LiDAR reflections from the canopy of dense riparian vegetation are miss-interpreted as ground points. Triangular artefacts in the river channel of the DEM (Figure 8) occur where the DEM is interpolated across the channel to fill gaps in the data where water absorbed the LiDAR laser pulses. A process was developed to flatten the water surface, but this was not successful in all cases and some manual editing was still required.

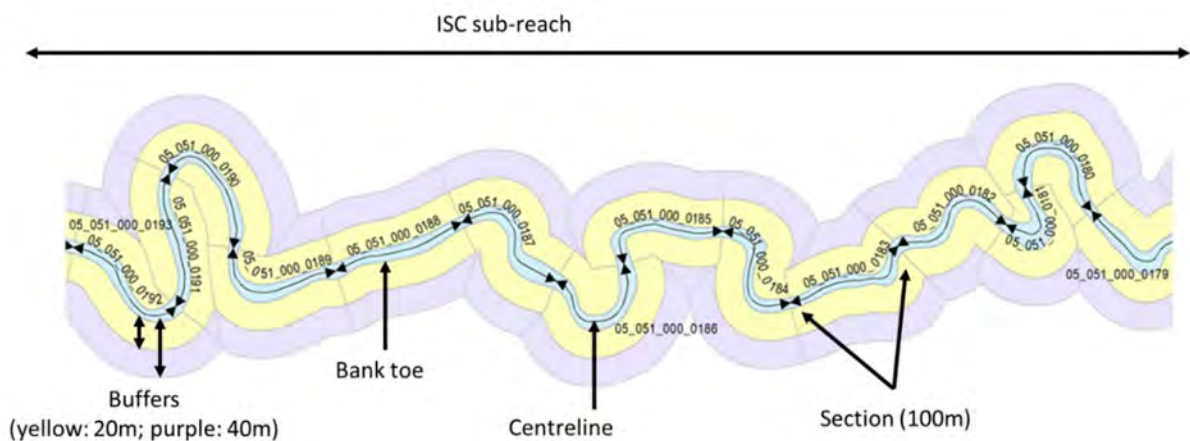
Figure 9 Vector data products for a section of an ISC sub-reach, derived from the streambed (blue) include the centreline divided into 100m sections, with buffers of different width extending from the toe of the bank.

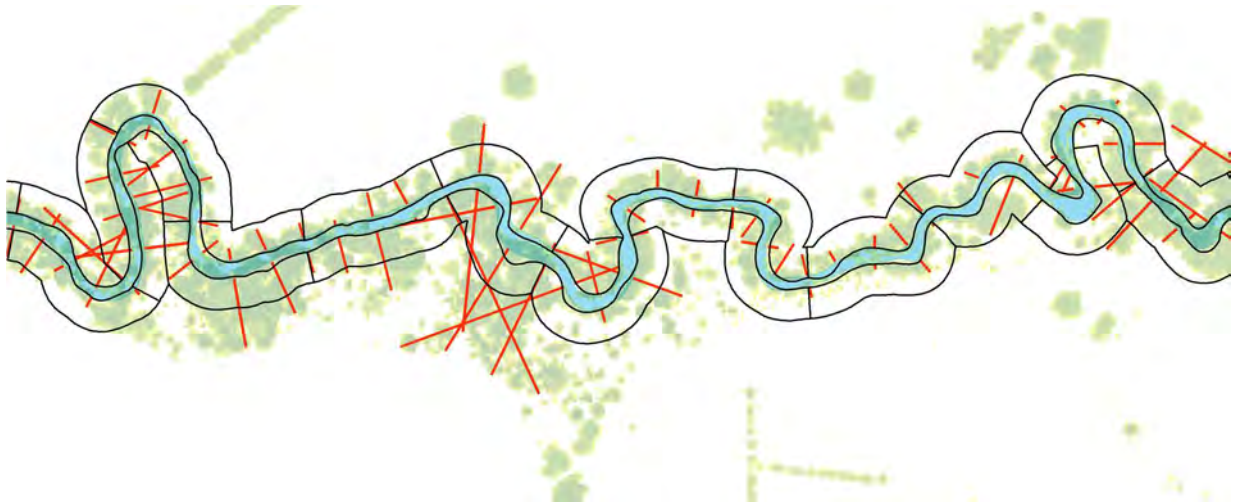
Figure 10 The woody riparian vegetation FCC (green) is used in combination with the vector line mapping to generate metrics. Vegetation width is shown in red. Vegetation overlapping the streambed maps overhang, vegetation overlapping the area for riparian vegetation assessment is used to map cover, height and structure, and the gaps between the vegetation map fragmentation.

Fragmentation (%)	<ul style="list-style-type: none"> Represents gaps in vegetation cover Defined as any areas where Overall FCC is less than 20% for an area of least 10m x 10m (essentially the white-space in Figure 10) Measured in each 100m section as the proportion of the assessment area that is classified as gap
Overhang (%)	<ul style="list-style-type: none"> Represents shading of the river bed Calculated as the proportion of the toe of bank line that is overlapped by woody vegetation with FCC > 20%
Large Trees (%)	<ul style="list-style-type: none"> The canopy area of large trees is mapped by recording contiguous areas of vegetation with FCC > 20% with minimum crown height and diameter determined from EVC benchmarks (lookup table in Fugro 2013) Calculated as the proportion of the section that is defined as "Large Tree Canopy" (Figure 11)
Structure 1 (Trees and Shrubs)	<ul style="list-style-type: none"> Uses the vegetation FCC in two height classes. Shrubs are defined as the vegetation < 5m in height Trees are the vegetation >5m in height Calculated as the average FCC for each height class within each 100m section

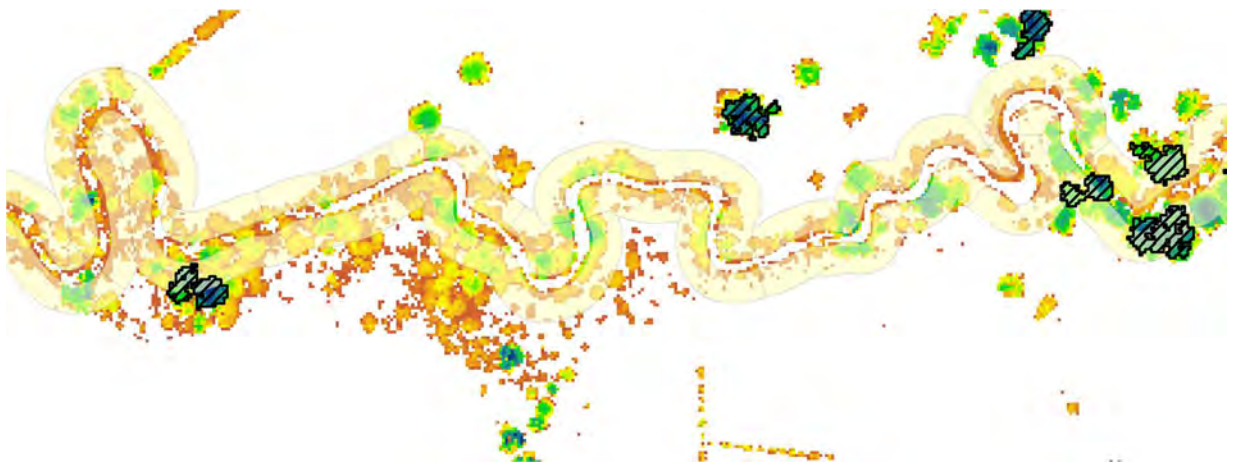
Figure 11 Large Trees are shown as hashed areas over the LiDAR CHM. This area of King Parrot Creek is Floodplain Riparian Woodland (EVC 56) where large trees are defined as having a minimum height of 20m and minimum crown area of 400m² (20m x 20m).

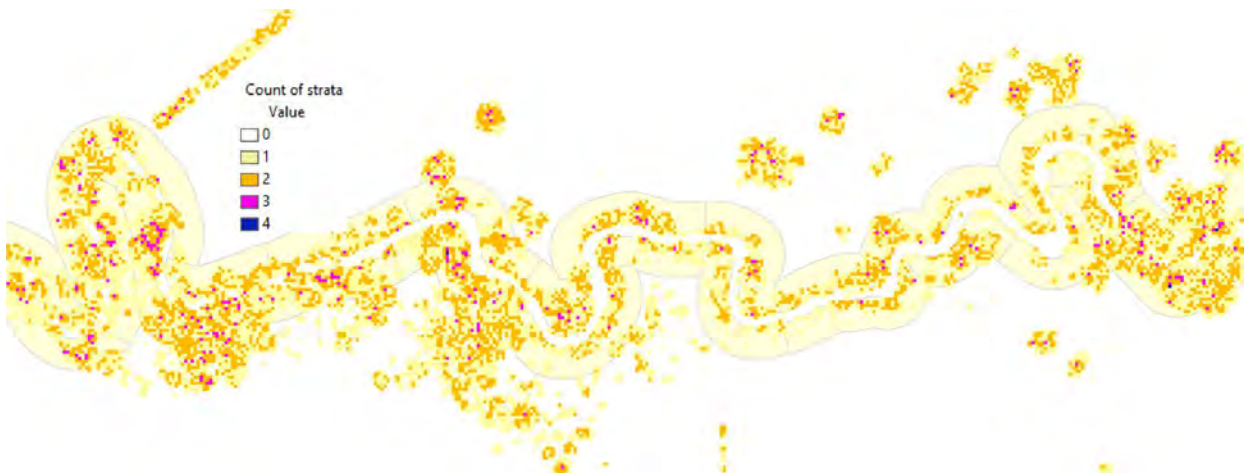
Figure 12 The Structure 2 metric is the count of 5m height classes present with FCC > 20%.

Structure 2	<ul style="list-style-type: none"> A structure 2 raster layer is created where each 2m x 2m pixel represents a count of the number of strata layers with FCC > 20% Stratum layers are defined in 5m increments as <5m, 5-10m, 10-15m, 15-20m, 20-25m, 25m-99m Calculated as the average Structure 2 pixel value within each 100m section (Figure 12)
Weeds (Willows and Hawthorn)	<ul style="list-style-type: none"> Woody weeds were mapped for the 2010 ISC as line features representing the longest width of the weed patch. The weeds metric is the mapped length of weeds as a proportion of the 100m section length

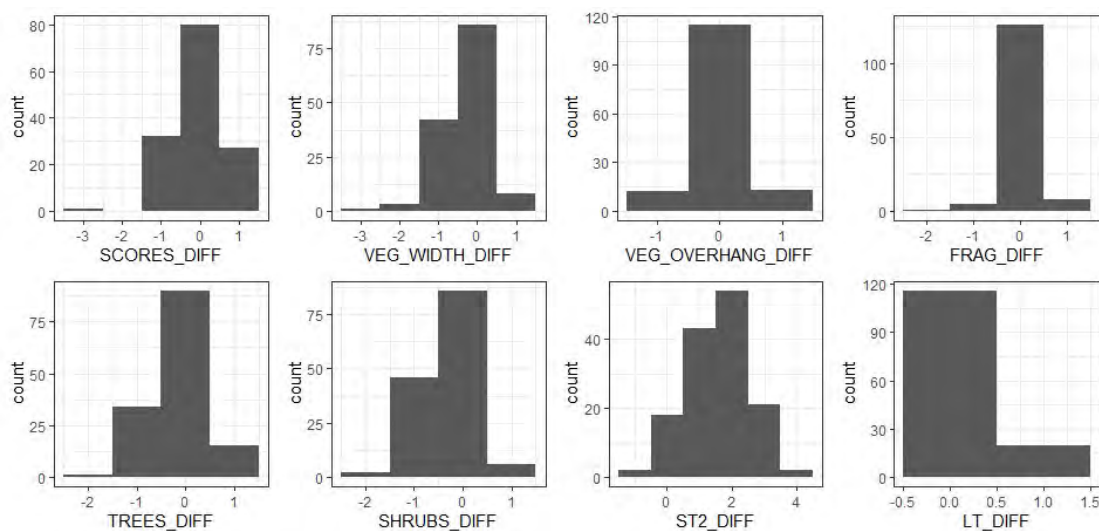
Figure 13 Illustration of how differences in calculation of metrics (at 141 ISC reaches sampled for the SCA) have altered Index of Stream Condition Streamside Zone Scores (Scores_diff) and seven metrics (Vegetation width, Vegetation overhang, Fragmentation, Tree cover, Shrub cover, Vegetation structure, Large trees; see Table 3 for details). The x-axis shows the difference as re-processed value – original ISC 2010 value; the y-axis shows the count of number of ISC reaches.

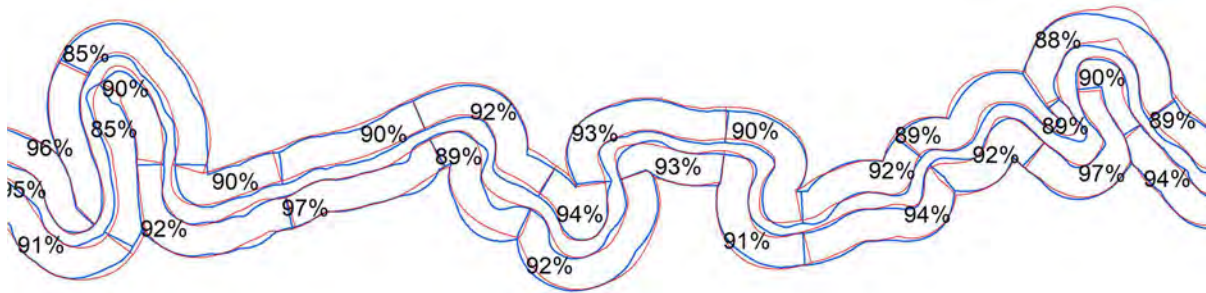
Figure 14 Percent overlap in sections between 2010 (blue) and 2018 (red) for a section of King Parrot Creek shown in Figure 4.

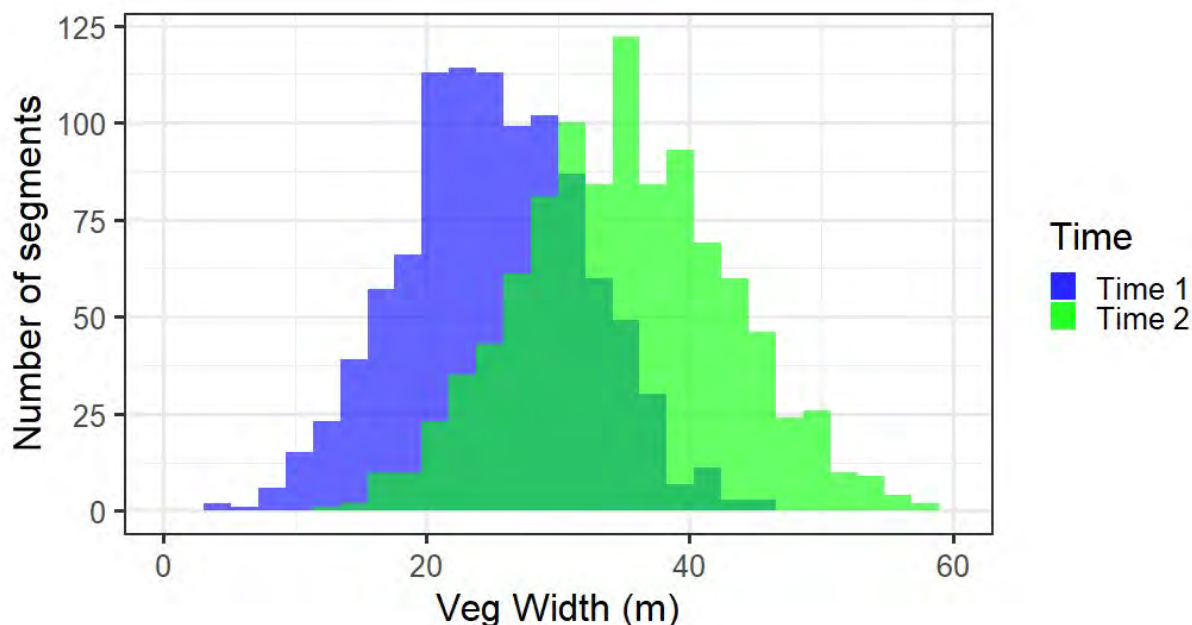
Figure 15 Histograms showing summary of vegetation width at 1000 hypothetical sections in two times.

Three pieces of information are presented in the results section of this report to visualise and evaluate changes in riparian metrics. First, histograms are presented showing the distribution of values for each vegetation metric in each of the two assessment periods. For instance, in Figure 15, data from 1000 hypothetical “sections” (i.e. analogous to the 100m sections shown on each river bank in Figure 14) shows vegetation width in Time 1 (blue) and Time 2 (green). We can see that while there is overlap in the two histograms between the two time periods, in Time 2 many of the sections have a greater vegetation width (note green sections above ~30 m versus blue sections below ~30 m). This provides a visual representation of the data from each time period, providing one way to quickly evaluate changes of interest.

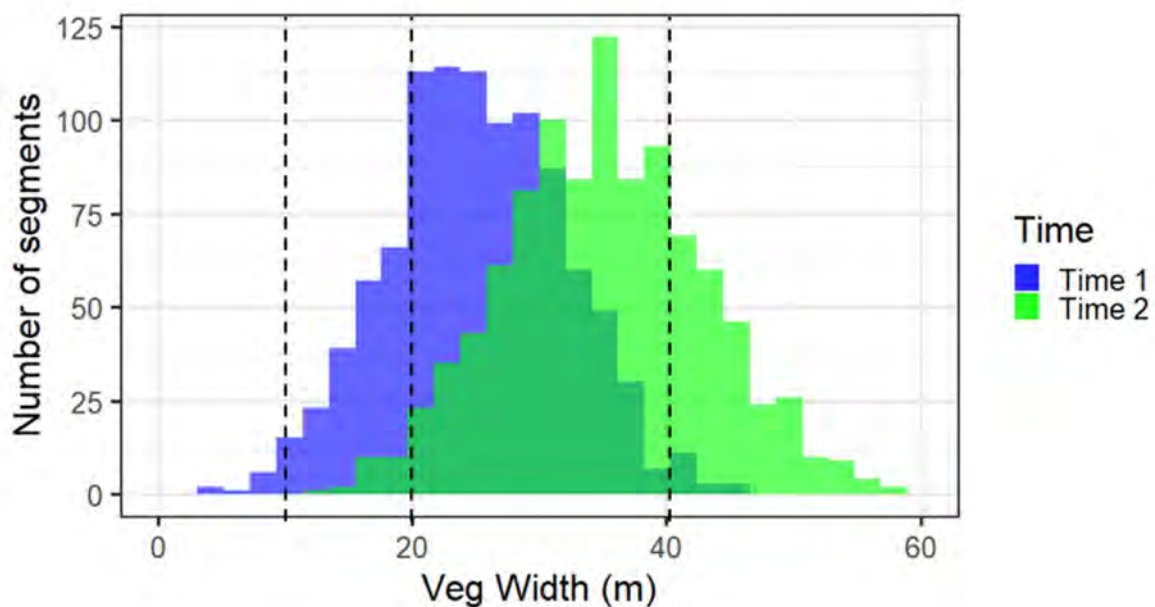
Figure 16 Histograms showing summary of vegetation width at 1000 hypothetical sections at Time 1 and Time 2. The box at the top shows the % of sections where the vegetation width exceeds 10m, 20m and 40m in the two periods and the % change in the proportion of sections above these thresholds.

>10m	>20m	>40m
% Segments above threshold (Time 1)	97	76	2
% Segments above threshold (Time 2)	100	97	27
% change Time 1 to Time 2	+3	+19	+25

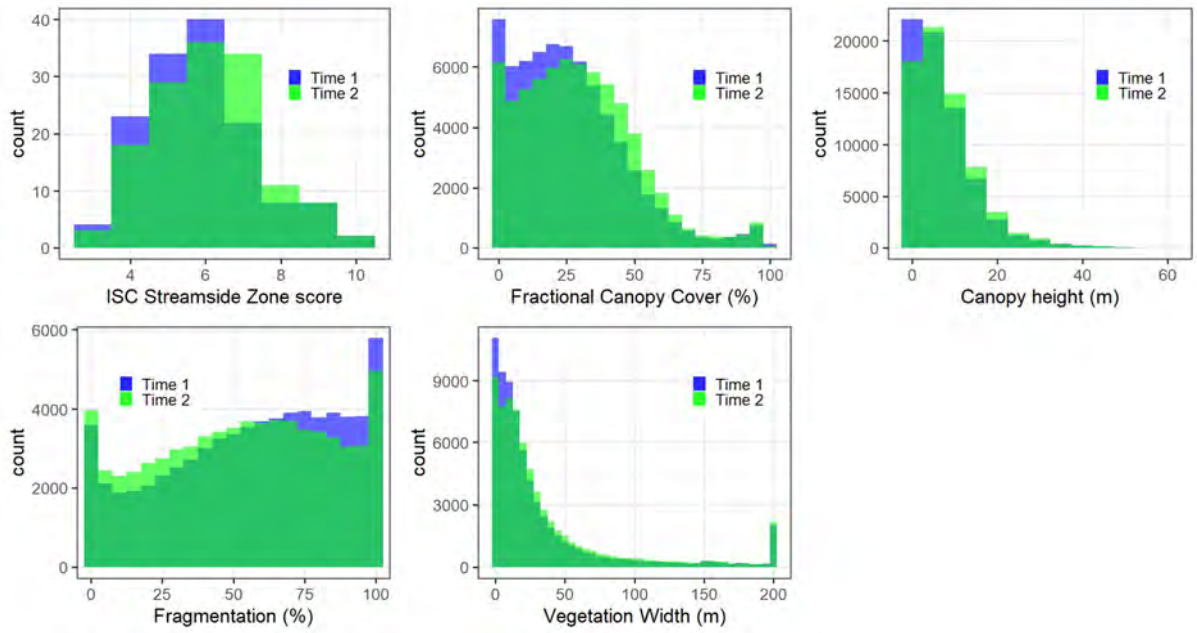
Figure 17 Changes in Streamside Zone ISC scores and the five riparian vegetation metrics at CMAs sampled across the state. The count on the y-axis is the number of ISC reaches for the ISC Streamside Zone score panel and the number of sections for all other panels.

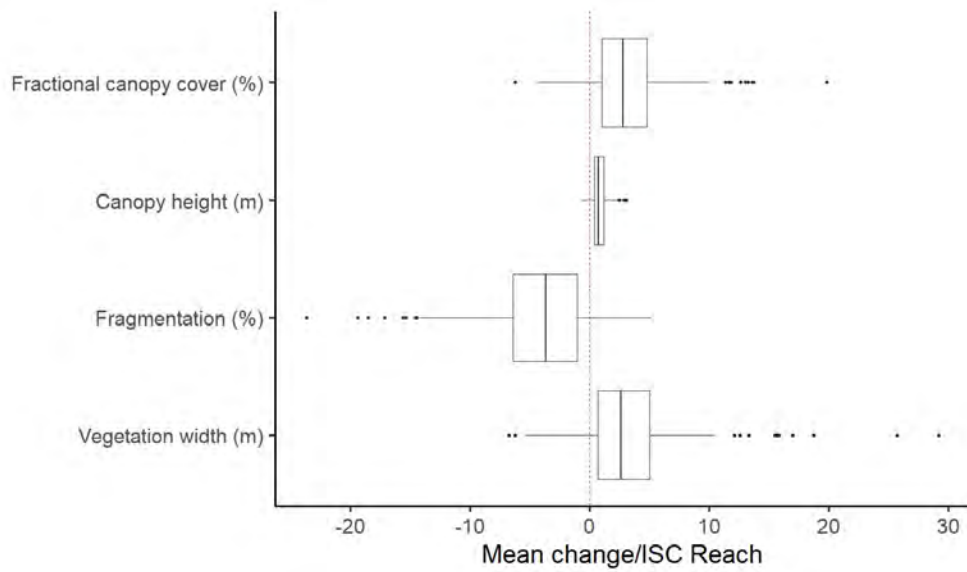
Figure 18 Summary of changes in vegetation metrics across the state. The change in each vegetation metric was calculated (i.e. metric value in Time 2 – metric value in Time 1) at each section, and then the averages of these sections taken at each ISC reach.

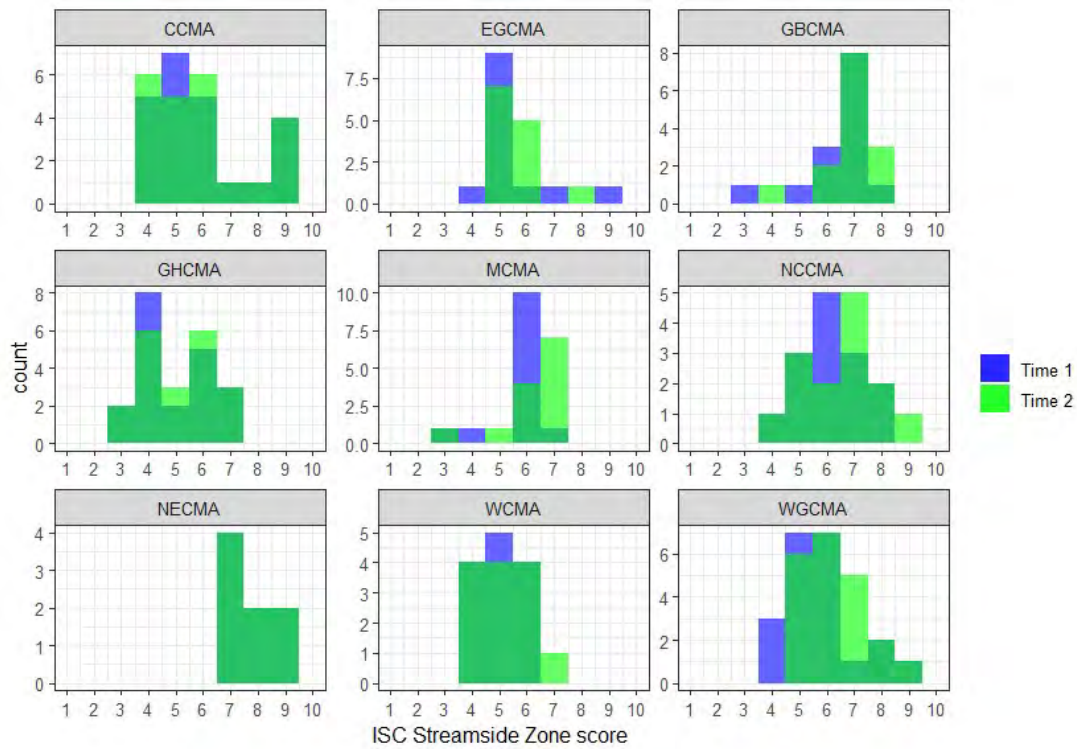
Figure 19 Changes in ISC Streamside Zone ISC scores across CMA regions. The count on the y-axis is the number of ISC reaches.

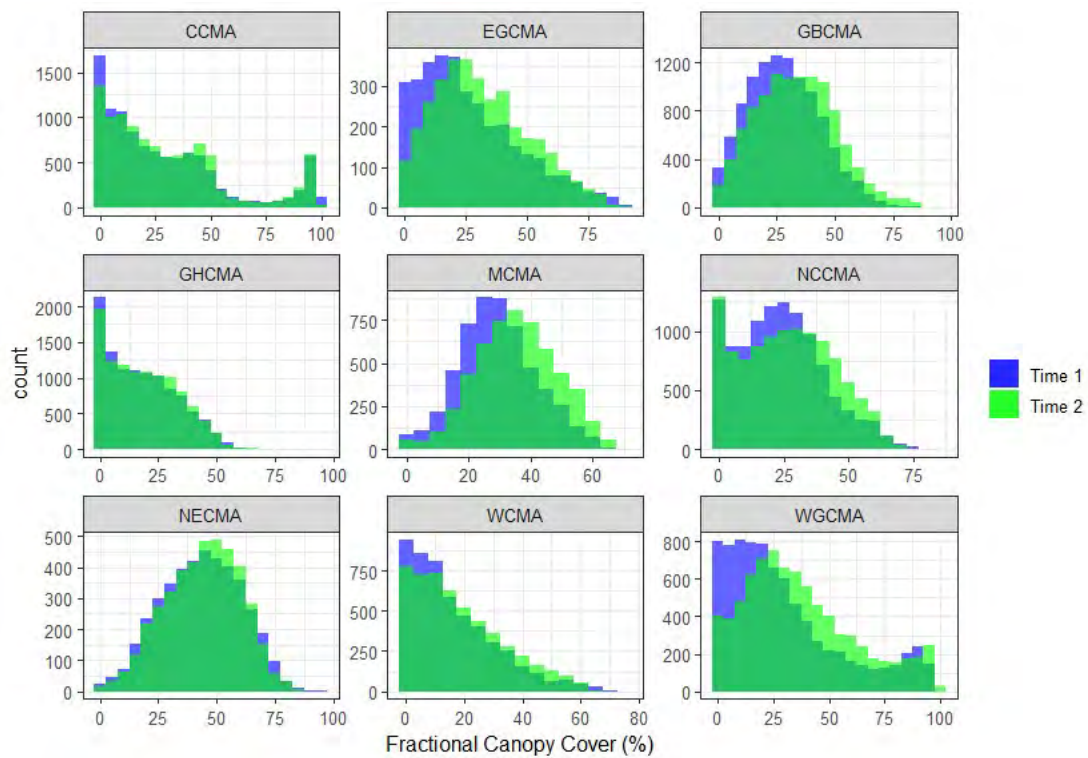
Figure 20 Changes in fractional canopy cover across CMA regions. The count on the y-axis is the number of sections.

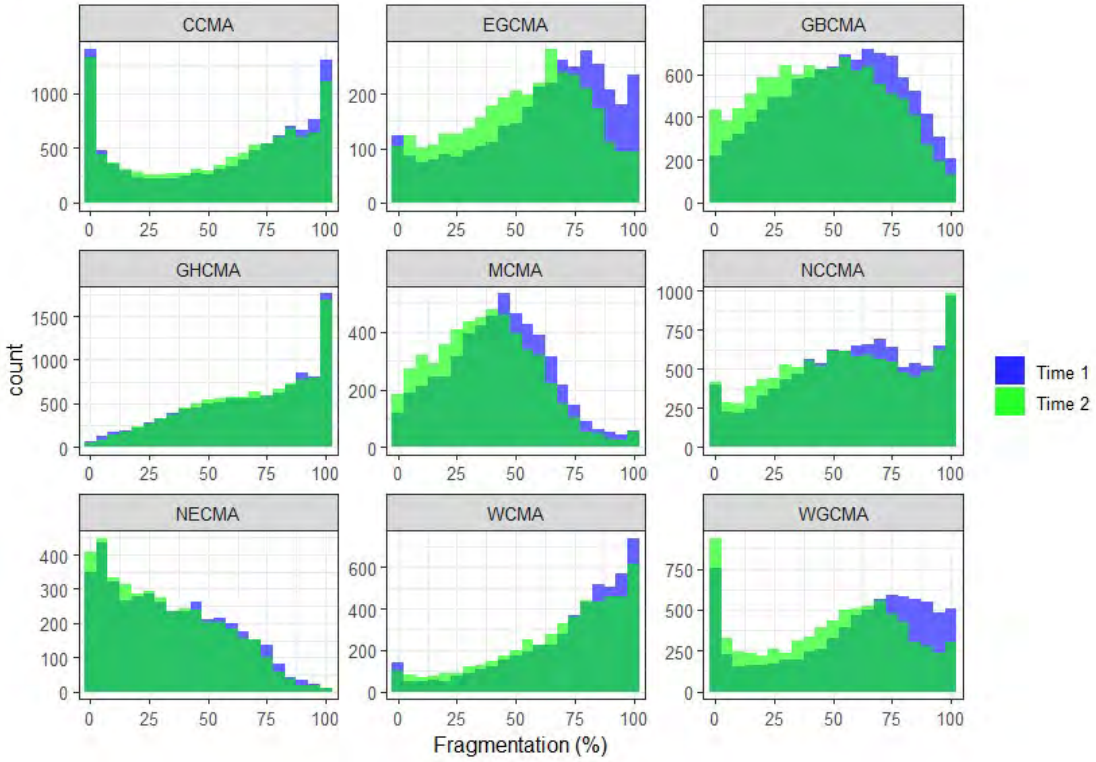
Figure 21 Changes in fragmentation across CMA regions. The count on the y-axis is the number of sections.

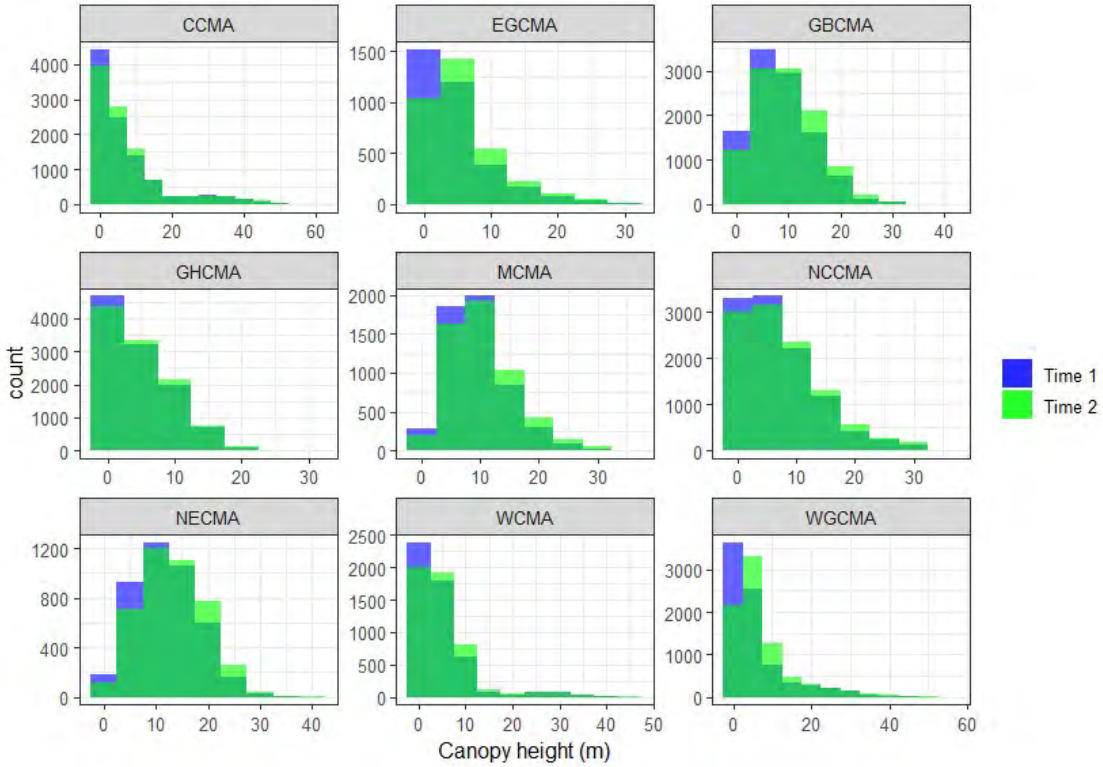
Figure 22 Changes in canopy height across CMA regions. The count on the y-axis is the number of sections.

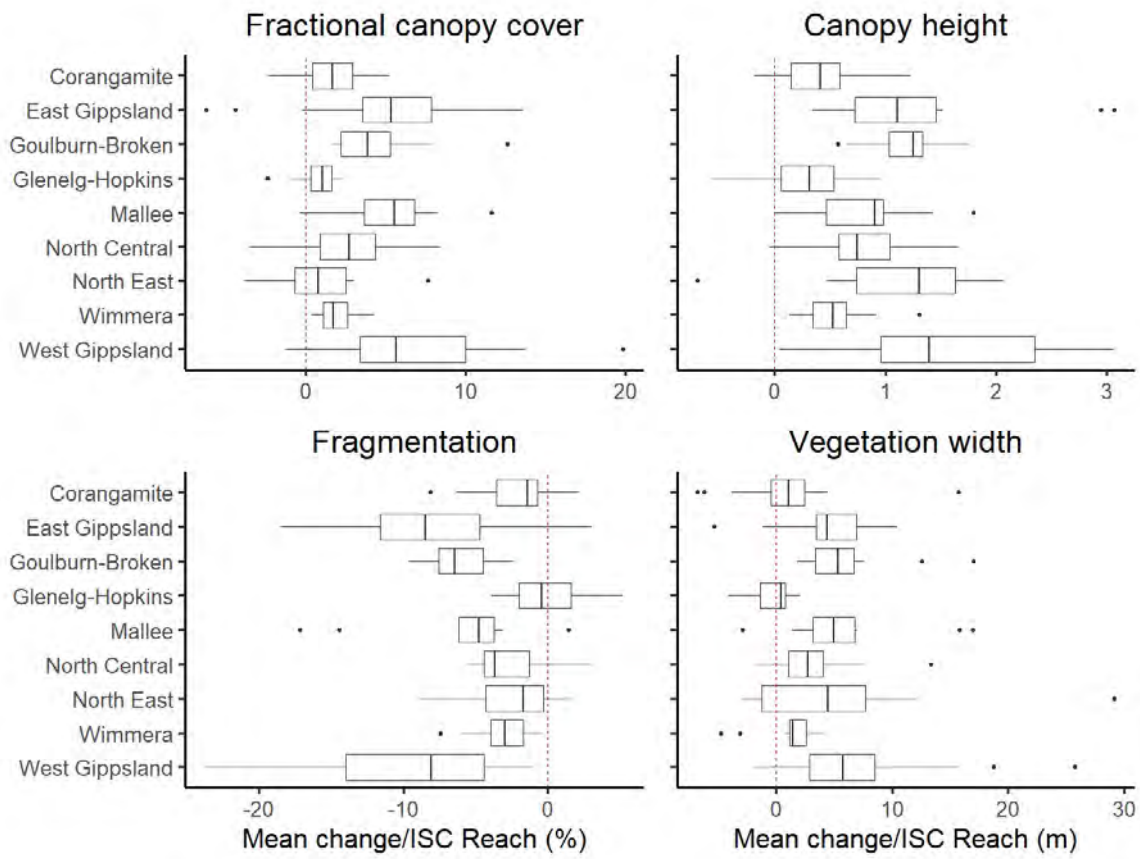
Figure 23 Summary of changes in vegetation metrics in each CMA region. The change in each vegetation metric was calculated (i.e. metric value in Time 2 – metric value in Time 1) at each section, and then the averages of these sections taken at each ISC reach.

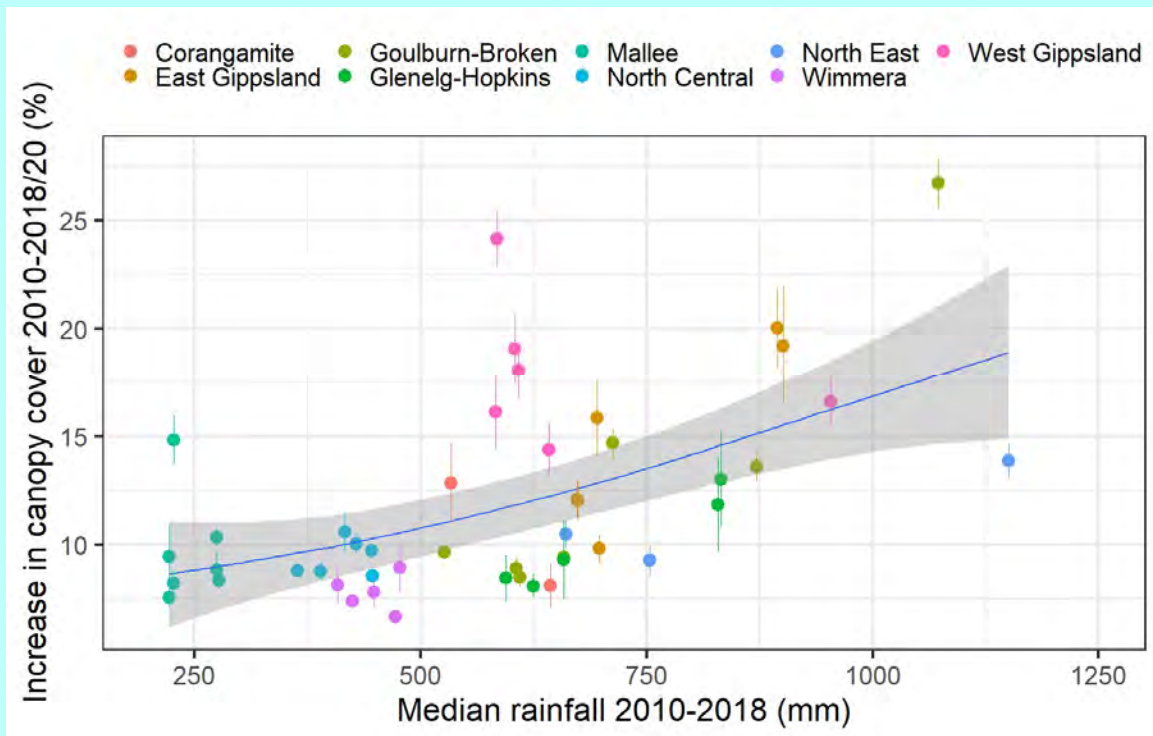
Figure 24 Relationship between increases in fractional canopy cover and rainfall at ISC reaches. Blue line and grey shading are mean and 95% confidence interval from a generalised additive model. Each point represents the mean increase in canopy cover at an ISC reach, with 95% confidence intervals. Only sections where 5% increase or greater were included in results.

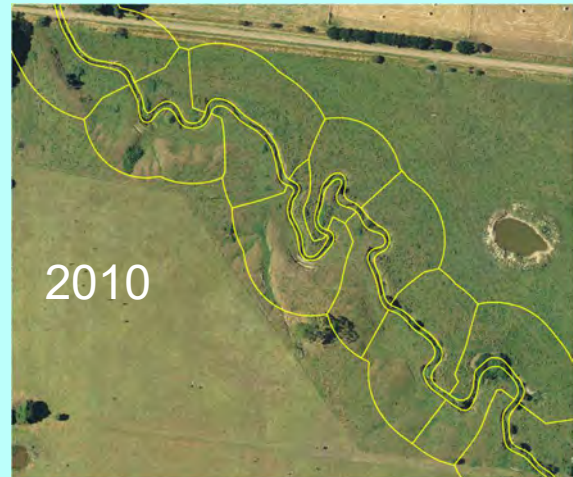
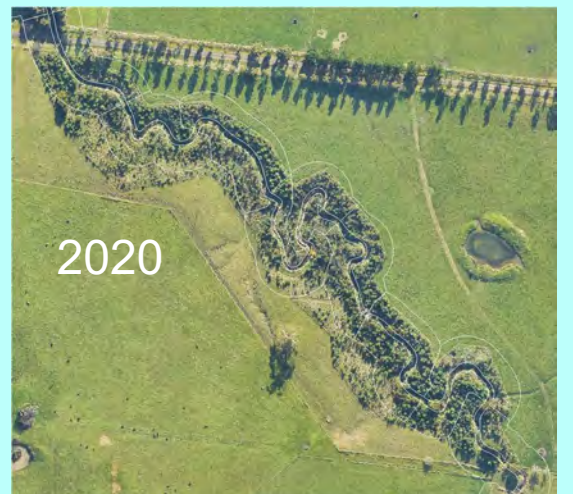
Aerial images were taken at the same time as the LiDAR capture. The image from 2010 is shown (panel c) with the 40m x 100m assessment sections as polygons with yellow borders, compared to the corresponding area in 2020 (panel d).

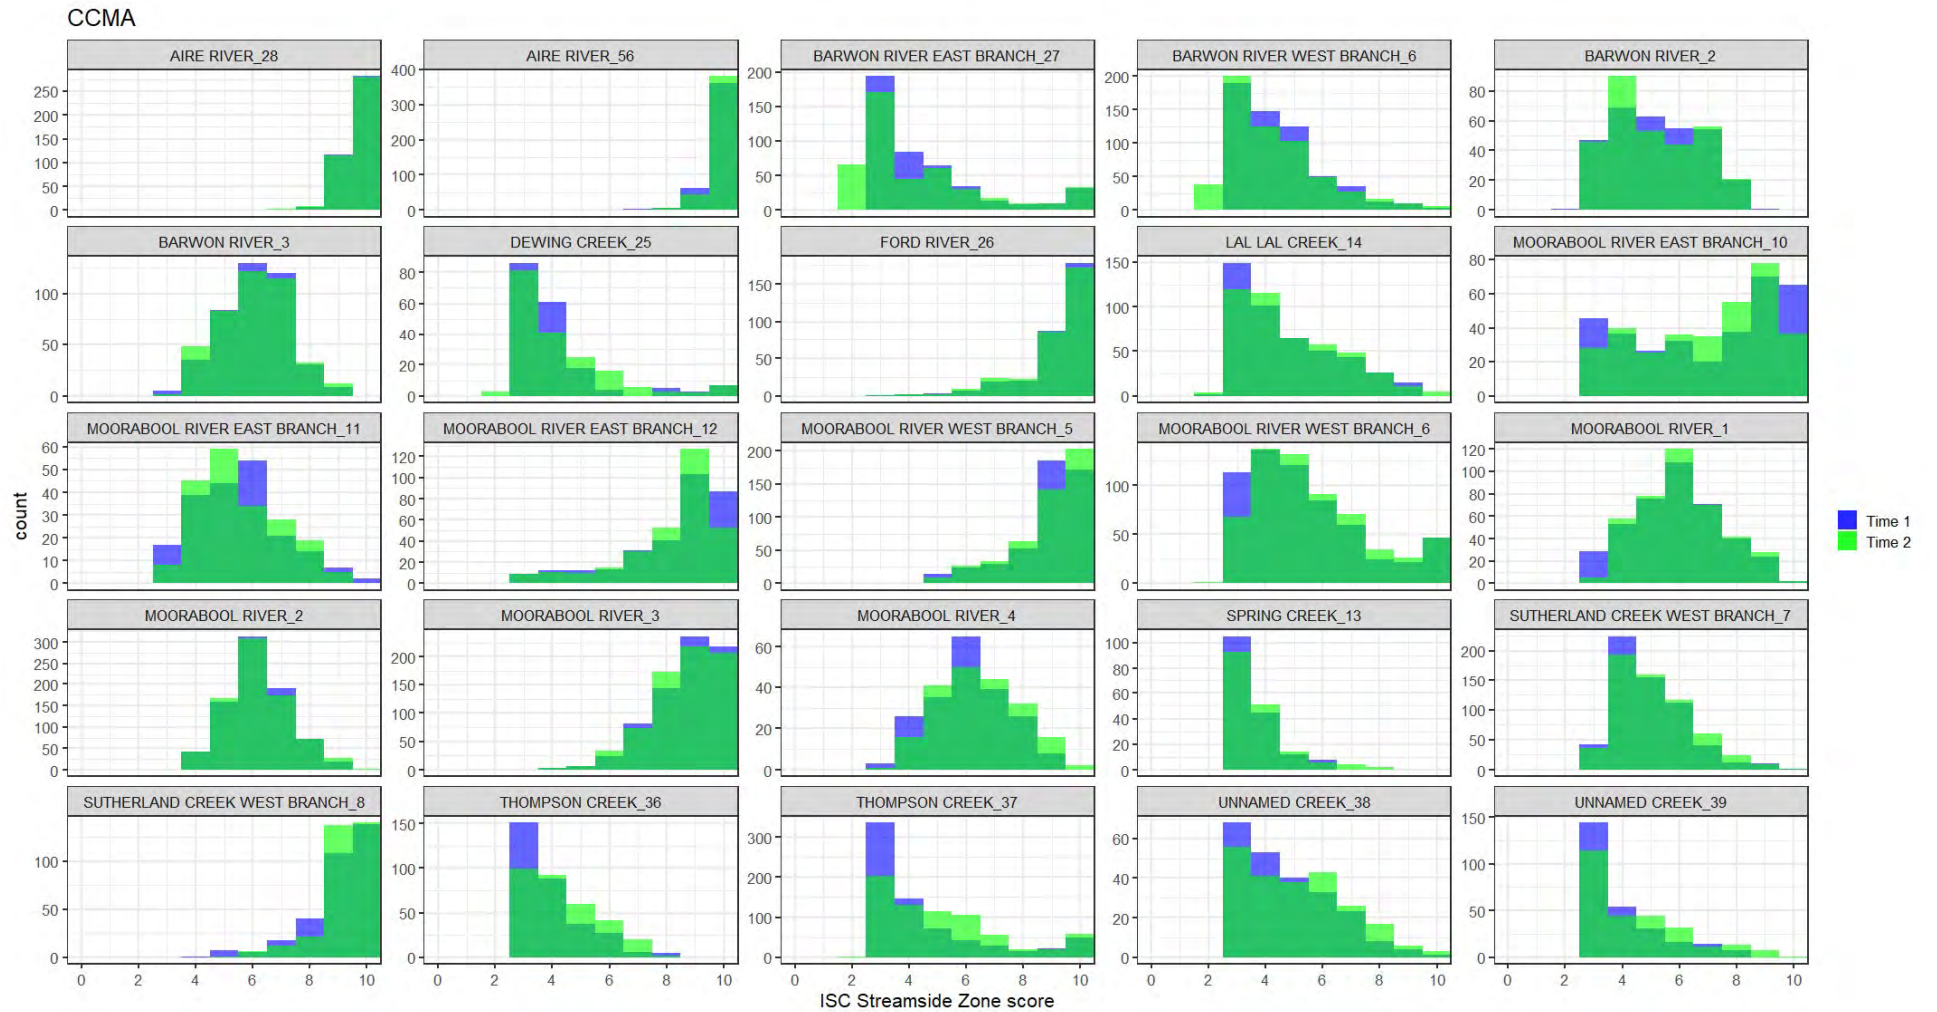
Figure 25 Streamside ISC scores for locations in the CCMA at the two assessment periods. The count on the y-axis is the number of sections.

For most ISC reaches in the Corangamite region, the two assessment periods were in December 2009 and January 2010 (Time 1), and again in 2019 (Table 9). Streamside Zone scores increased by one unit at Thompson Creek reach 37 but remained unchanged at all other reaches (Figure 25; Table 10).
