Stream Change Assessment: detecting change in riparian woody vegetation using LiDAR derived data

April 2022

Catchments, Waterways, Cities and Towns, Waterway Programs Branch

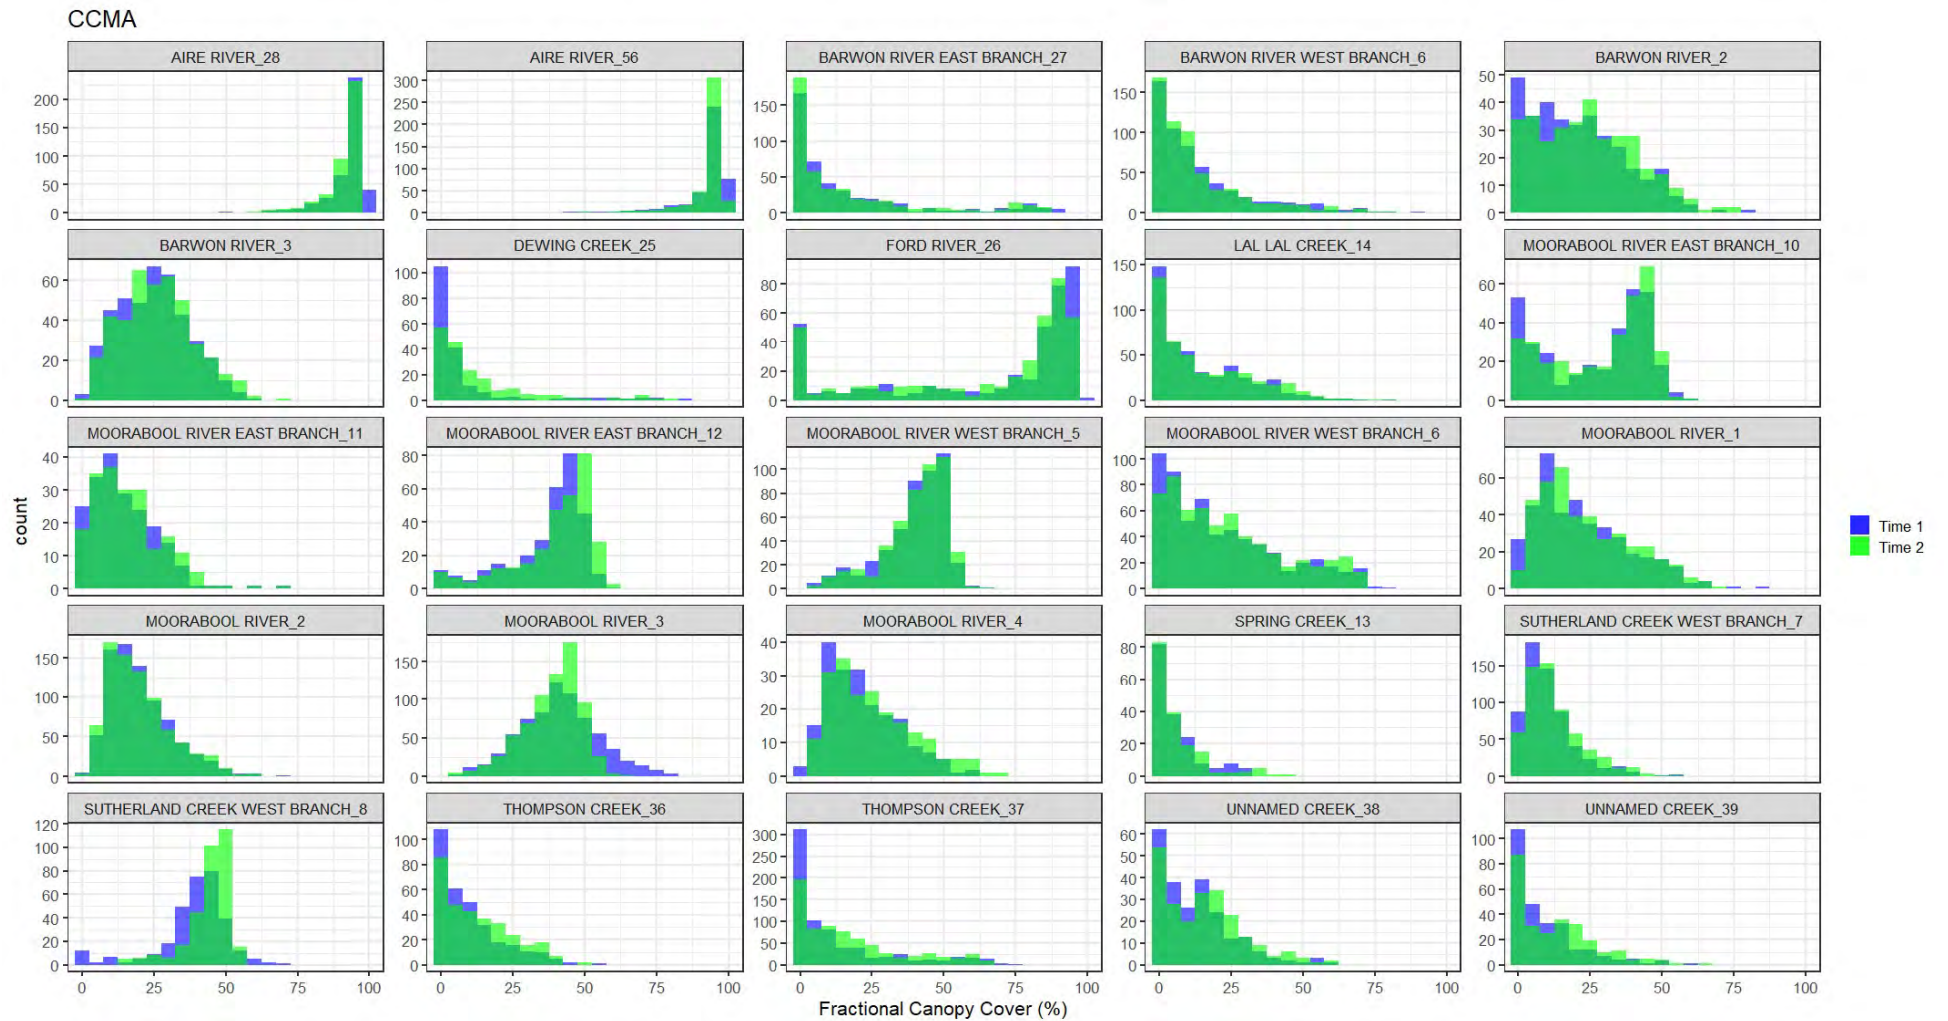
Figure 26 Fractional canopy cover for locations in the CCMA at the two assessment periods. The count on the y-axis is the number of sections.

Fractional canopy cover was higher at 18 of the 25 reaches in the Corangamite region (Figure 26; Table 11), although these changes were variable and typically small. The largest increase was at Sutherland Creek West Branch Basin reach 8, where canopy cover increased by 5%, and there was a 24% increase in the proportion of sections with canopy cover greater than 40% (Table 12). The largest decrease was at Moorabool River Basin reach 3, where canopy cover decreased by 2% overall, and 9% fewer sections had canopy cover greater than 60%. It is important to note that LiDAR capture at several reaches (such as Barwon River West Branch reach 6 and Barwon River East Branch reach 27) within the Corangamite region was undertaken in June, deliberately after willow leaf fall to ensure the channel was most visible and could be defined with greater reliability. As such, small decreases in canopy cover at these reaches may be attributable to differences in the timing of data capture.

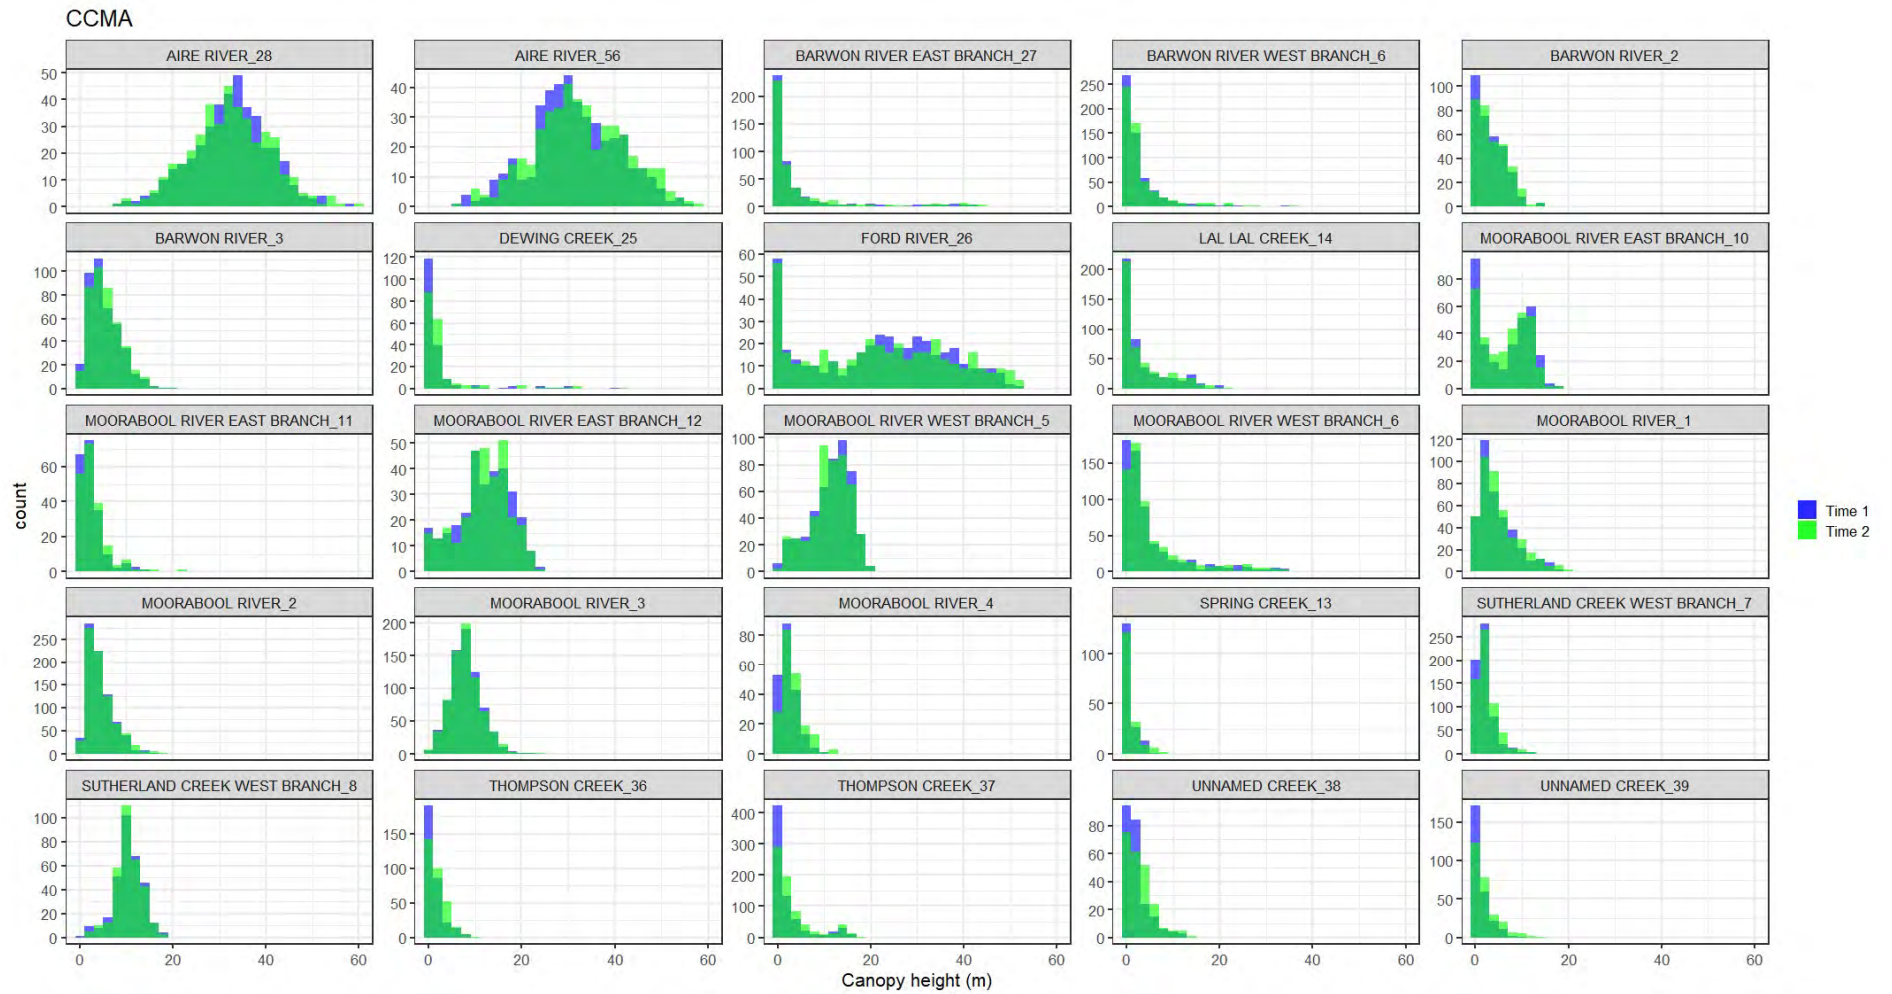
Figure 27 Canopy height for locations in the CCMA at the two assessment periods. The count on the y-axis is the number of sections.

Canopy height increased at 21 of the 25 reaches but the magnitude of these changes was very small (Figure 27; Table 11). The largest increases were observed at Aire River reach 56 (1.2m), Unnamed Creek reach 39 (0.9m), and Thompson Creek reach 37 (0.9m). The largest decreases were of small magnitude (<0.2m), and were observed at Aire River reach 28, Moorabool River East Branch reach 10 and Moorabool River West Branch reach 5.

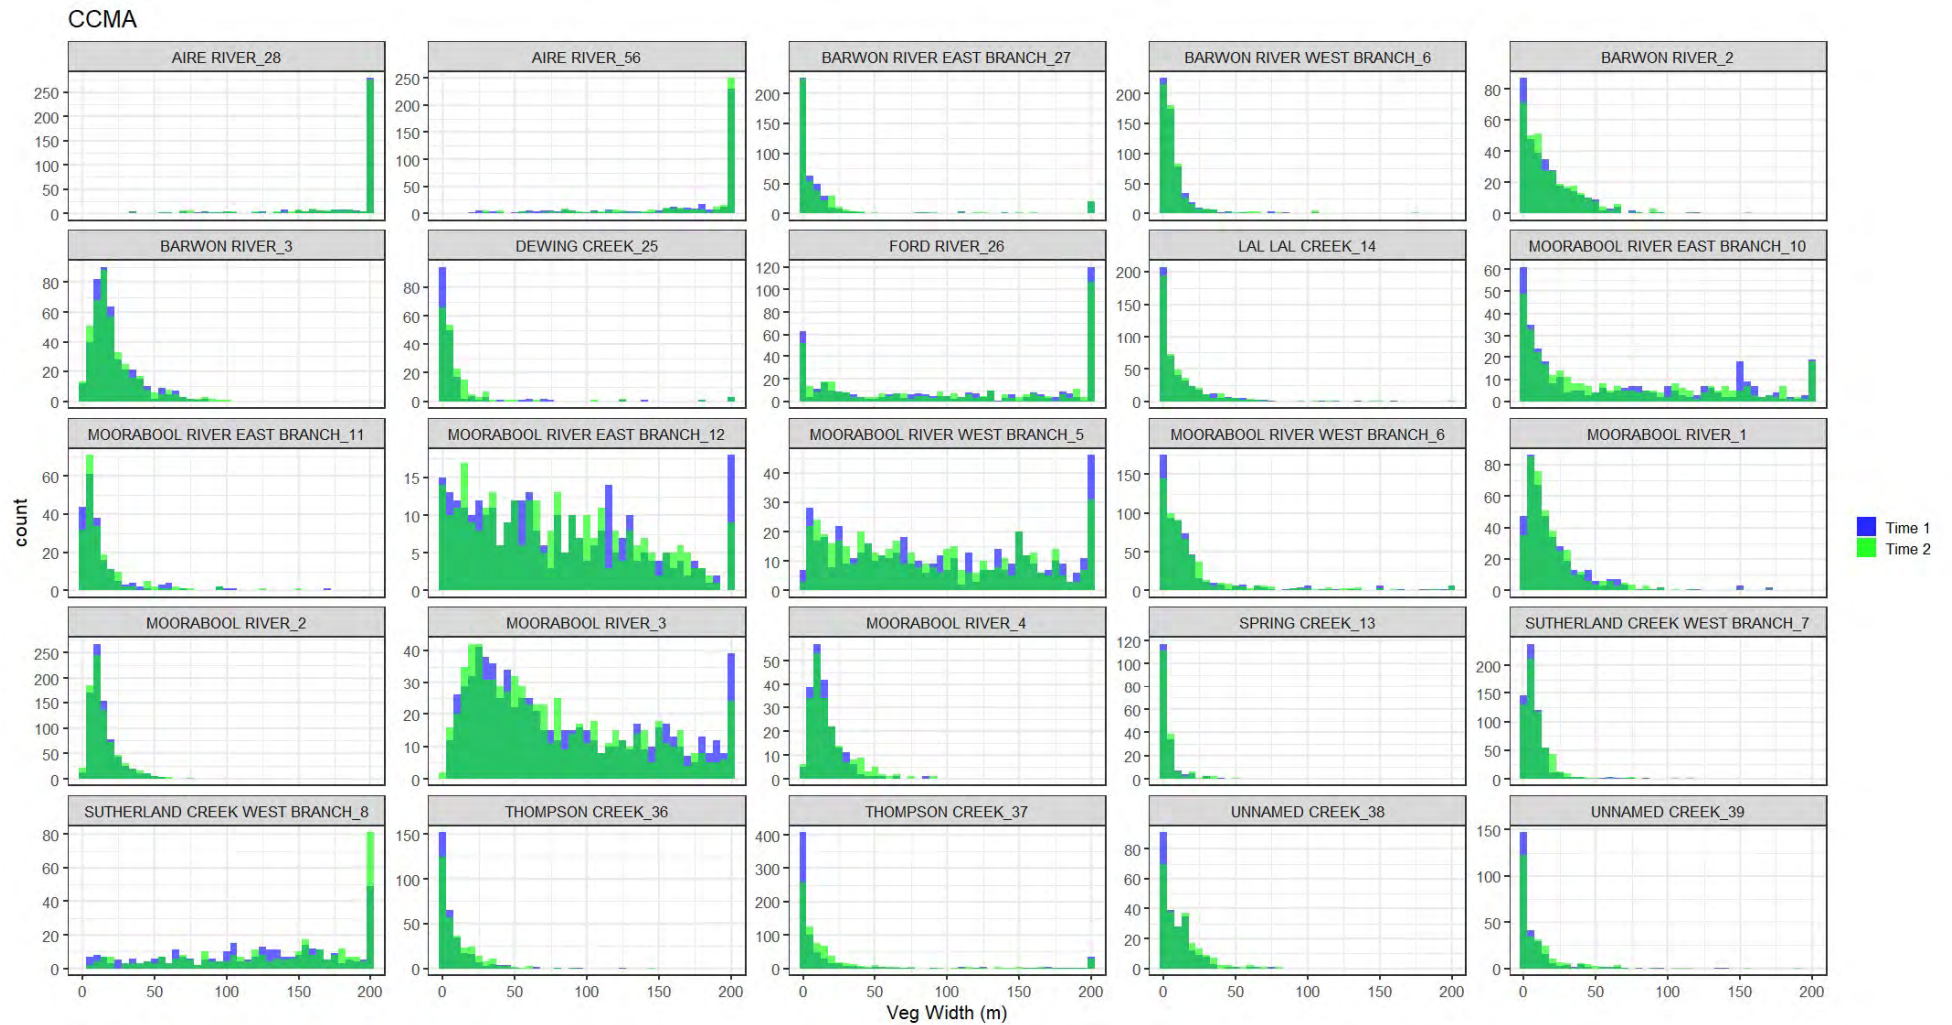
Figure 28 Vegetation width for locations in the CCMA at the two assessment periods. The count on the y-axis is the number of sections.

Increases in vegetation width were observed a relatively small number of sections at some reaches (Figure 28; Table 11). For instance, at the Dewing Creek reach 25 and Thompson Creek reach 37 10% and 17% more sections had vegetation widths greater than 10m (Table 12).

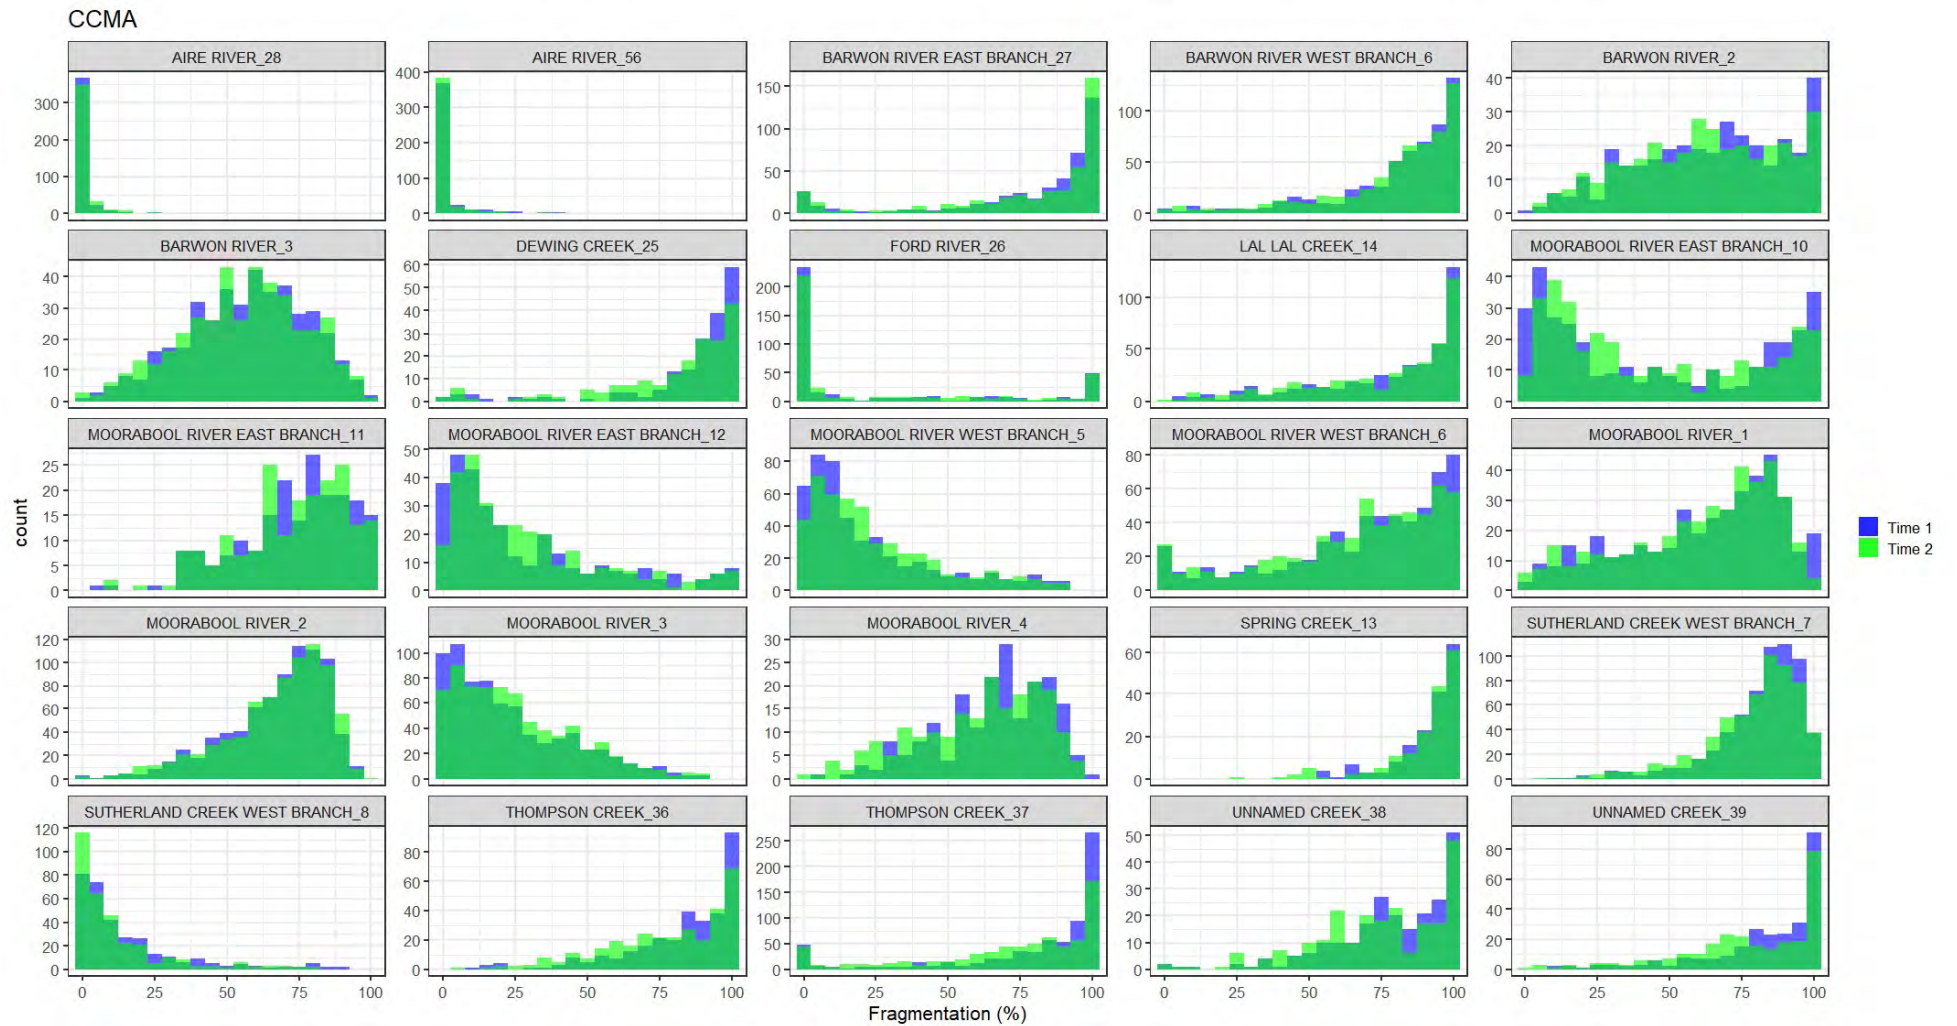
Figure 29 Fragmentation for locations in the CCMA at the two assessment periods. The count on the y-axis is the number of sections.

Decreases in fragmentation (Figure 29, Table 10, Table 11) were also observed at a relatively small number of sections at some reaches. At the Dewing Creek and Thompson Creek reaches highlighted above, 15% and 18% fewer sections had fragmentation >75% in 2018.

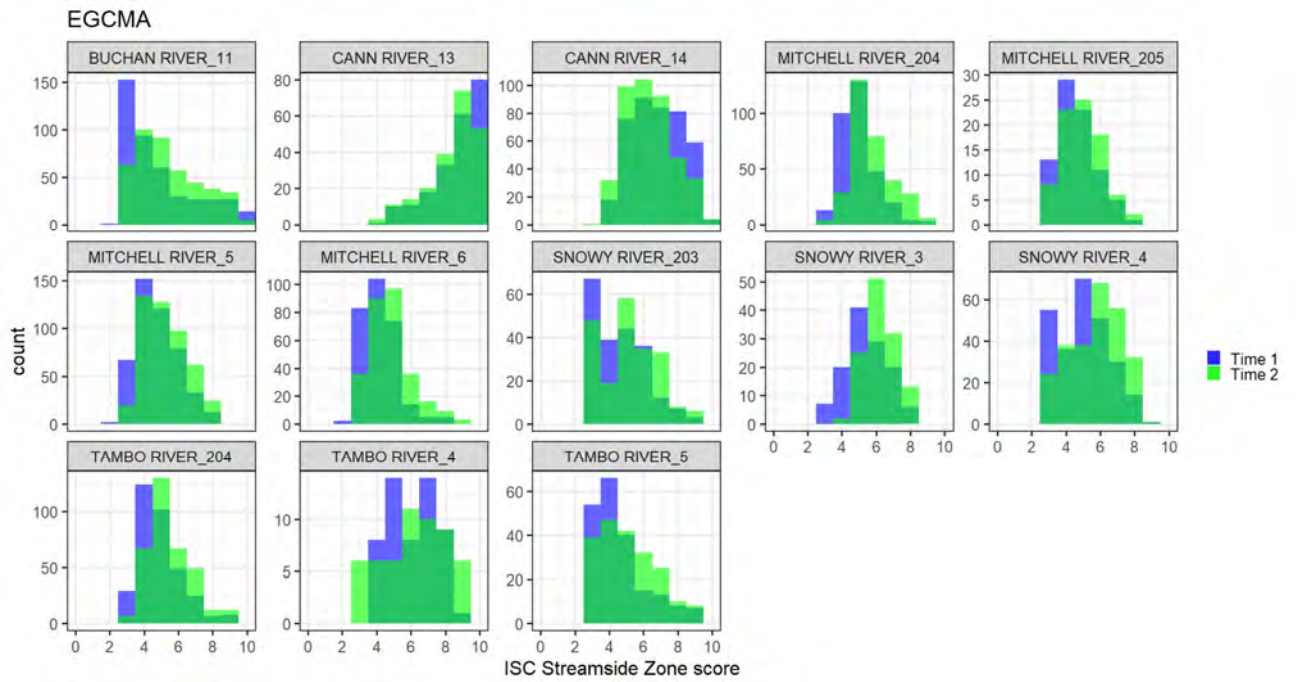
Figure 30 Streamside Zone ISC score for locations in the EGCMA at the two assessment periods. The count on the y-axis is the number of sections.

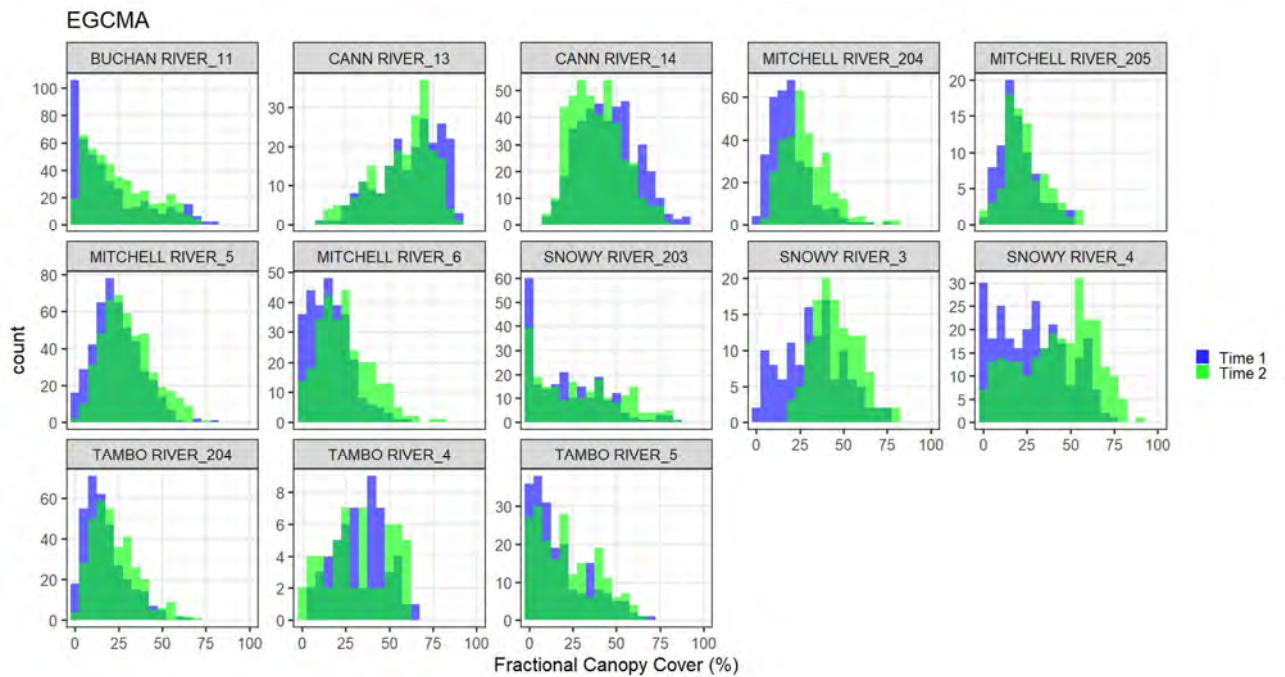
Figure 31 Fractional canopy cover for locations in the EGCMA at the two assessment periods. The count on the y-axis is the number of sections.

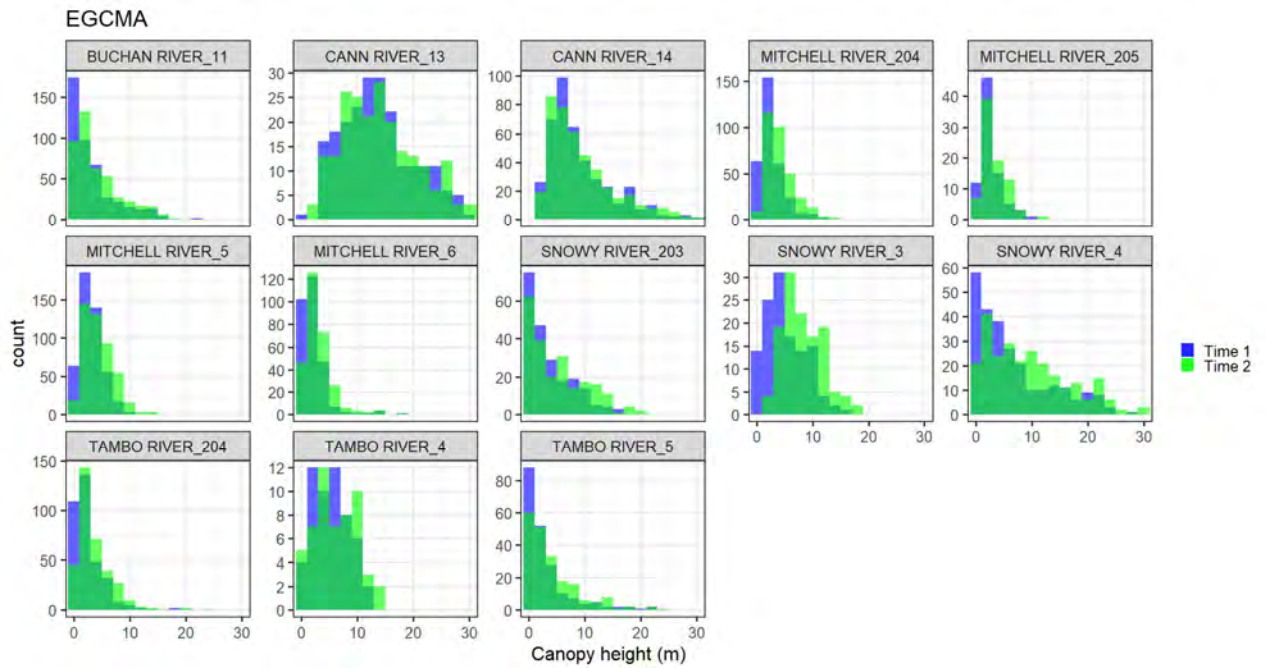
Figure 32 Canopy height for locations in the EGCMA at the two assessment periods. The count on the y-axis is the number of sections.

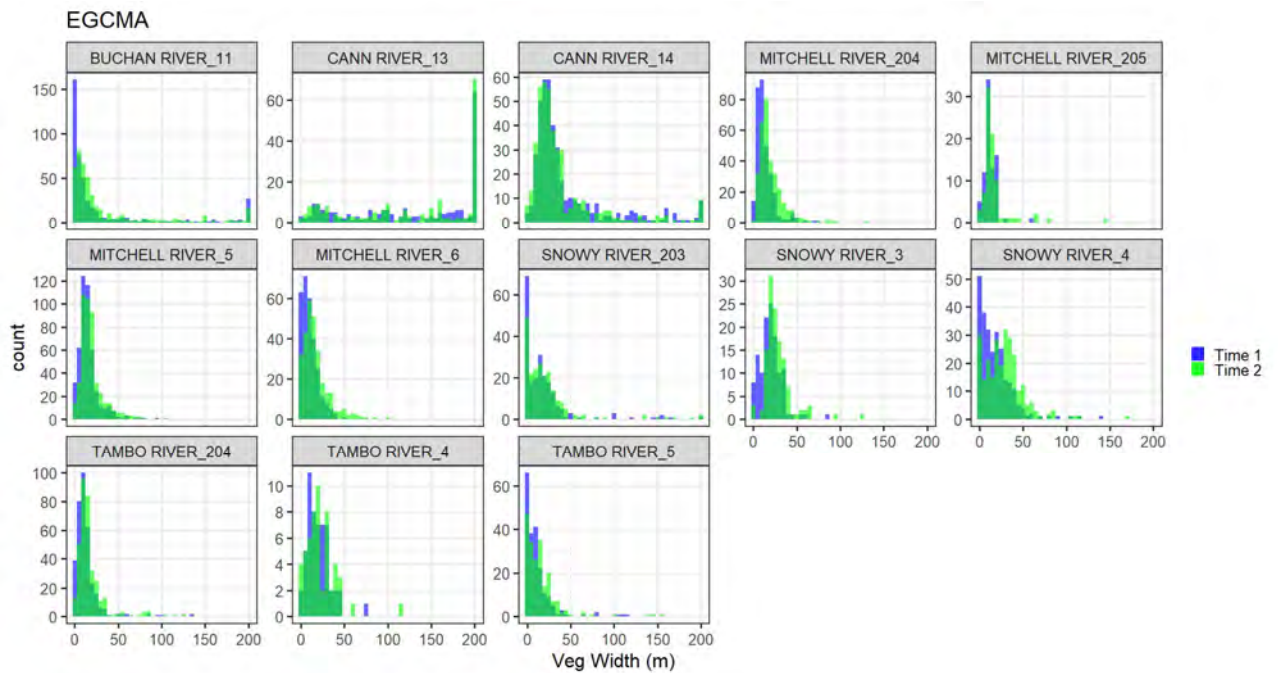
Figure 33 Vegetation width for locations in the EGCMA at the two assessment periods. The count on the y-axis is the number of sections.

Vegetation width also increased at most reaches (Figure 33 Table 11). The largest increases also occurred at Snowy River reaches 3 and 4. For example, at Snowy River reach 3, there were 21%, 20% and 7% more sections with vegetation wider than 10, 20 and 40m in 2018 (Figure 34).

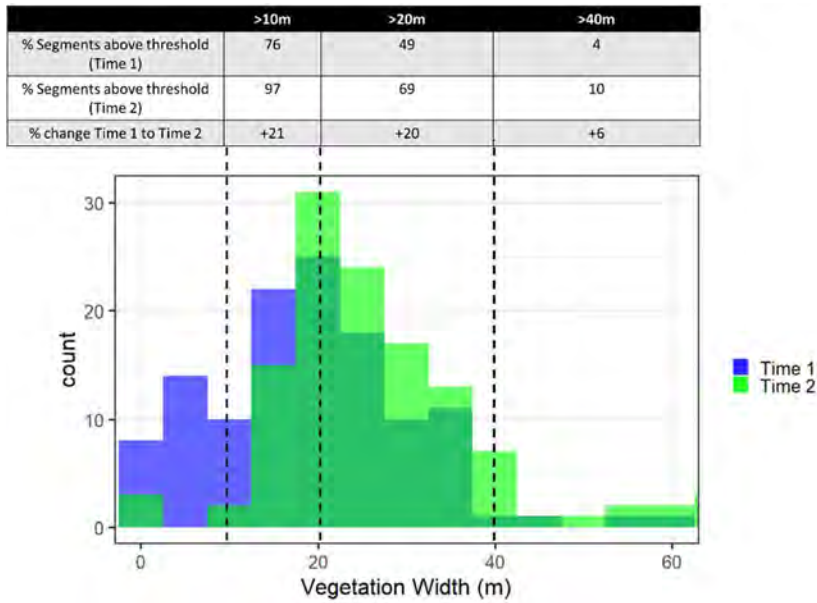
Figure 34 Histograms showing summary of vegetation width at Snowy River reach 3 in 2010 (Time 1) and 2018 (Time 2). The box at the top shows the % of sections where the vegetation width exceeds 10m, 20m and 40m in the two periods and the % change in the proportion of sections above those thresholds.

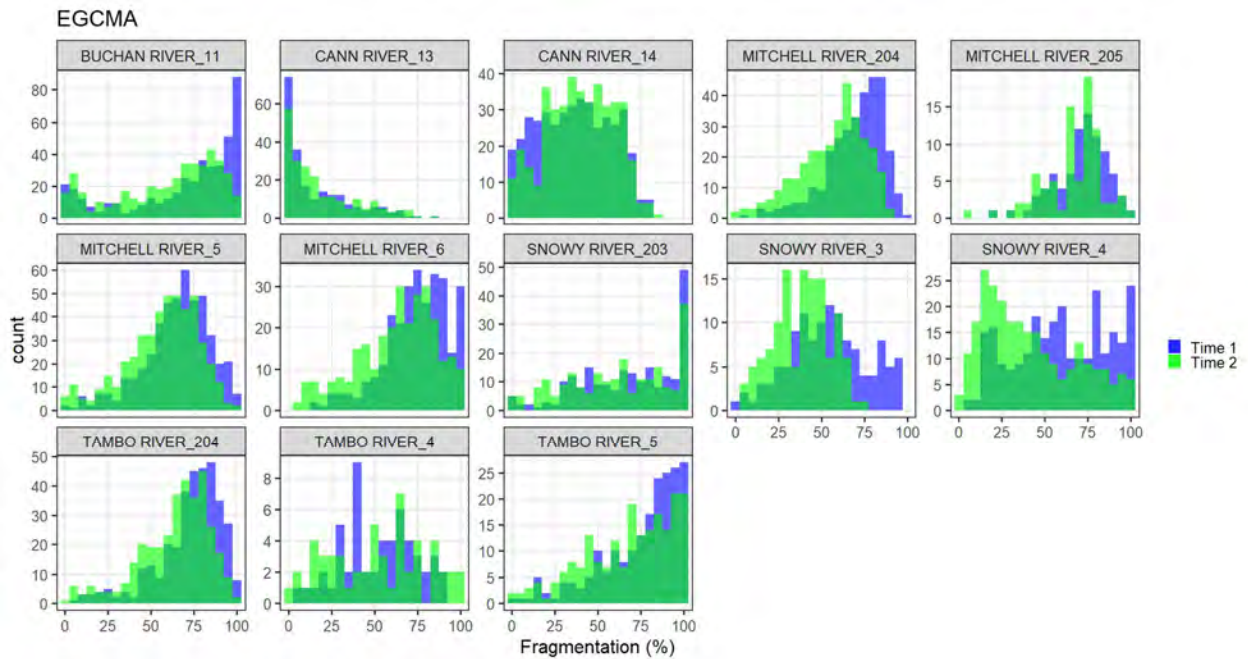
Figure 35 Fragmentation for locations in the EGCMA at the two assessment periods. The count on the y-axis is the number of sections.

Fragmentation decreased at most reaches (Figure 35). At Snowy River reaches 3 and 4, fragmentation decreased at more than 82% of sections, by 15-19% on average. ~30% fewer sections at these two reaches had fragmentation greater than 50% (Table 12). Fragmentation also decreased at the majority of sections at Mitchell River reaches 204 and 6 (96% and 81% respectively).

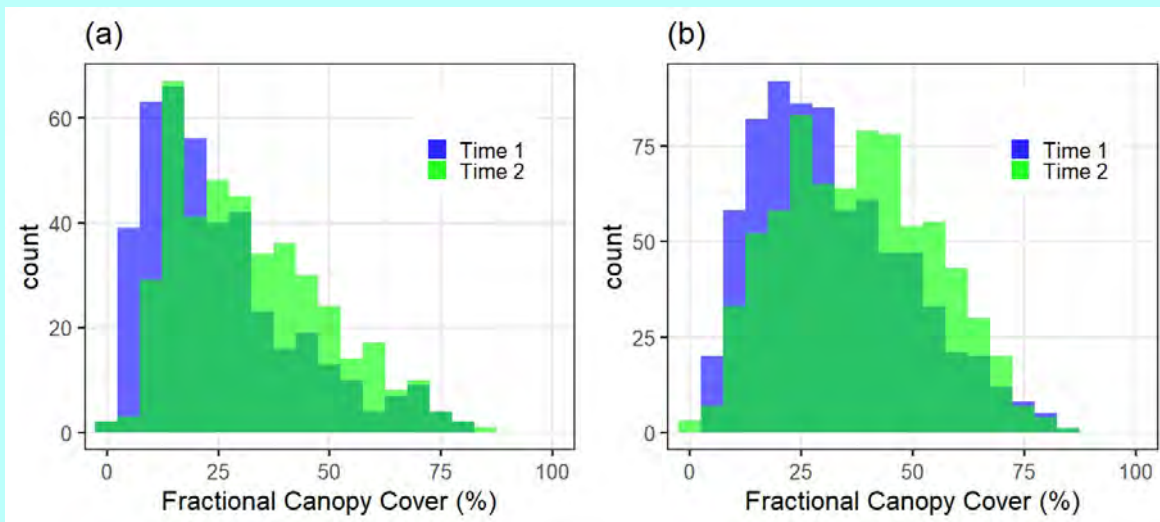
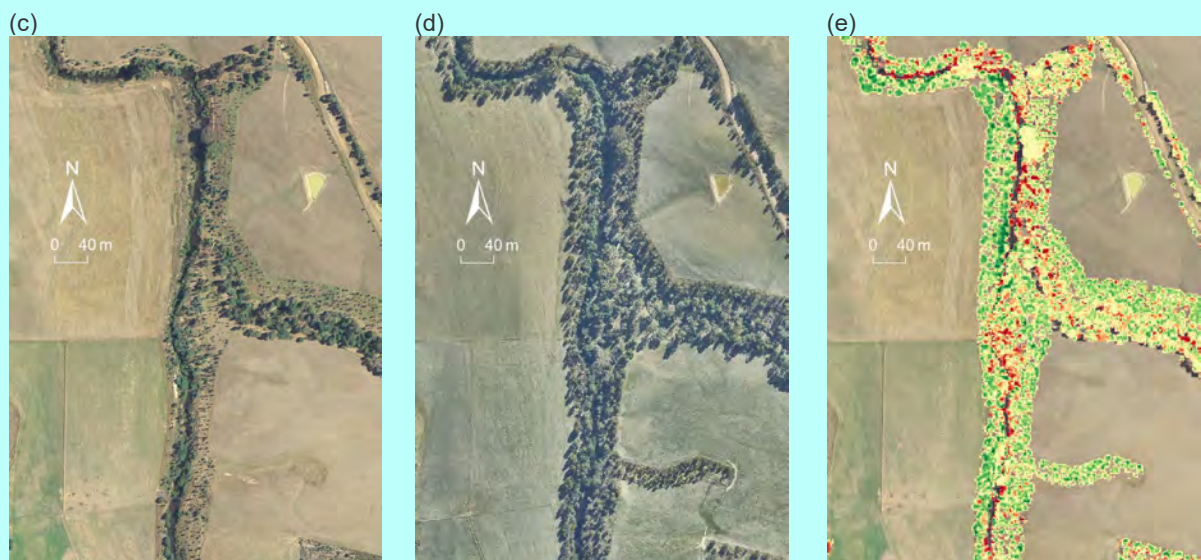
Panel c shows a ~550m length of King Parrot Creek between Flowerdale-Strath Creek in 2010. Panel d is the same section in 2018. Panel e shows the fractional canopy cover with areas of woody weed control showing as red areas with up to a 100% reduction in canopy cover, whereas green areas indicate increased canopy cover of between 25 and 100% due to revegetation and growth.

Fractional canopy cover in 2010 at the focal reach (average 25%; panel a) was lower than the remainder of the King Parrot Creek (average 32%, panel b). From 2010 to 2018, 21% more sections had fractional canopy cover greater than 20% in the focal reach (panel a; an increase from 50 to 71% of sections) compared to only 11% at other sections of King Parrot Creek (panel b; an increase from 71 to 83% of sections). However, these increases in canopy cover were patchy, reflecting both past and recent management regimes which included a mosaic of woody weed control and revegetation.

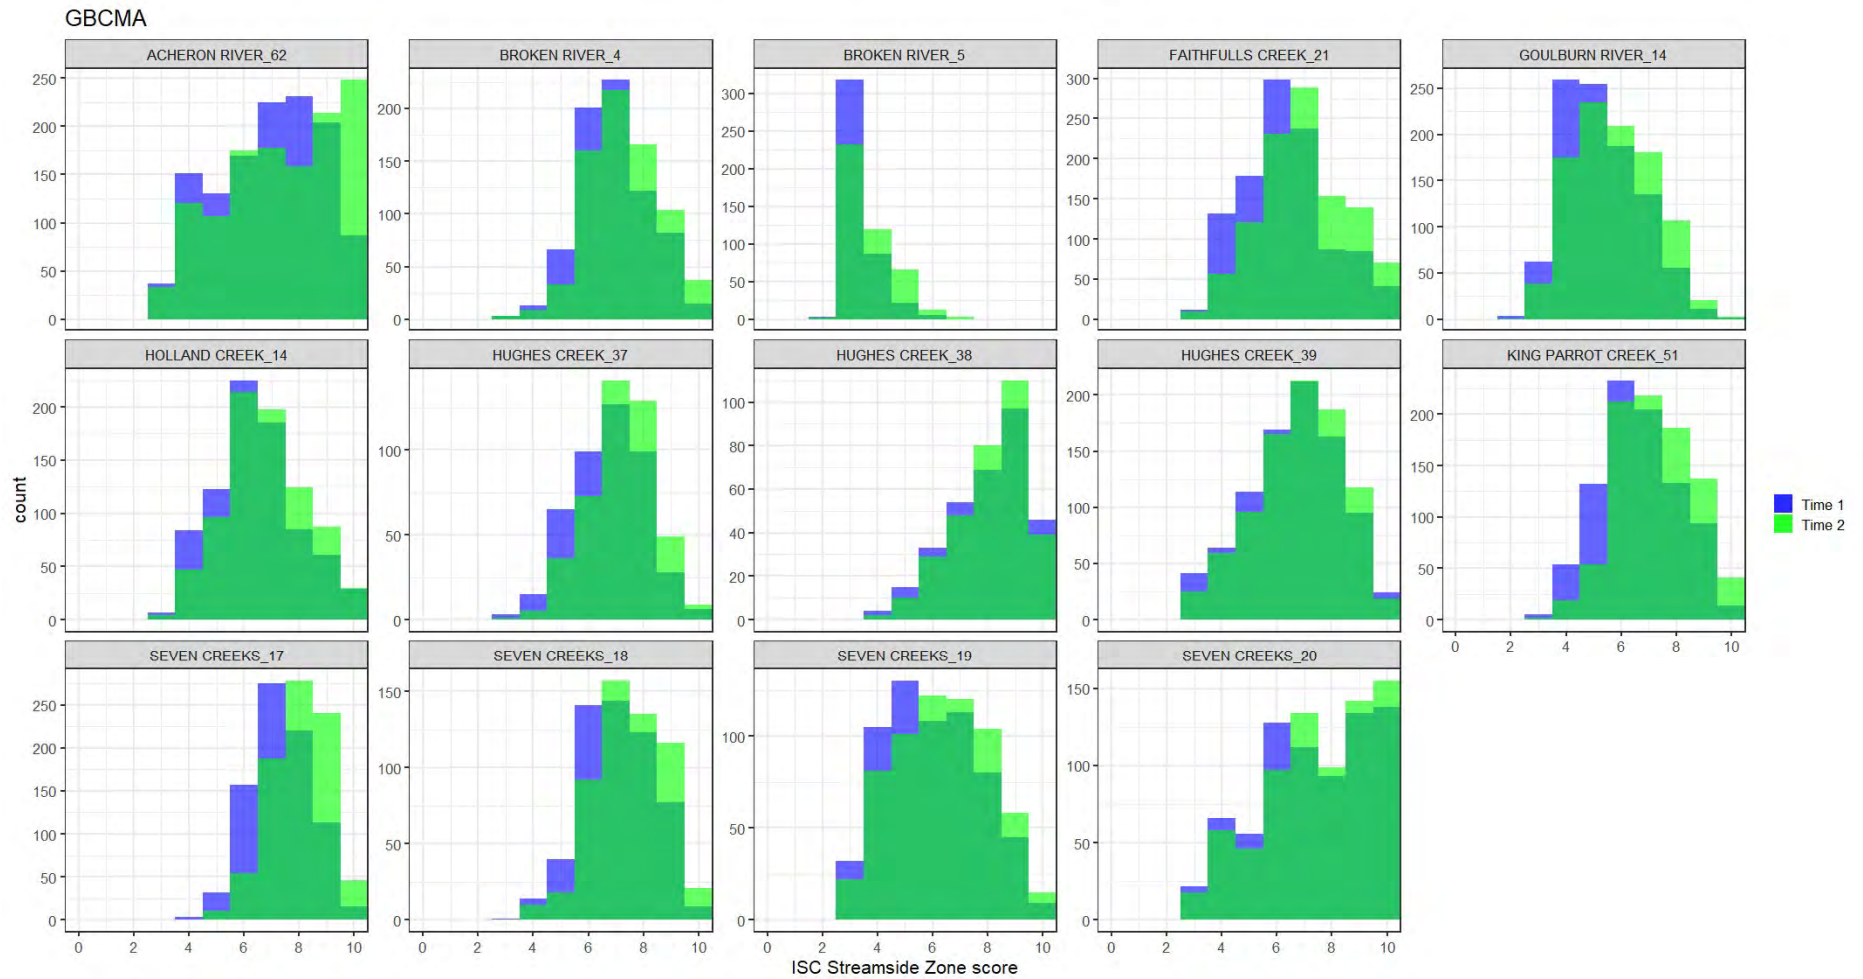
Figure 36 ISC Streamside Zone scores for ISC reaches in the GBCMA at the two assessment periods. The count on the y-axis is the number of sections.

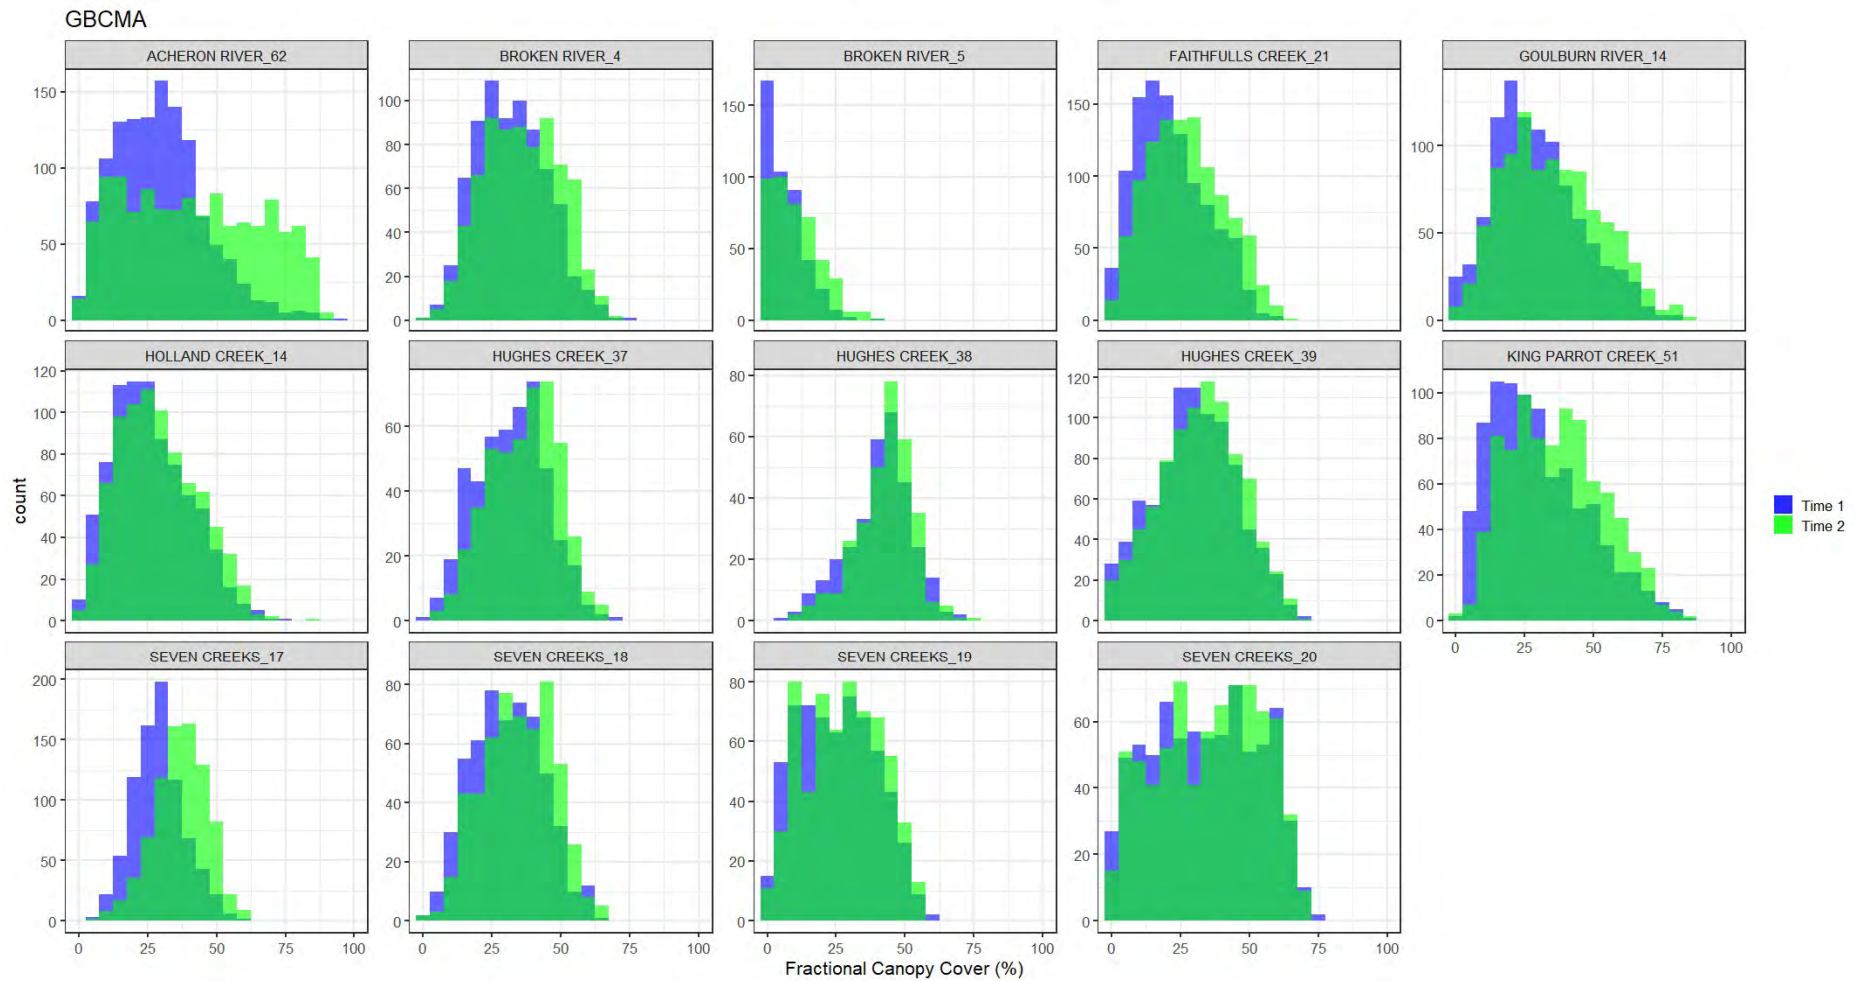
Figure 37 Fractional canopy cover for ISC reaches in the GBCMA at the two assessment periods. The count on the y-axis is the number of sections.

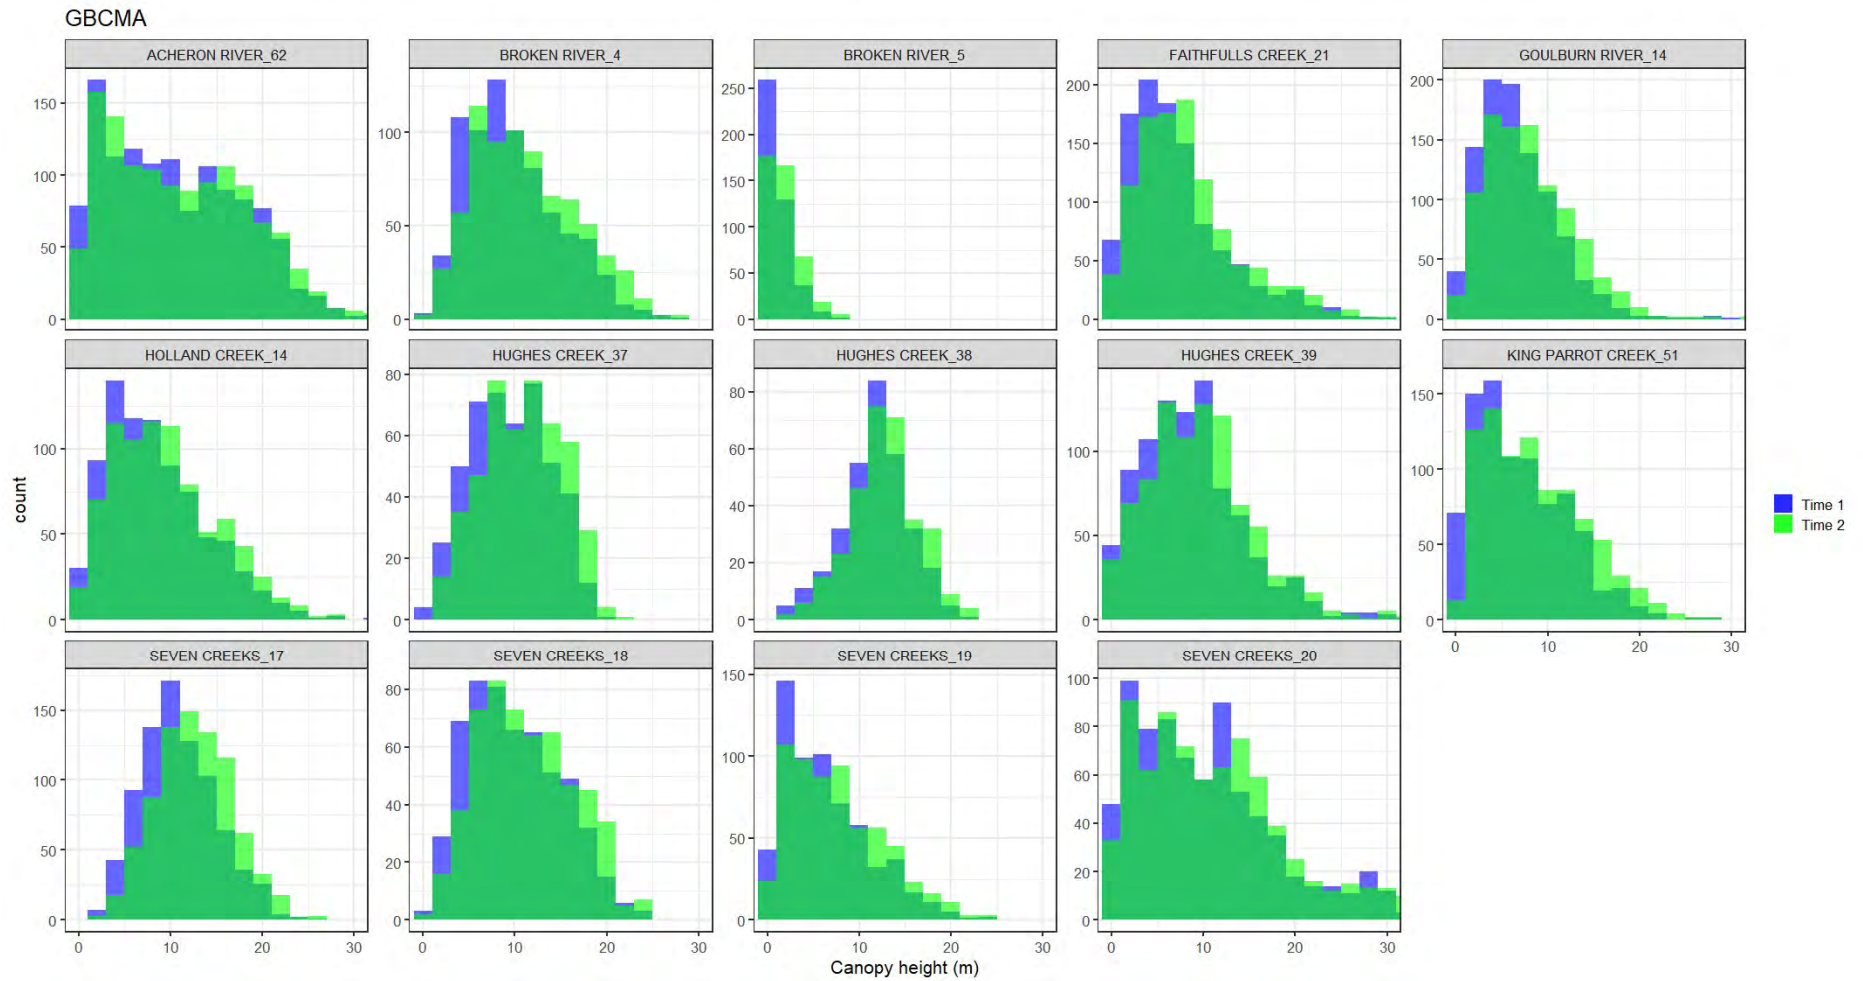
Figure 38 Canopy height for ISC reaches in the GBCMA at the two assessment periods. The count on the y-axis is the number of sections.

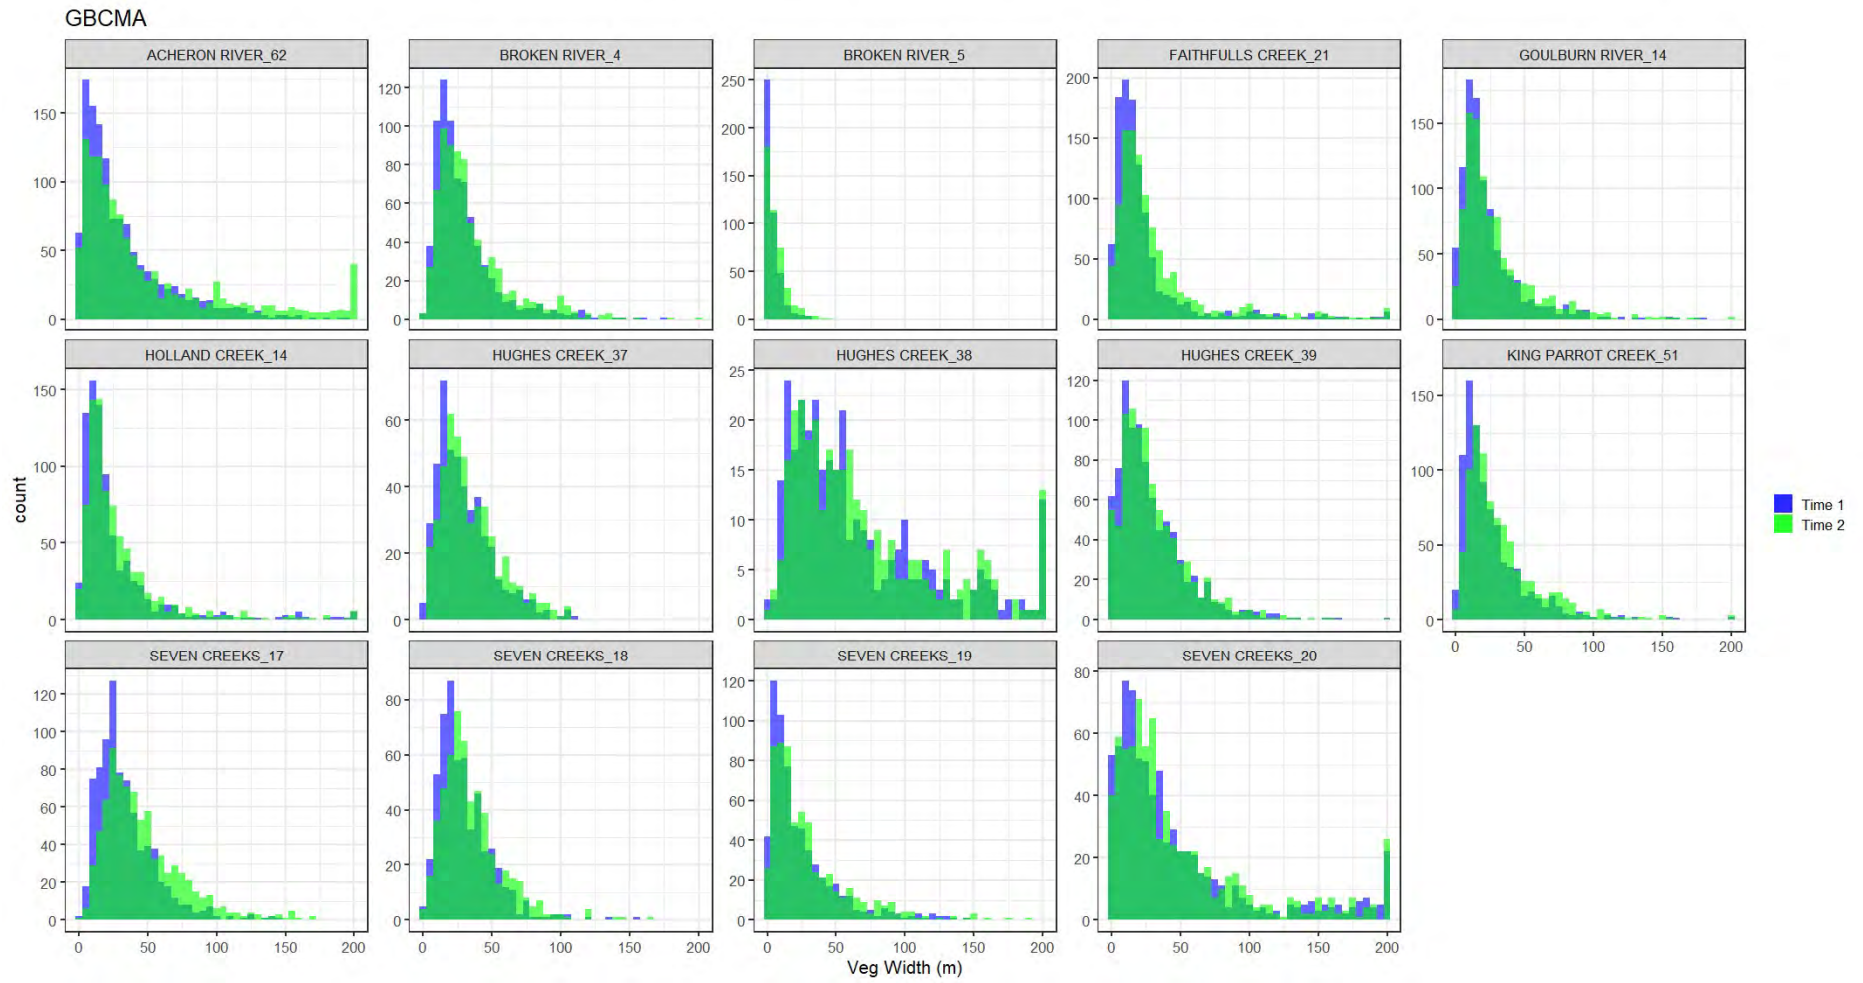
Figure 39 Vegetation width for ISC reaches in the GBCMA at the two assessment periods. The count on the y-axis is the number of sections.
