Stream Change Assessment: detecting change in riparian woody vegetation using LiDAR derived data

April 2022

Catchments, Waterways, Cities and Towns, Waterway Programs Branch

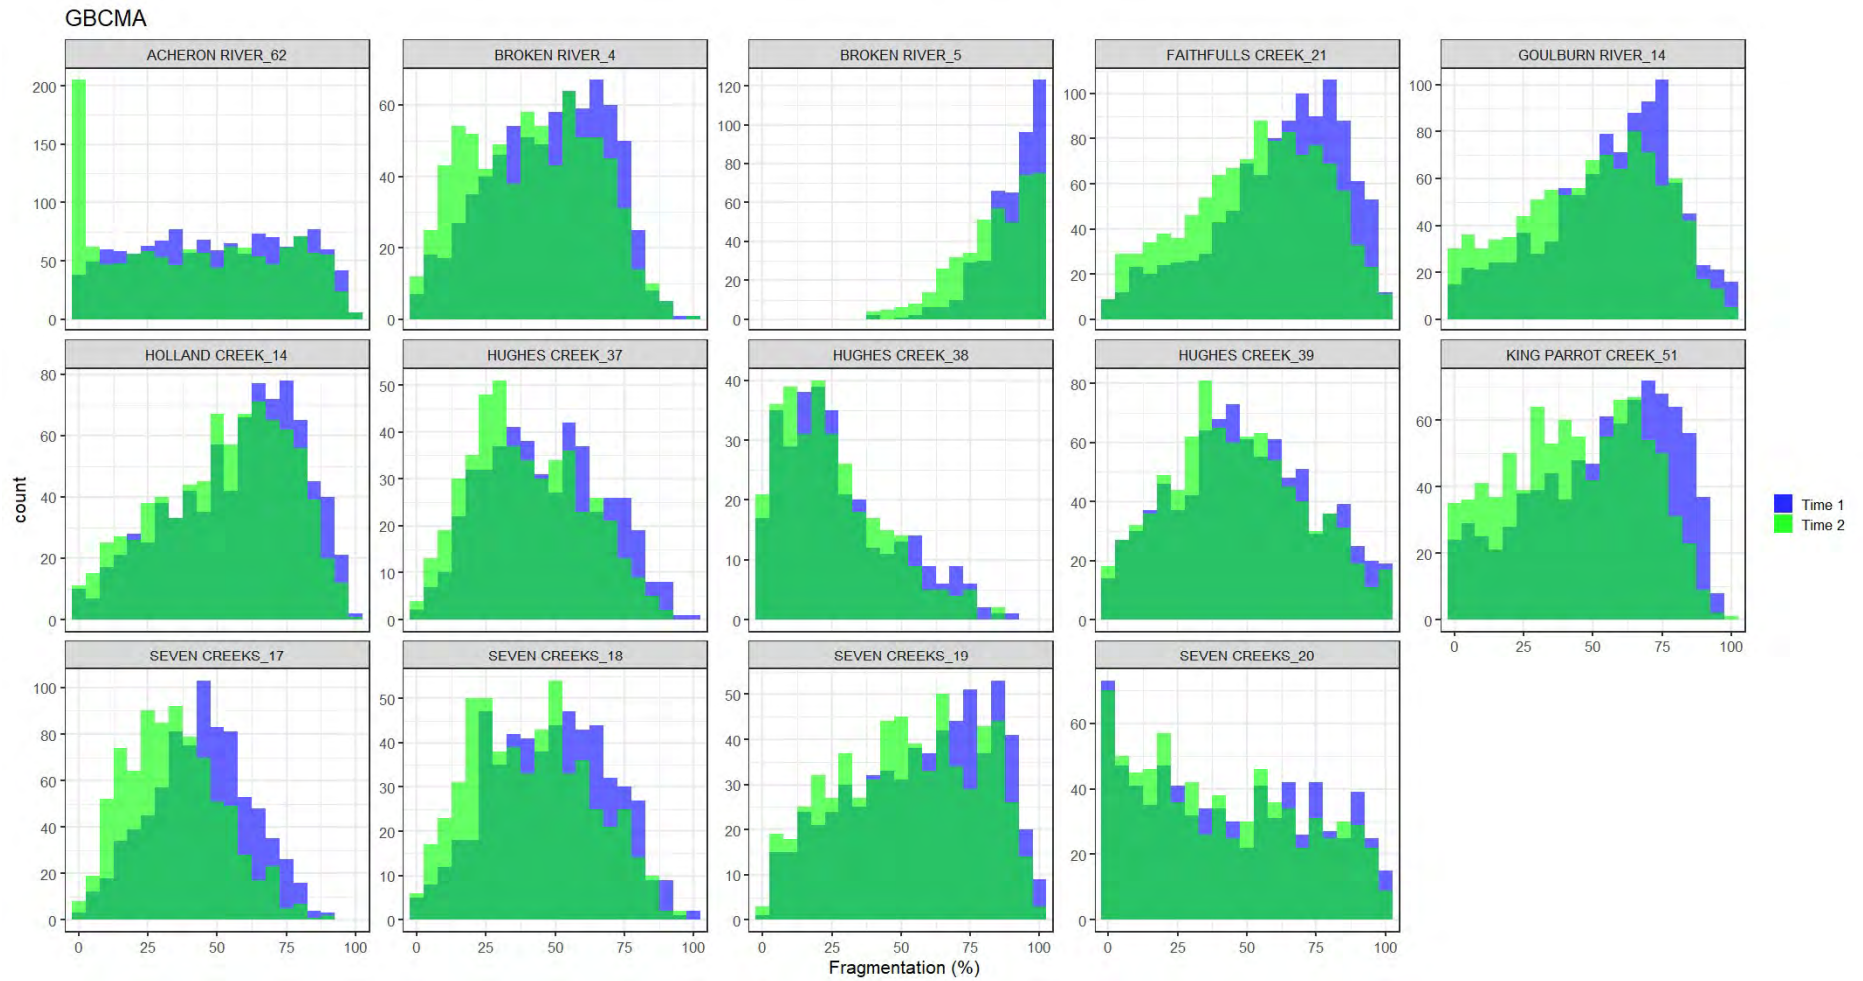
Figure 40 Fragmentation for ISC reaches in the GBCMA at the two assessment periods. The count on the y-axis is the number of sections.

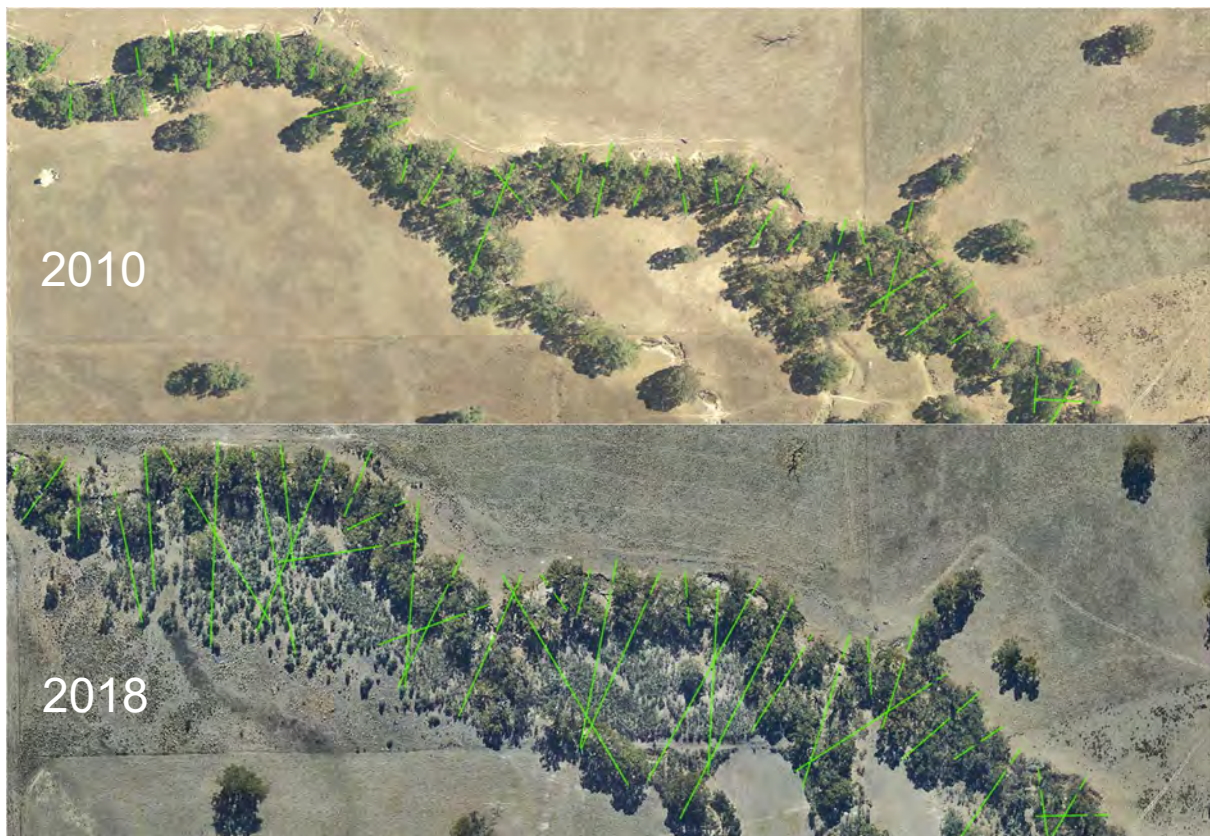
Figure 41 Histograms and aerial imagery showing vegetation width at Faithfuls Creek reach 21 in 2010 (Time 1) and 2018 (Time 2). The box at the top shows the % of sections where the vegetation width exceeds 10m, 20m and 40m in the two periods and the % change in the proportion of sections above those thresholds. Green lines on photographs are transects perpendicular to the stream used to measure vegetation width.

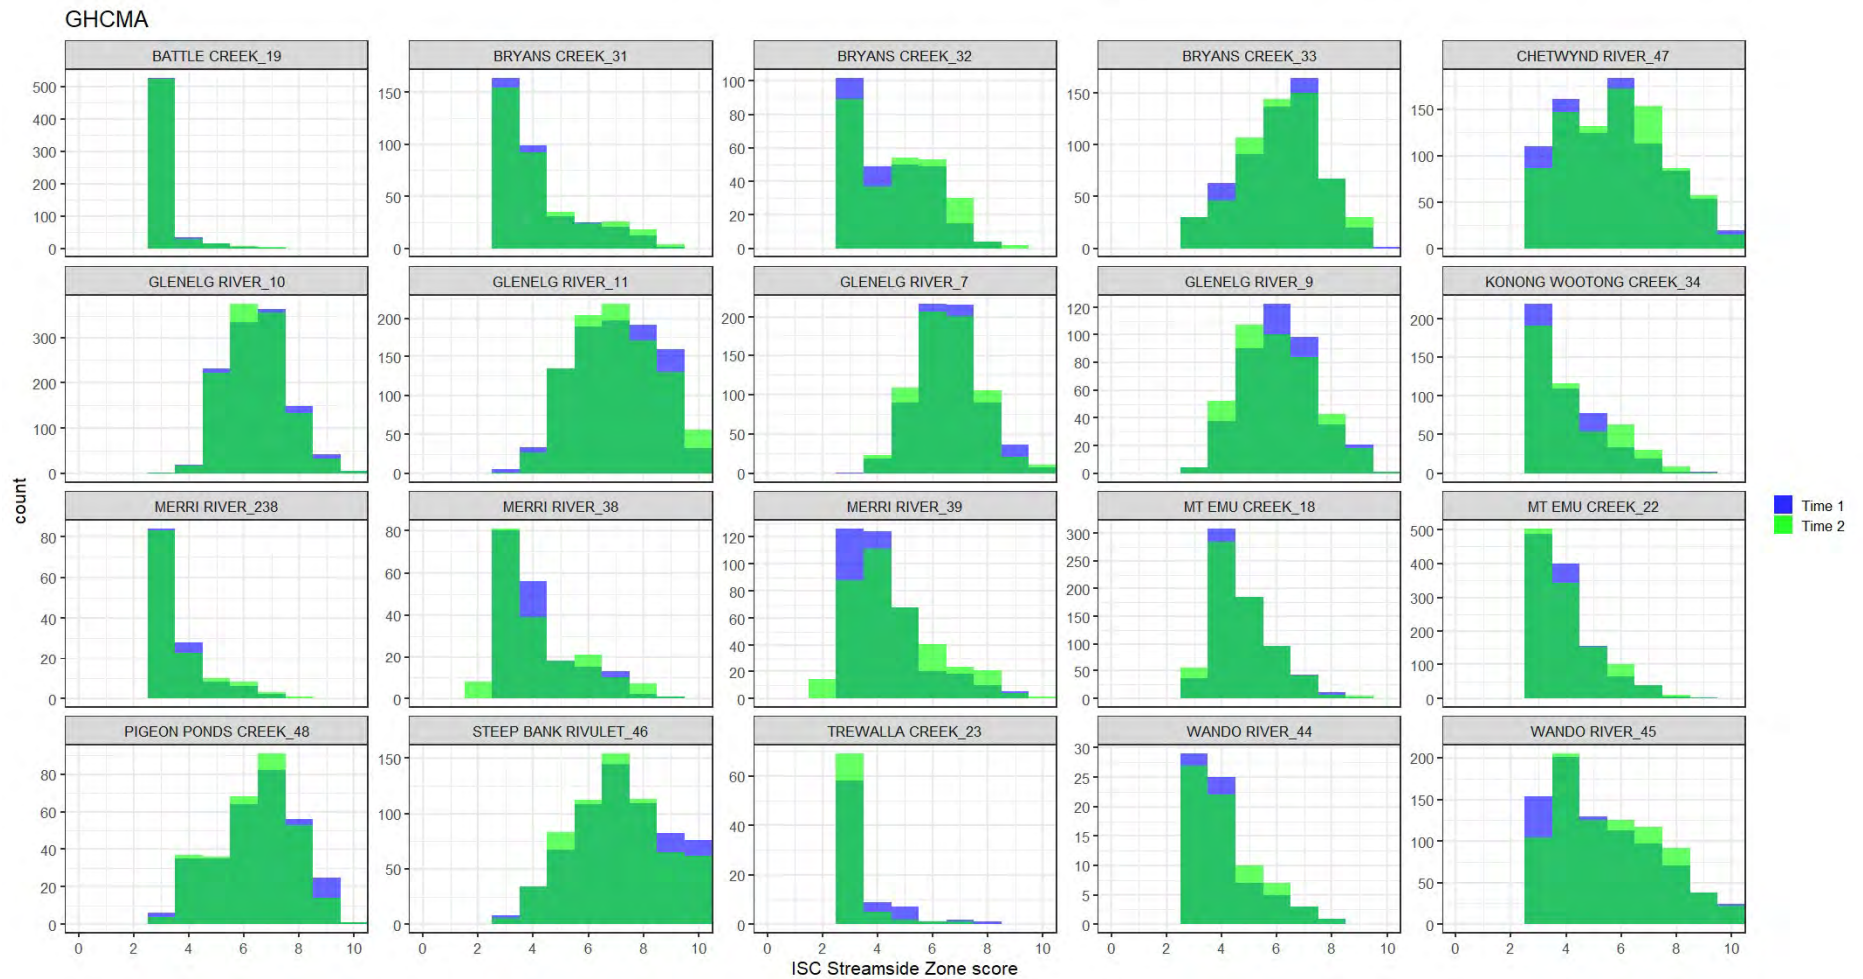
Figure 42 Streamside Zone ISC scores for locations in the GHCMA at the two assessment periods. The count on the y-axis is the number of sections.

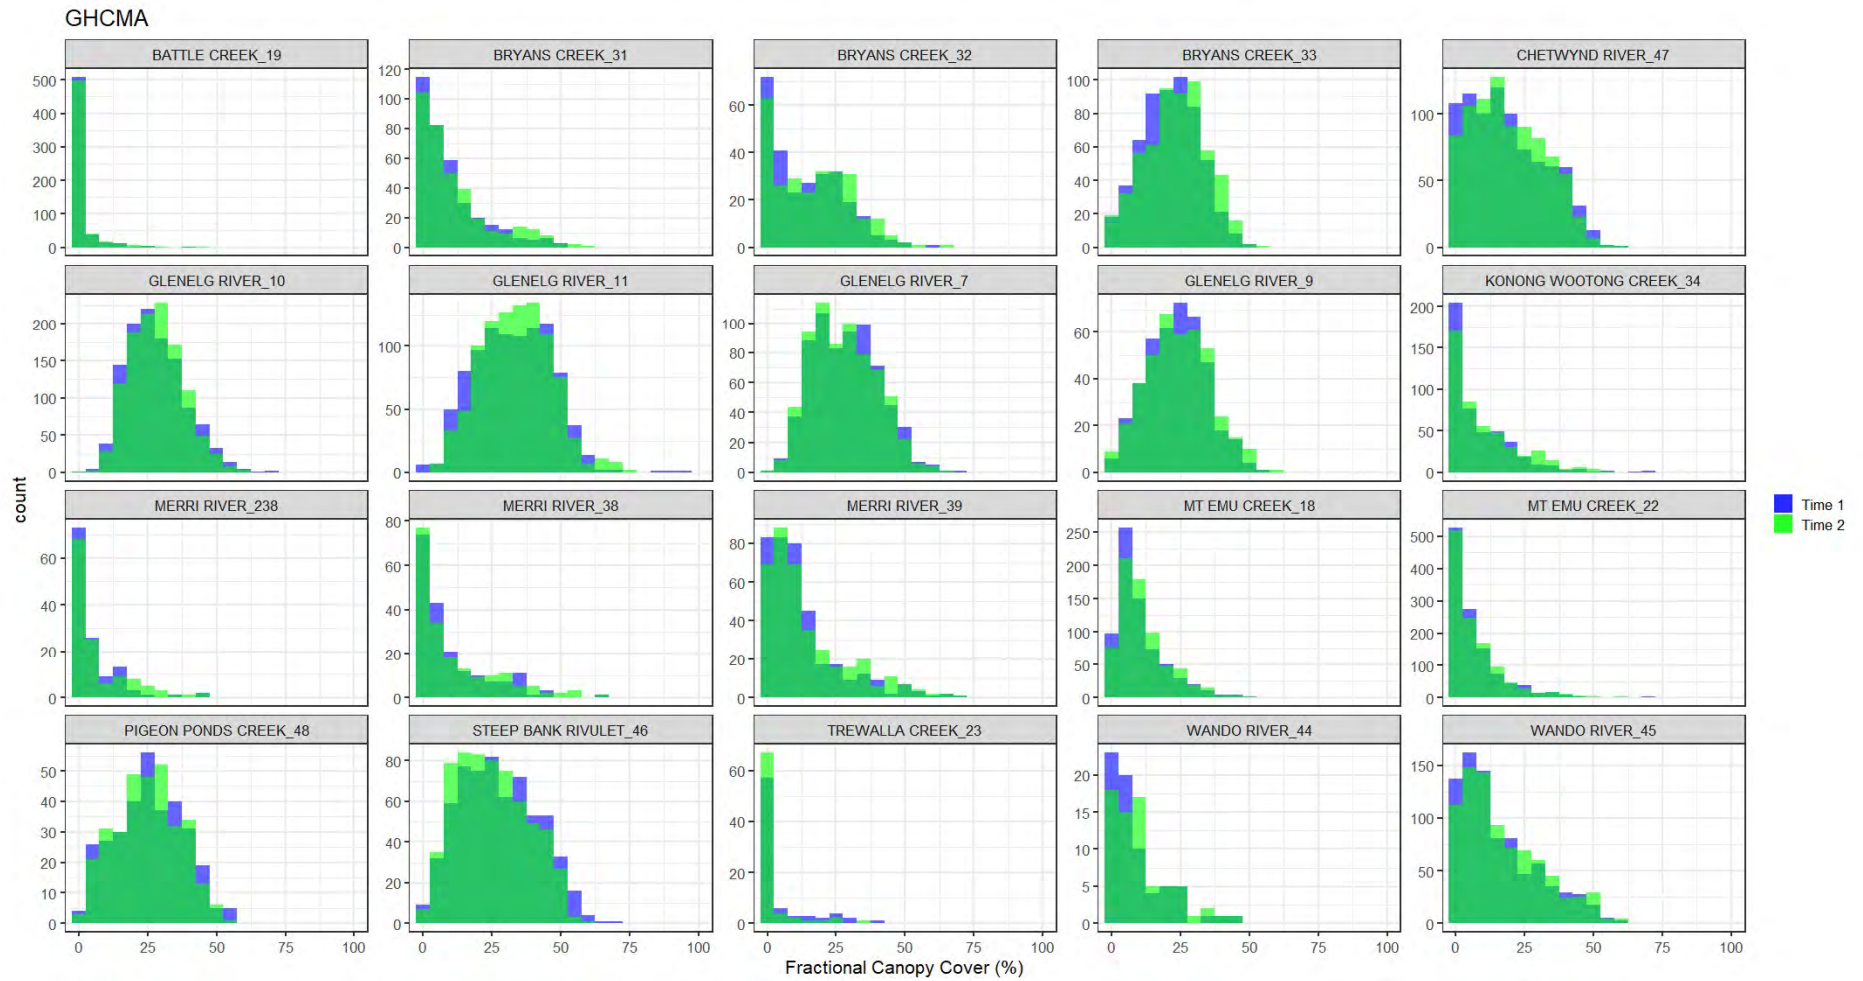
Figure 43 Canopy cover for locations in the GHCMA at the two assessment periods. The count on the y-axis is the number of sections.

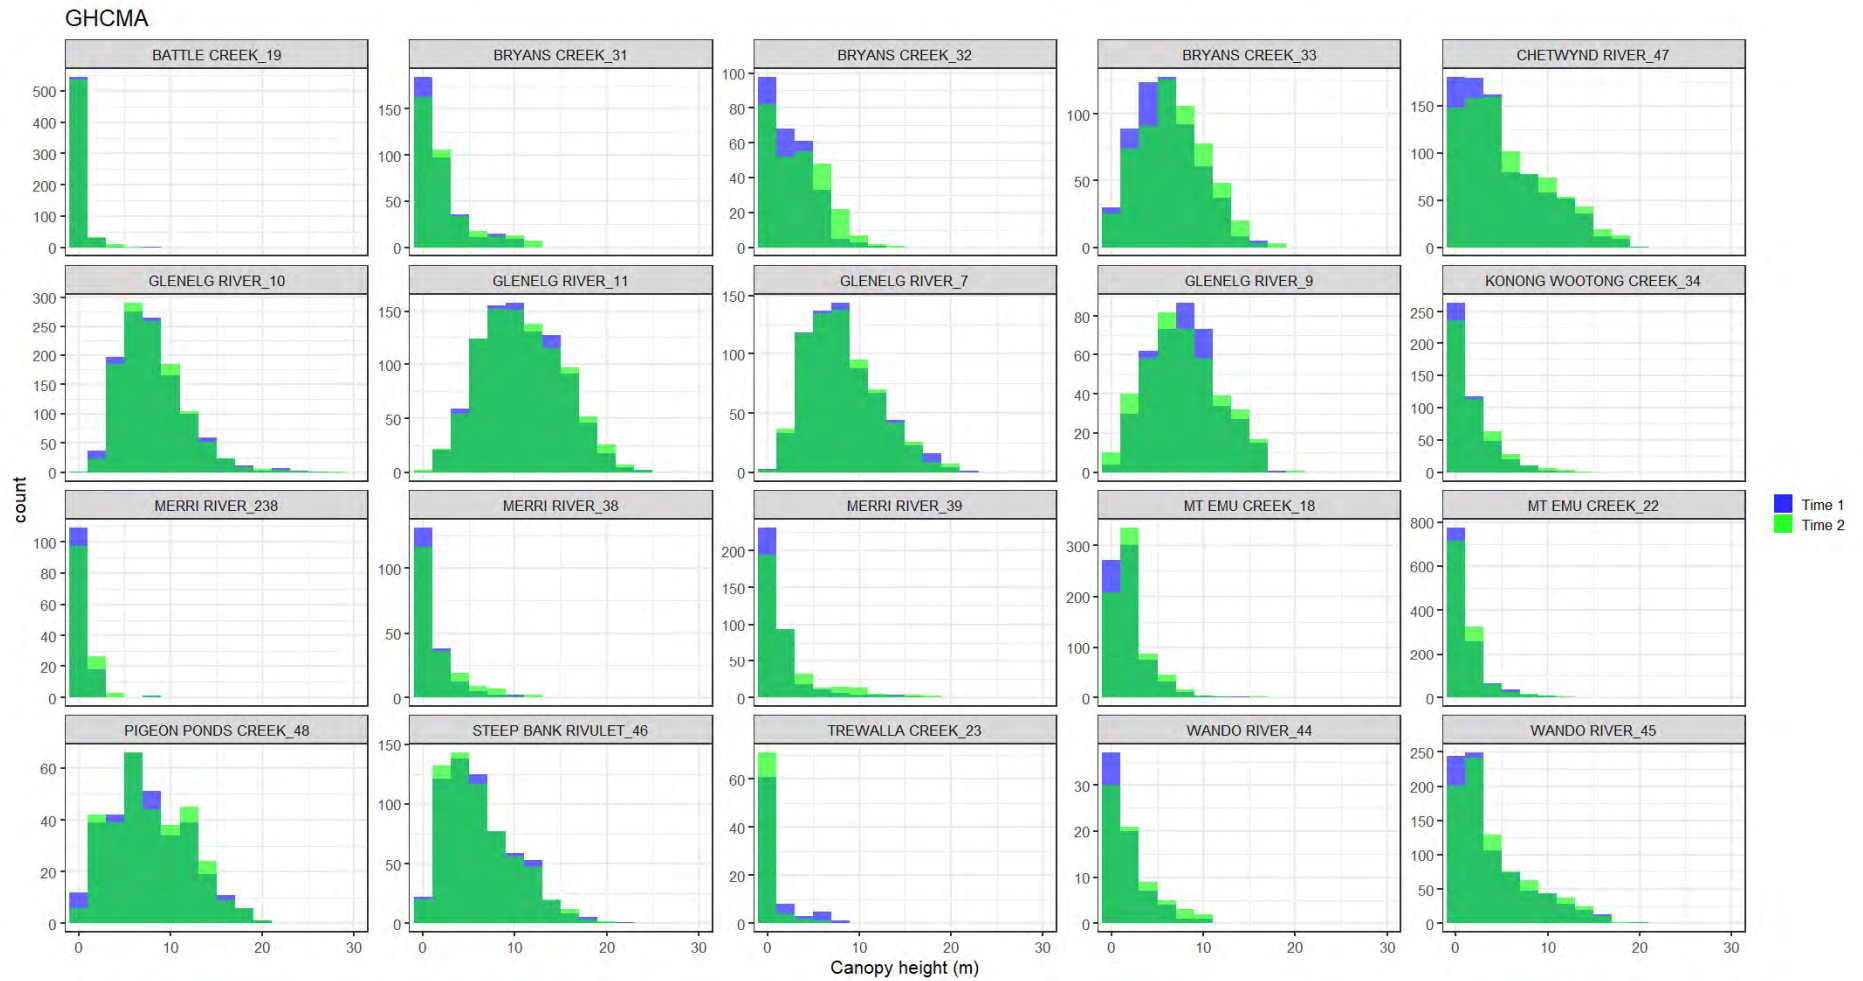
Figure 44 Canopy height for locations in the GHCMA at the two assessment periods. The count on the y-axis is the number of sections.

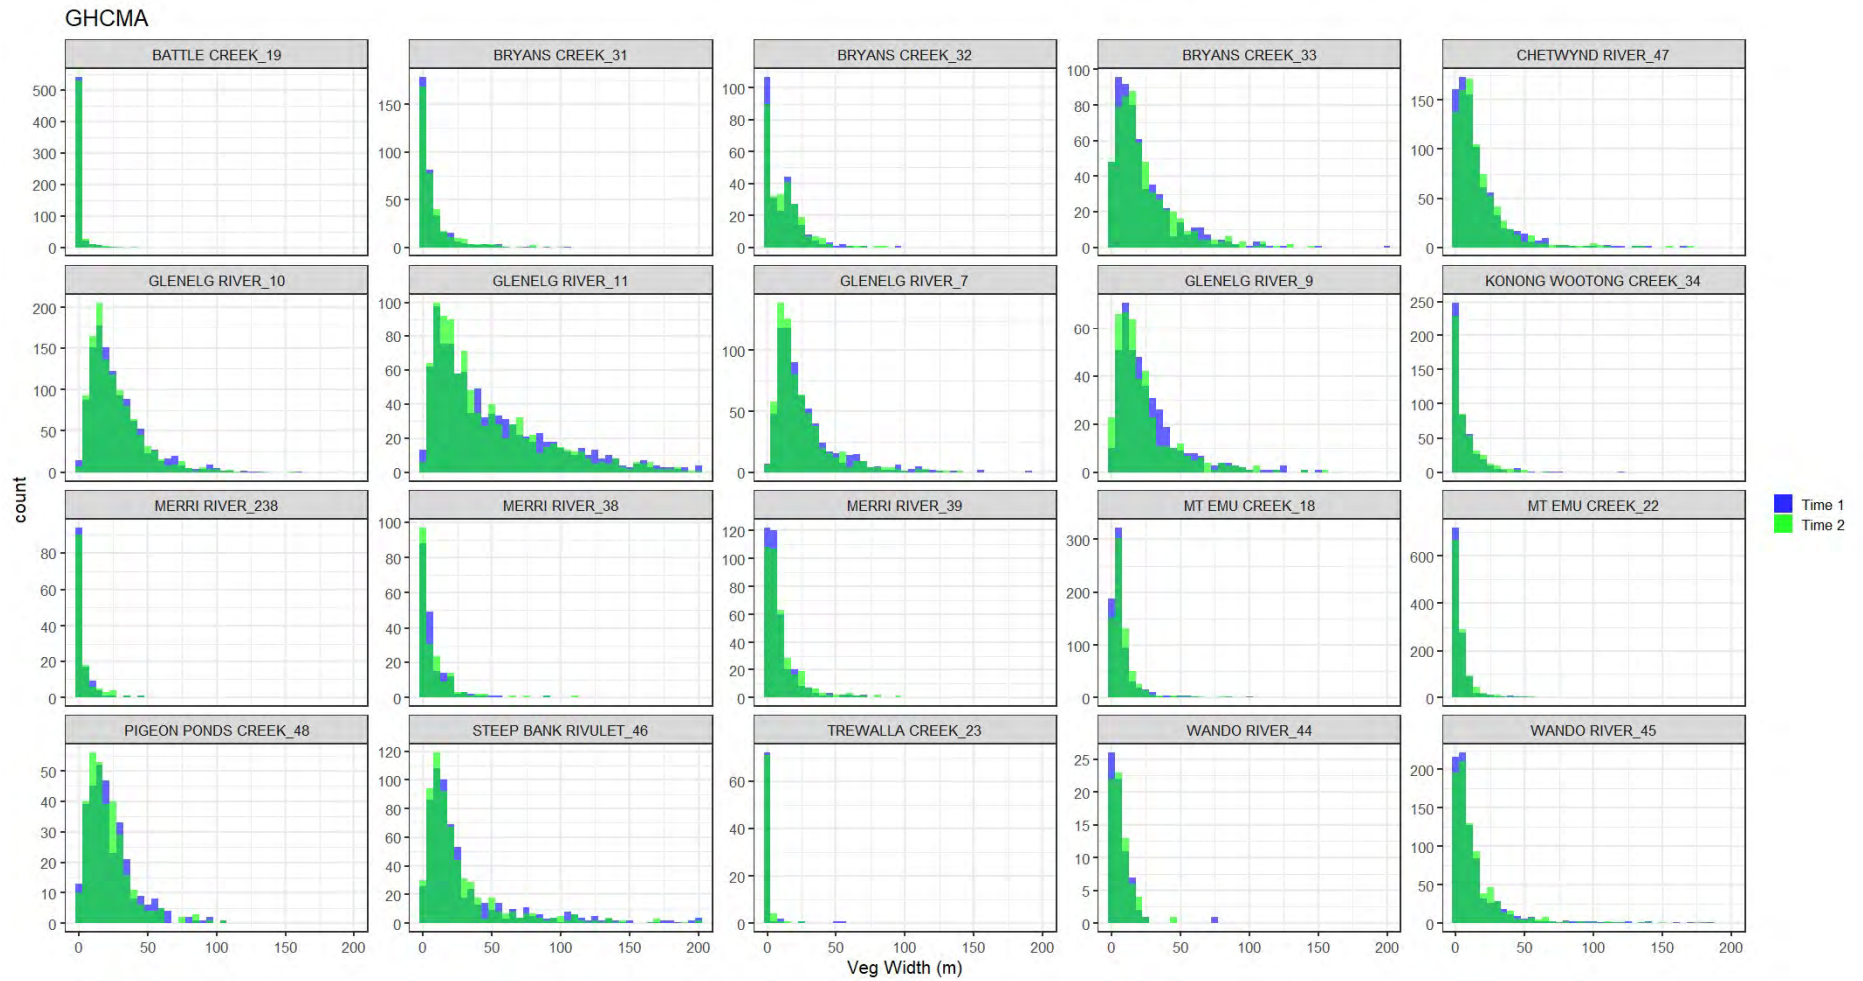
Figure 45 Vegetation width for locations in the GHCMA at the two assessment periods. The count on the y-axis is the number of sections.

Changes in vegetation width were also mostly small, ranging from a 4m decrease at Glenelg River reach 11 and Steep Bank Rivulet reach 46 to a ~2.1m increase at Merri River reach 39 (Figure 45). Across all reaches, the mean change in vegetation width was negligible (a decrease of less than 0.5m)

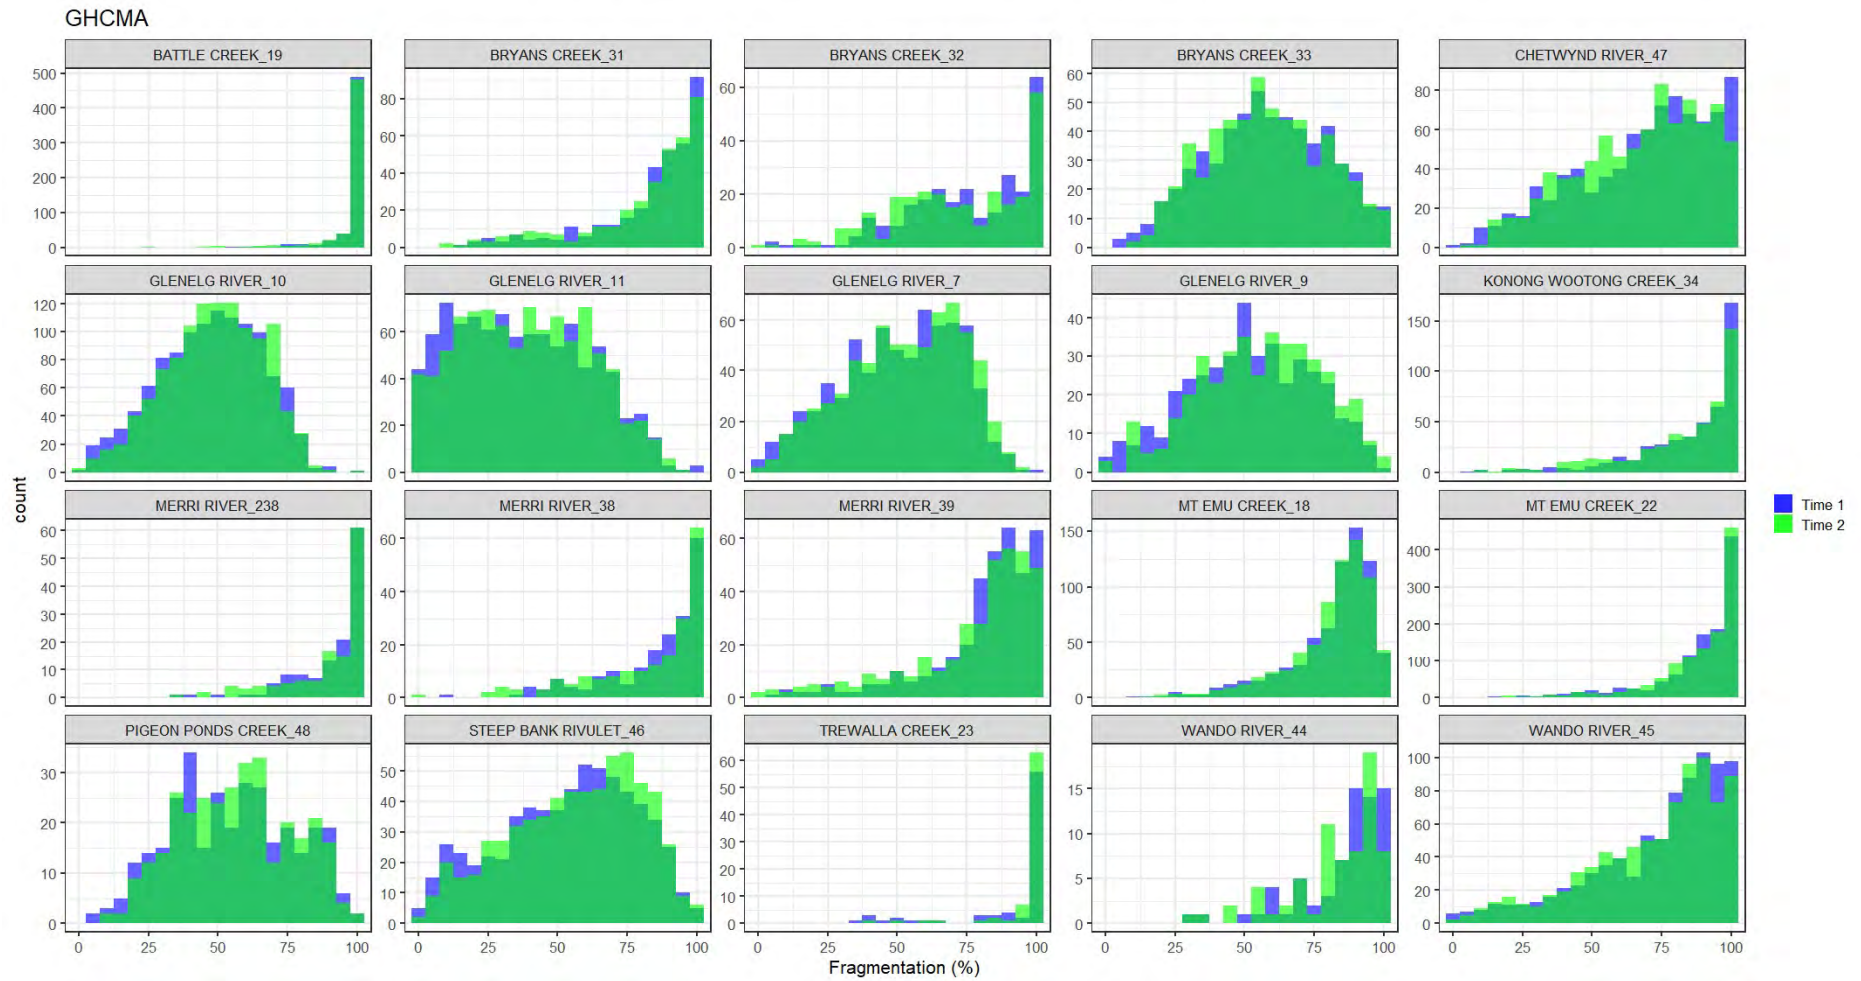
Figure 46 Fragmentation for locations in the GHCMA at the two assessment periods. The count on the y-axis is the number of sections.

Only small changes in fragmentation were observed, ranging from a 4% decrease at Merri River Basin reach 39 to a 5% increase at Trewalla Creek reach 23 (Figure 46). At both reaches, the changes were at sections with high fragmentation: at Merri River reach 39, 10% fewer sections had fragmentation over 75% in 2018; at Merri River reach 39, 14% more sections had fragmentation over 90% in 2018 (Table 12).

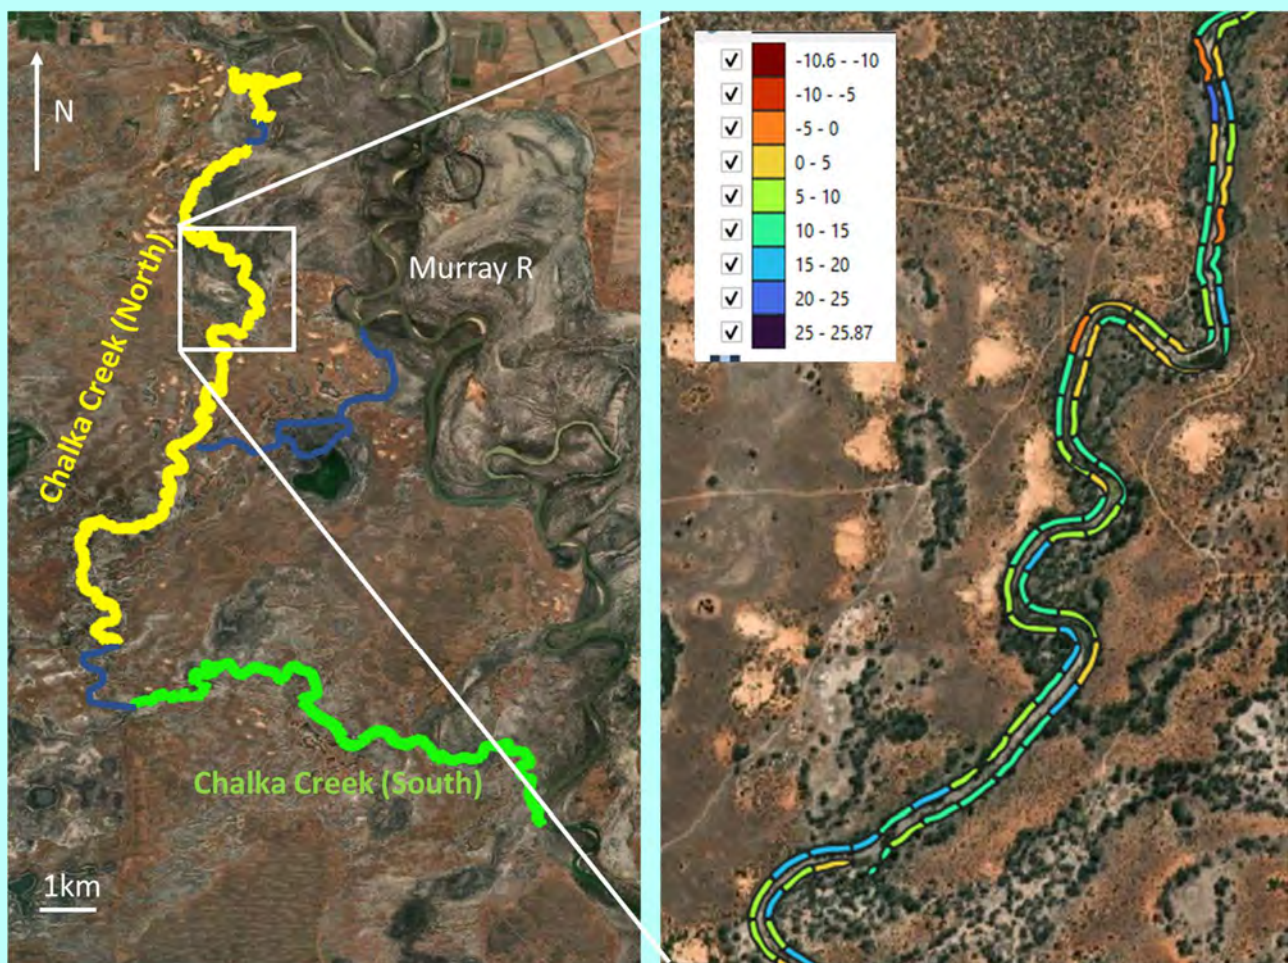
Summary of changes in riparian vegetation at Chalka Creek (left panels show Chalka Creek South; right panels show Chalka Creek North).

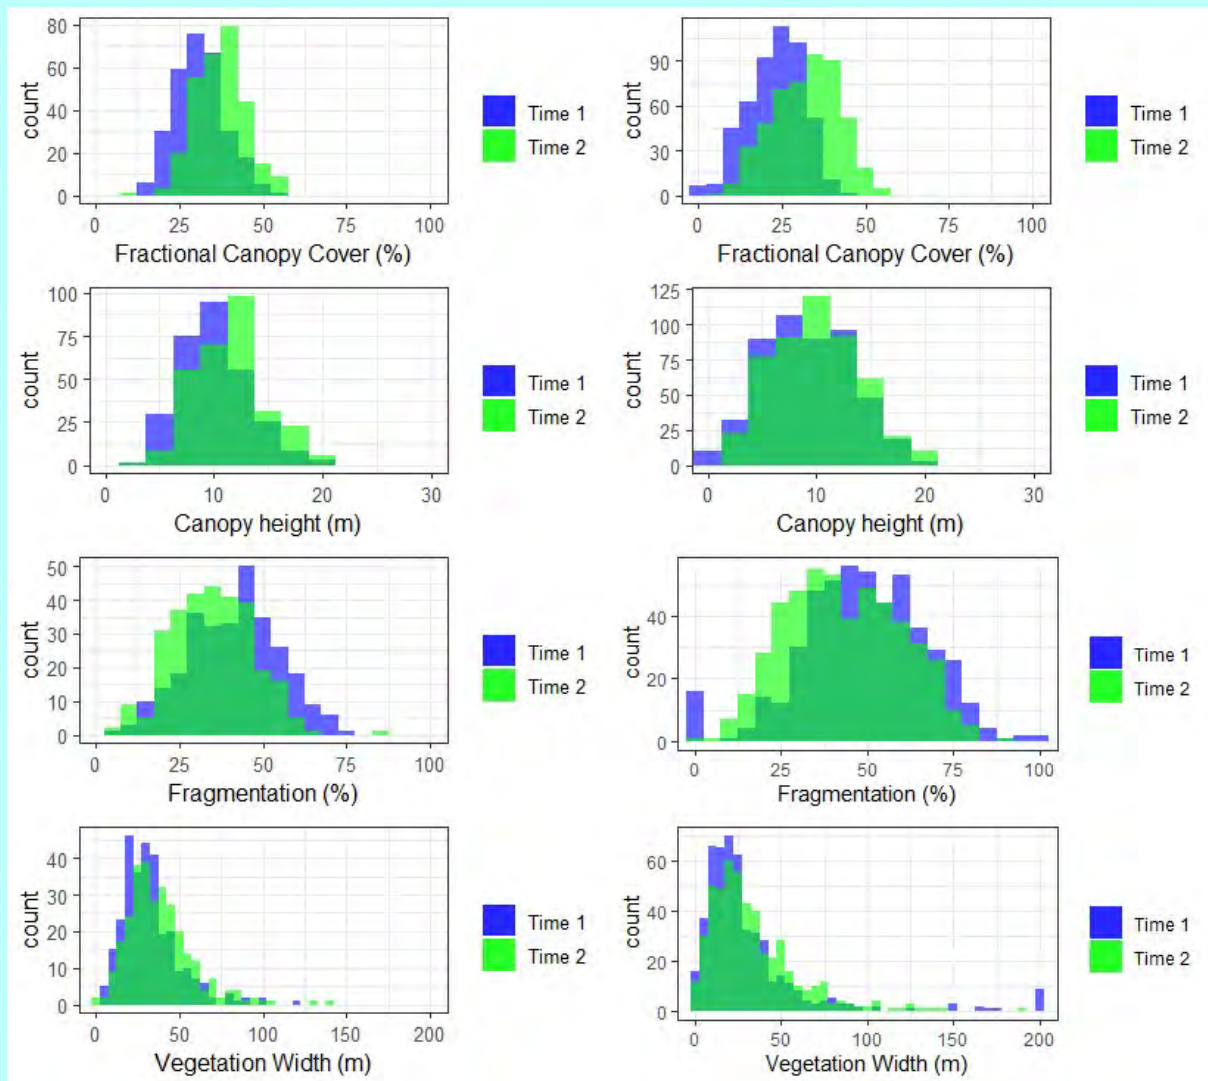
Summary of changes in vegetation metrics on Chalka Creek

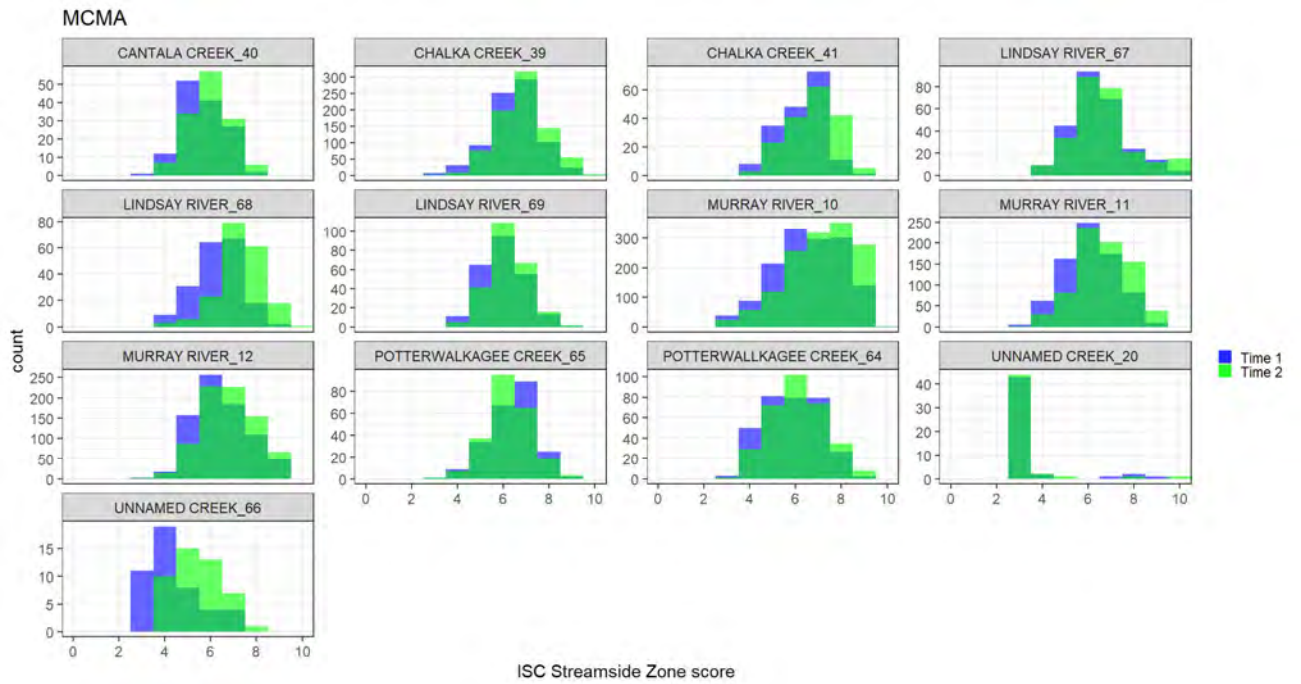
Figure 47 ISC Streamside Zone scores for locations in the MCMA at the two assessment periods. The count on the y-axis is the number of sections.

ISC Streamside Zone scores were higher by one unit at four reaches (Lindsay River reach 68, Murray River reaches 10 and 11, and Unnamed Creek reach 66) and unchanged at the other nine (Figure 47; Table 10).

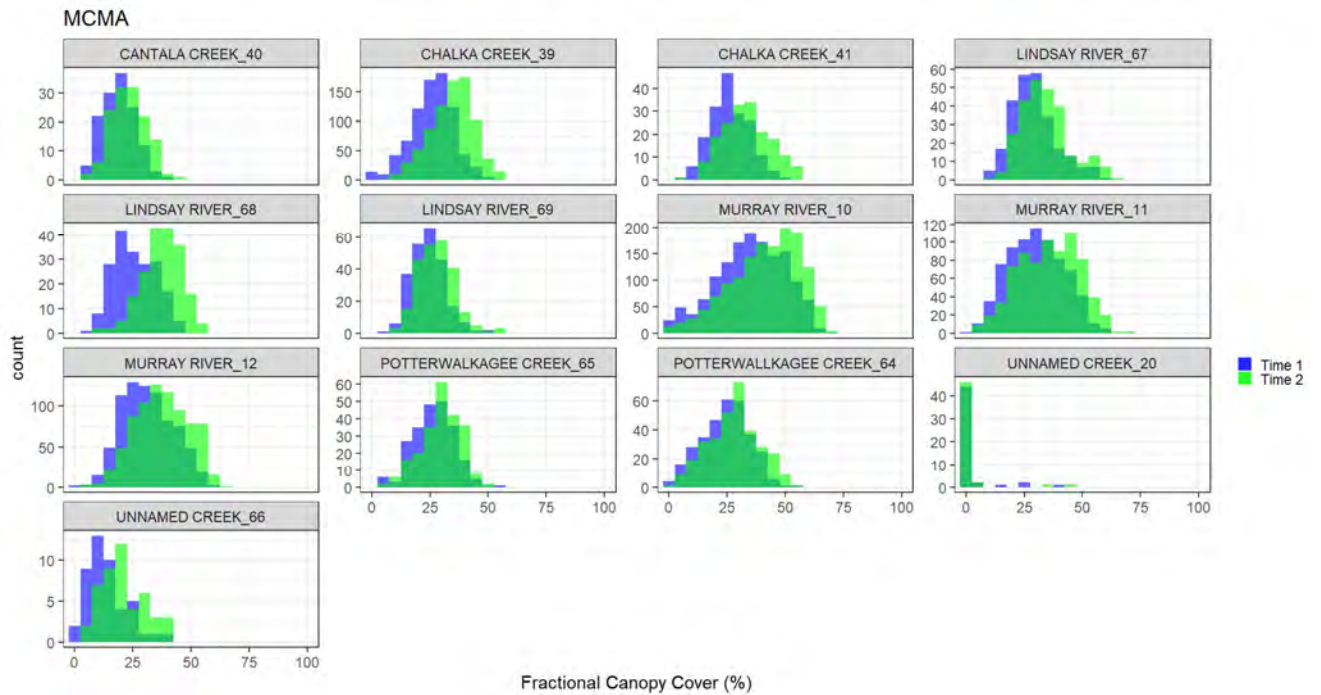
Figure 48 Canopy cover for locations in the MCMA at the two assessment periods. The count on the y-axis is the number of sections.

With the exception of Unnamed Creek reach 20, canopy cover increased at all reaches and by between 3 and 12% (Figure 48; Table 11; Table 12). The largest increases, of 8% and 12% respectively, were observed at Chalka Creek reach 39 and Lindsay River reach 68. At the two sites, there were 23% (Chalka Creek) and 34% (Lindsay River) more sections with canopy cover above 40% in 2018 when compared to 2010 (Table 12).

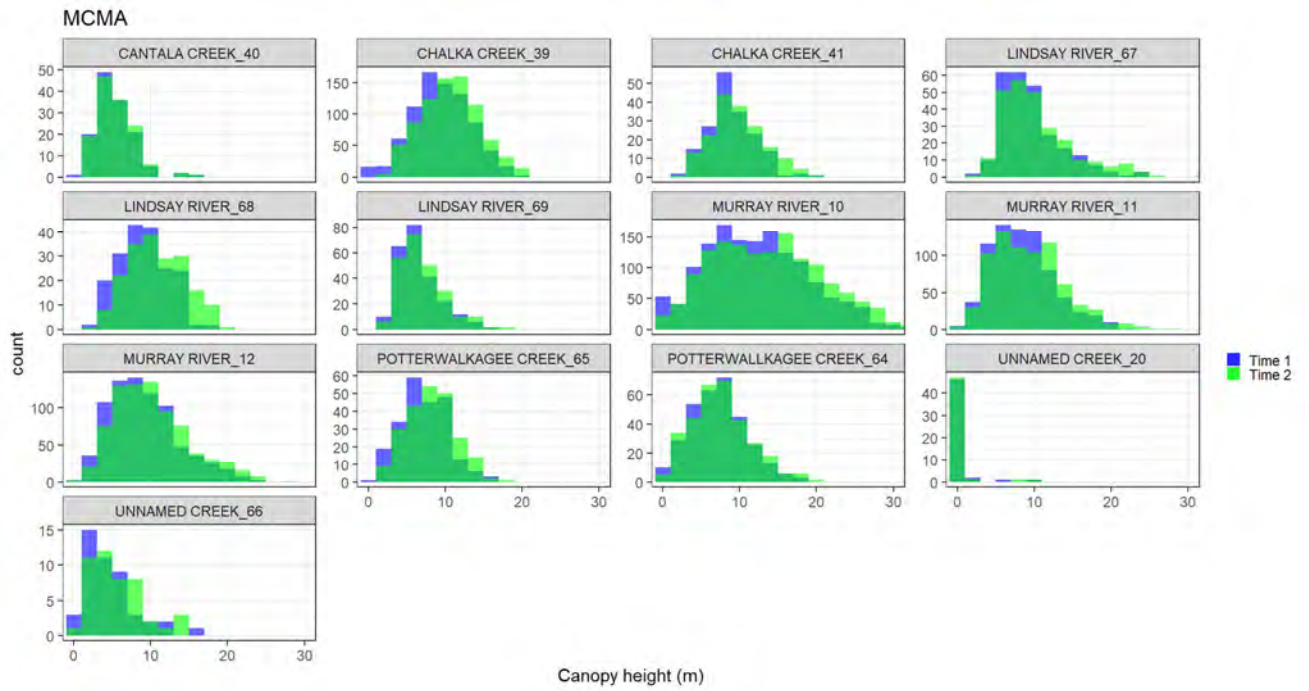
Figure 49 Canopy height for locations in the MCMA at the two assessment periods. The count on the y-axis is the number of sections.

Canopy height increased at most reaches, but the magnitude of these changes was very small (Table 11; Table 12). Increases of 1m or greater were observed at four reaches: Murray River reach 12 (1m), Chalka Creek reach 39 (1.2m), Murray River reach 10 (1.4m) and Lindsay River reach 68 (1.8m).

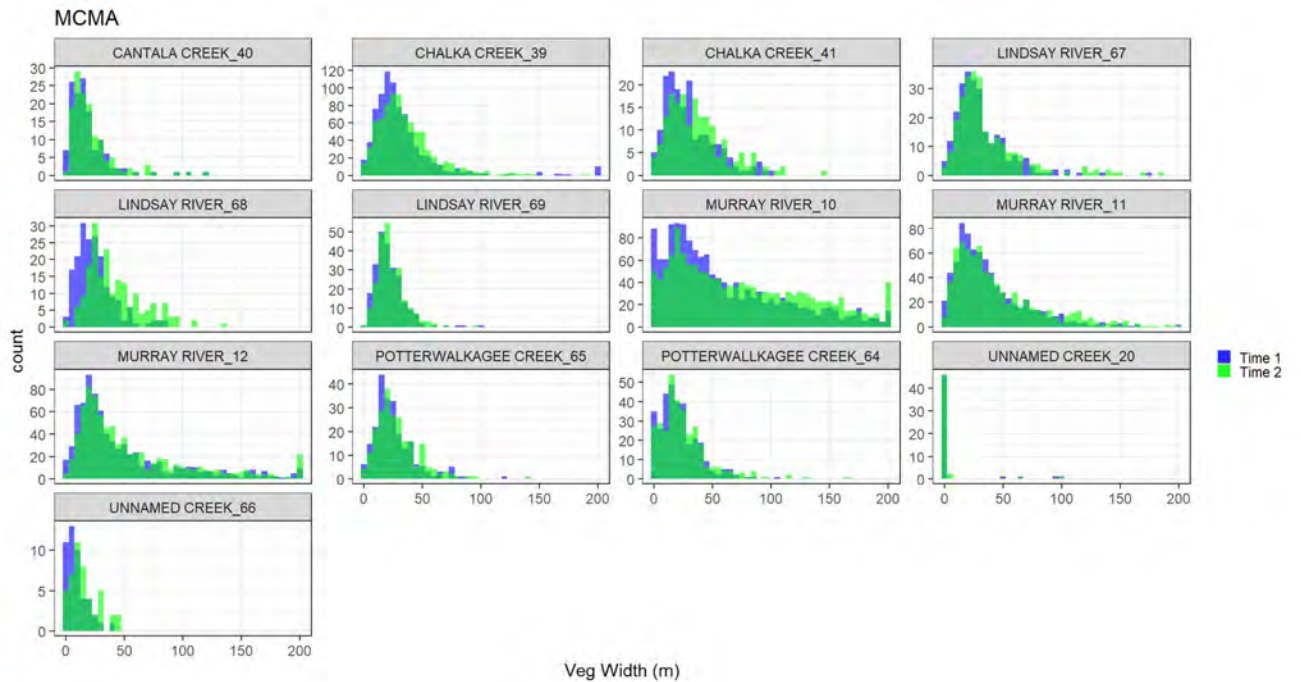
Figure 50 Vegetation width for locations in the MCMA at the two assessment periods. The count on the y-axis is the number of sections.

Vegetation width increased at more than 50% of sections across all reaches other than Unnamed Creek reach 20 (Figure 50), and by between 1 and 17 metres. The largest magnitude changes were observed at Lindsay River reach 68, where ~30% more sections had vegetation wider than both 20m and 40m in 2018. At Unnamed Creek reach 20, vegetation width was ~3m narrower in 2018 than 2010.

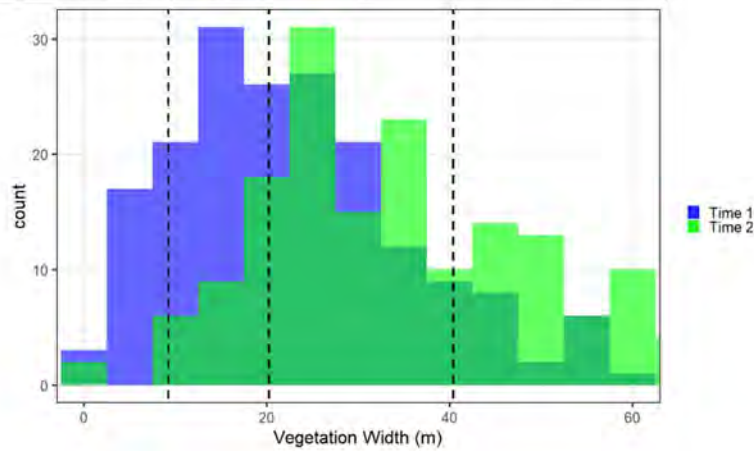
>10m	>20m	>40m
% Segments above threshold (Time 1)	84	56	15
% Segments above threshold (Time 2)	97	86	43
% change Time 1 to Time 2	+13	+30	+28

Figure 51 Histograms showing summary of vegetation width at Lindsay River reach 68 in 2010 (Time 1) and 2018 (Time 2). The box at the top shows the % of sections where the vegetation width exceeds 10m, 20m and 30m in the two periods and the % change in the proportion of sections above those thresholds.

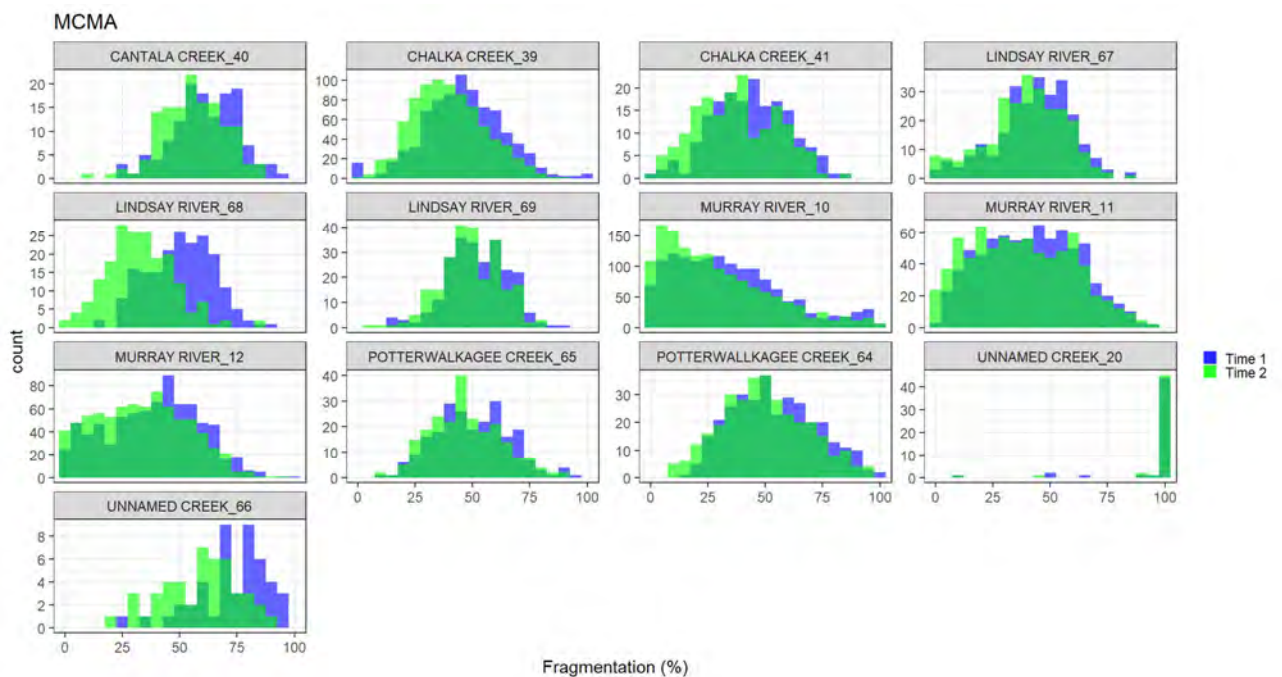
Figure 52 Fragmentation for locations in the MCMA at the two assessment periods. The count on the y-axis is the number of sections

Fragmentation decreased at more than 70% of sections at all reaches except Unnamed Creek reach 20, and by more than 14% at Lindsay River reach 68 and Unnamed Creek reach 66 (Figure 52).

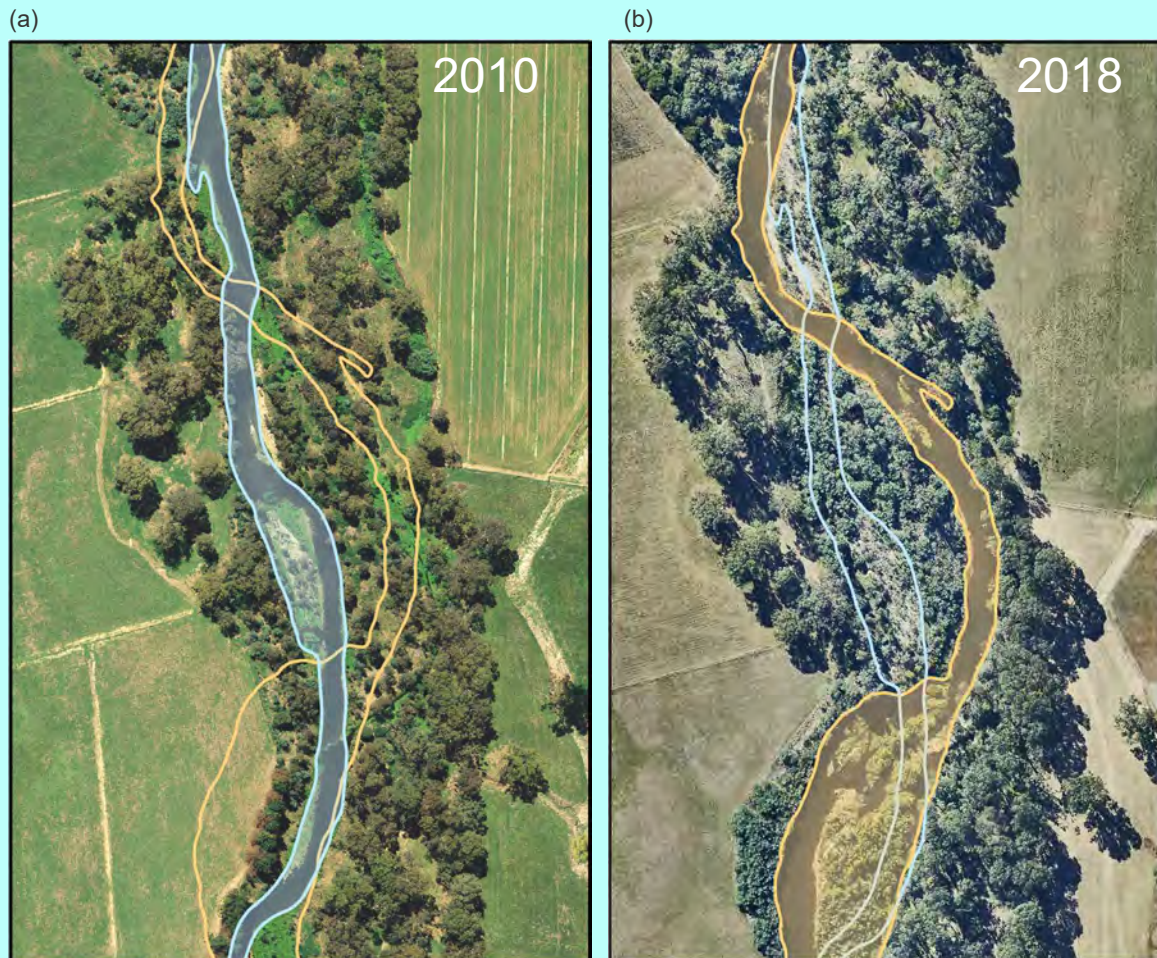
Lateral shifts in the channel is challenging for assessment of change in riparian vegetation because the position of the riparian zone, and the vegetation it contains, changes through time. The amount of overlap of buffer regions (panel c) was used in this study to identify river sections with migrating channels. Sections were excluded from summary results if they overlapped by less than 50% between the two assessment periods.

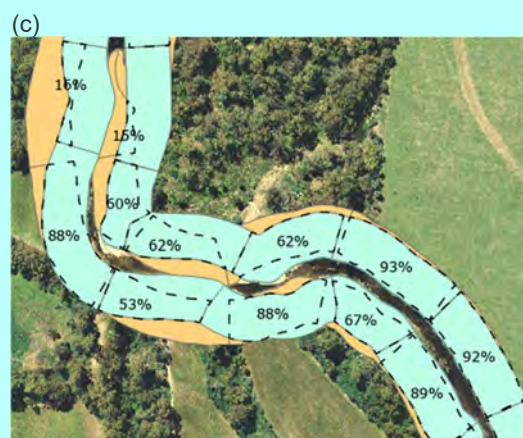
Comparing 2010 and 2018 mapping of the King River ISC reaches 23 and 24, approximately 8% of sections overlapped by less than 50% and were excluded (e.g. panels a and b and the two sections at the top of panel c).

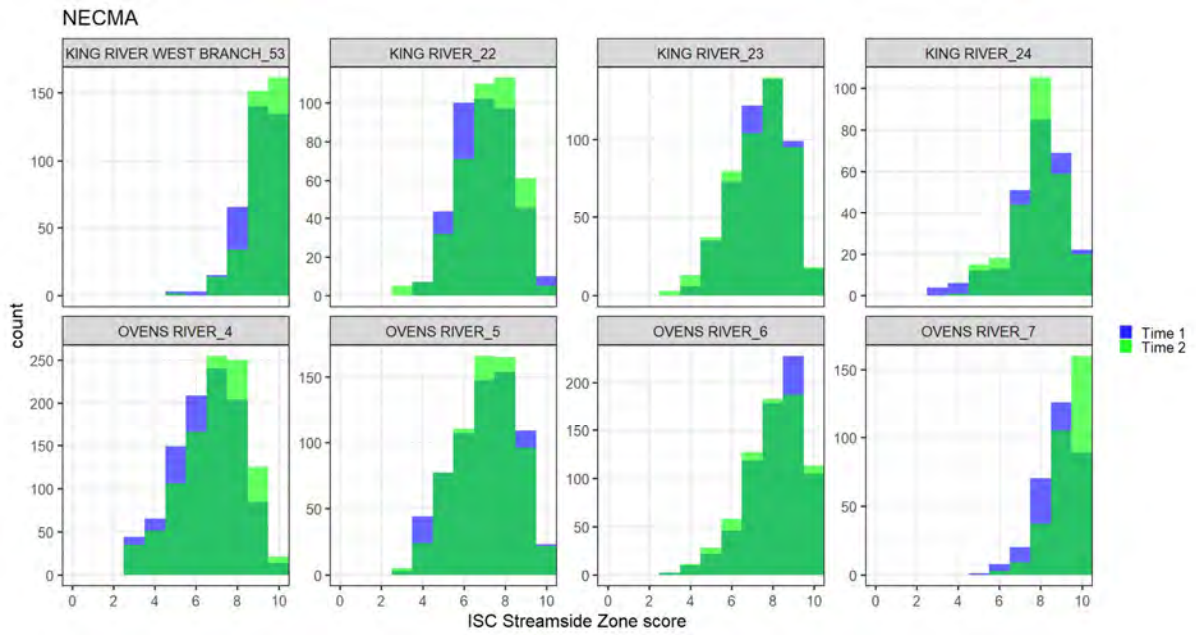
Figure 53 Streamside Zone ISC scores for locations in the NECMA at the two assessment periods. The count on the y-axis is the number of sections.

ISC Streamside Zone scores did not change at any reach (Figure 53; Table 10).
