Stream Change Assessment: detecting change in riparian woody vegetation using LiDAR derived data

April 2022

Catchments, Waterways, Cities and Towns, Waterway Programs Branch

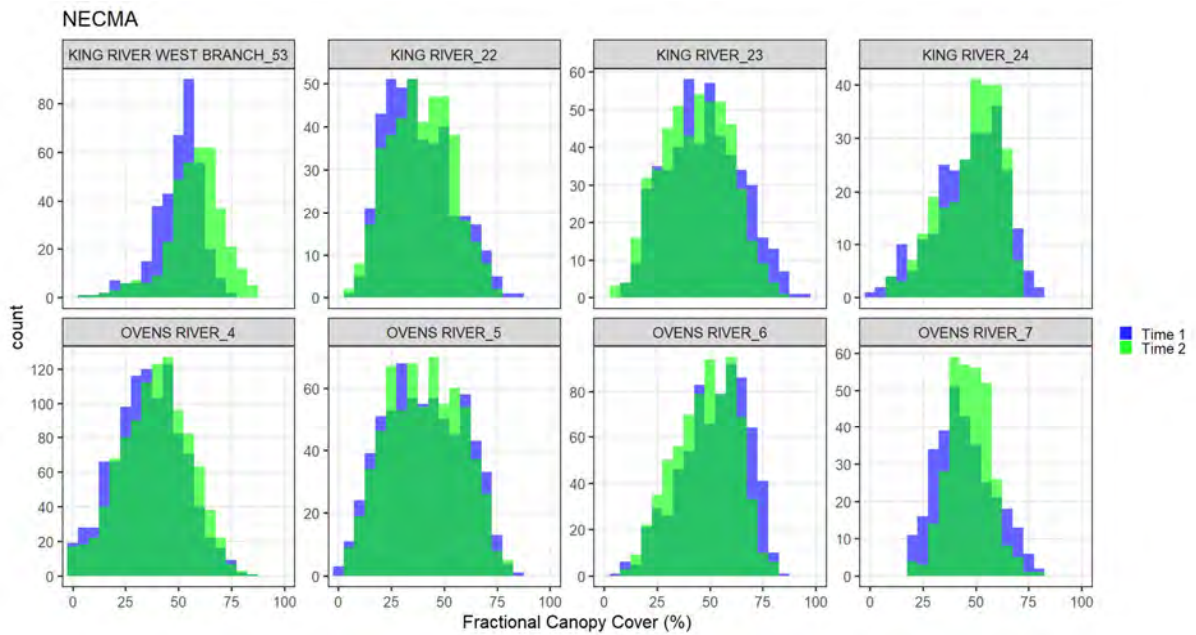
Figure 54 Fractional canopy cover for locations in the NECMA at the two assessment periods. The count on the y-axis is the number of sections.

Fractional canopy cover was higher at six of the eight reaches assessed (Figure 54; Table 11). The most significant increase was at King River reach 53 where there were 7% more sections with canopy cover greater than 40% in 2019, and ~34% more sections with cover greater than 60% (Table 12). Mean changes in canopy cover ranged from a decrease of 4% (Ovens River Basin 3 reach 6, King River Basin 3 reach 23) to an increase of 8% (King River West Branch Basin 3 reach 53).

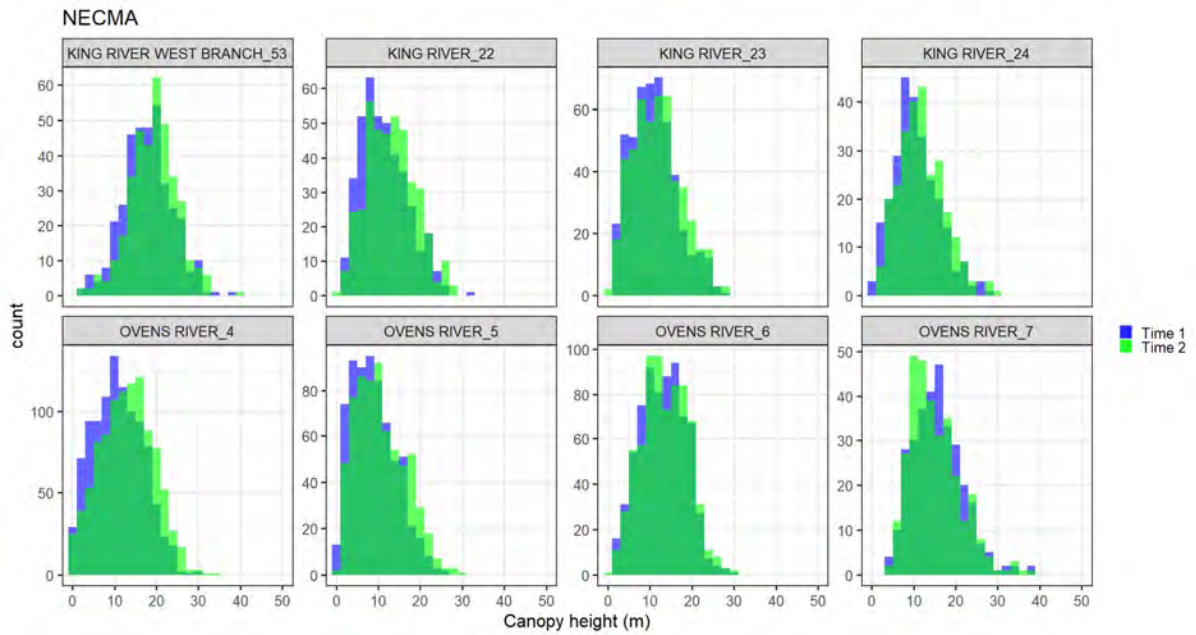
Figure 55 Canopy height locations in the NECMA at the two assessment periods. The count on the y-axis is the number of sections.

Canopy height (Figure 55) decreased by 0.7m at Ovens River reach 7 but increased at all other reaches, by between 0.5m (Ovens River reach 6) and 2.1m (Ovens River reach 4) (Table 12).

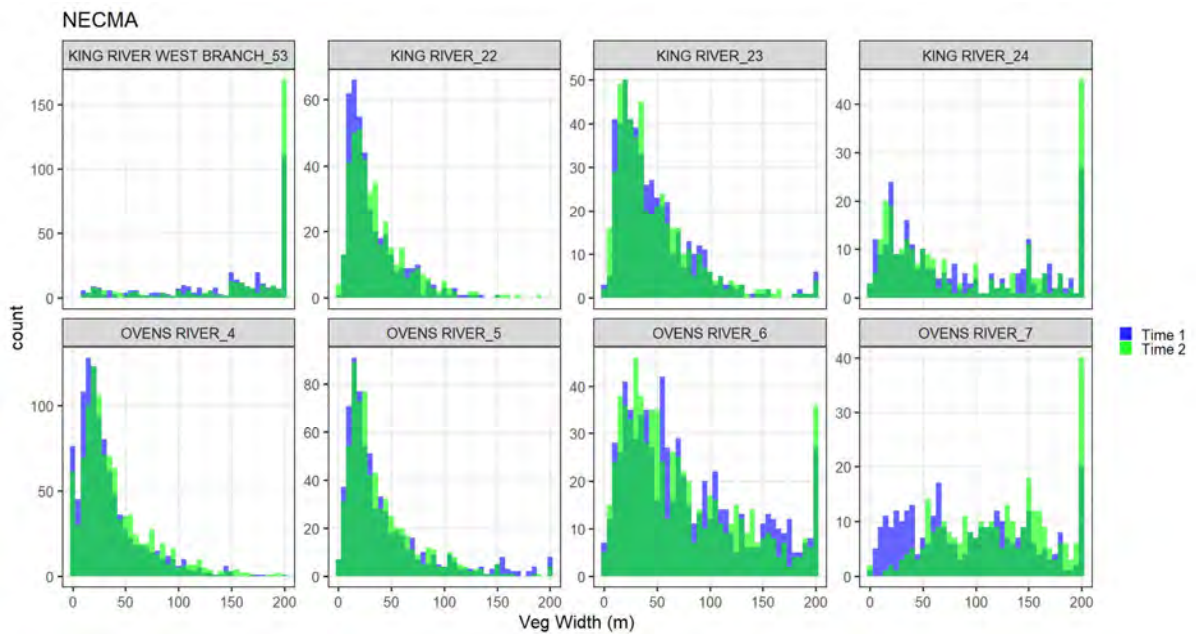
Figure 56 Vegetation width locations in the NECMA at the two assessment periods. The count on the y-axis is the number of sections.

Vegetation width increased at more than 50% of sections across all reaches but the magnitude of this change was generally small (Figure 56).

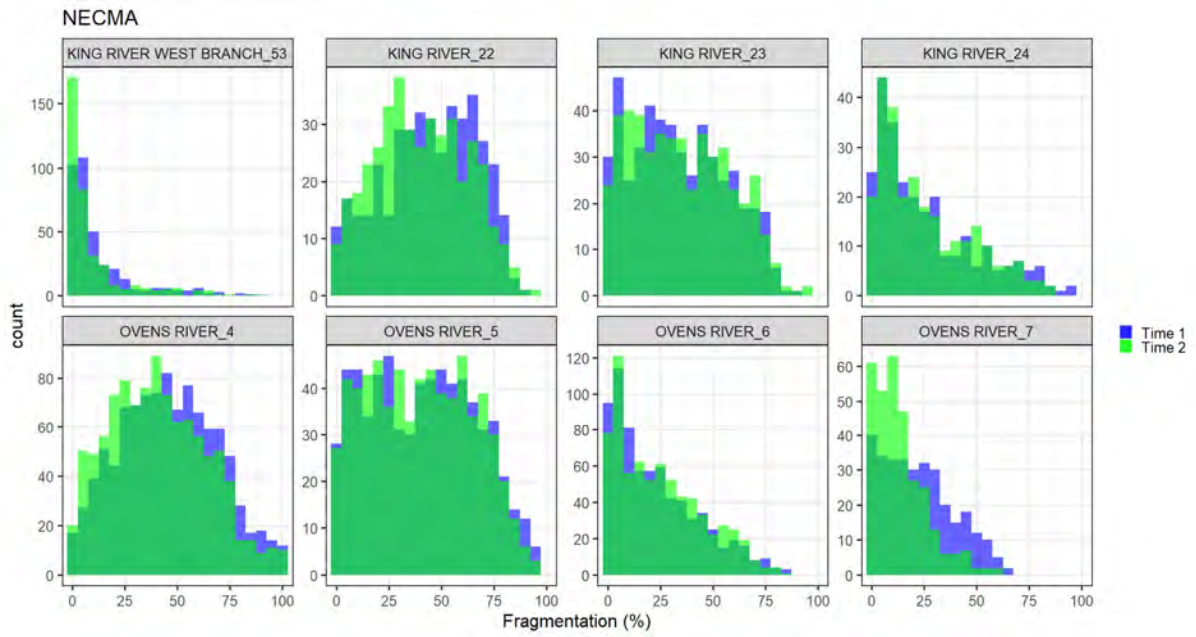
Figure 57 Fragmentation locations in the NECMA at the two assessment periods. The count on the y-axis is the number of sections.

Fragmentation decreased at more than 50% of sections at all reaches in 2018 (Figure 57), although the magnitude of these changes was relatively small overall, <5% change. The exception to this was Ovens River reach 7, where there was a 29% decrease, and ~27% fewer sections with fragmentation above 25% in 2018.

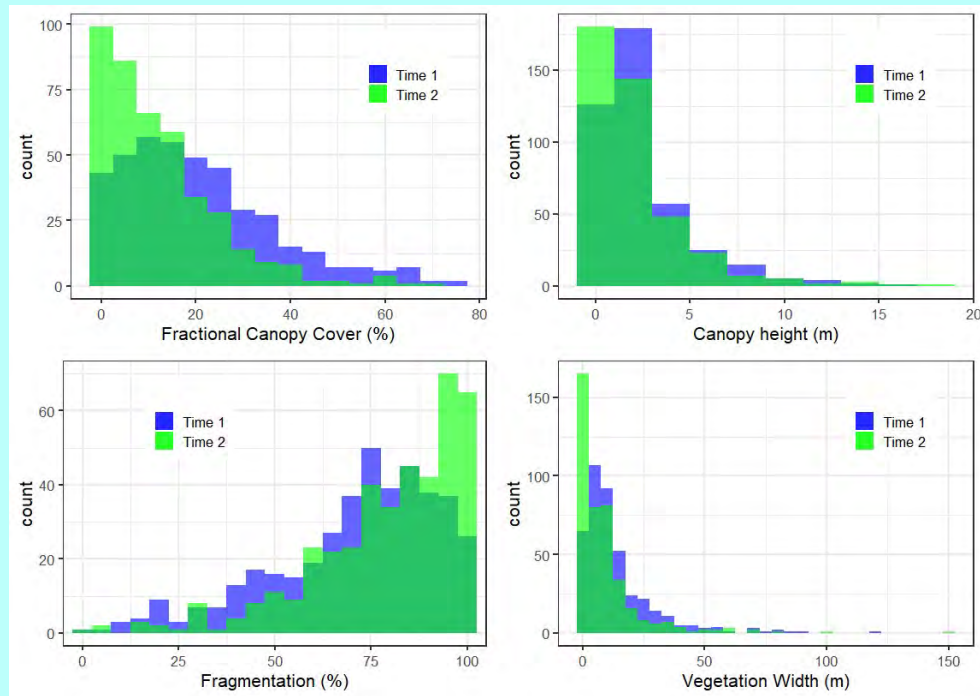
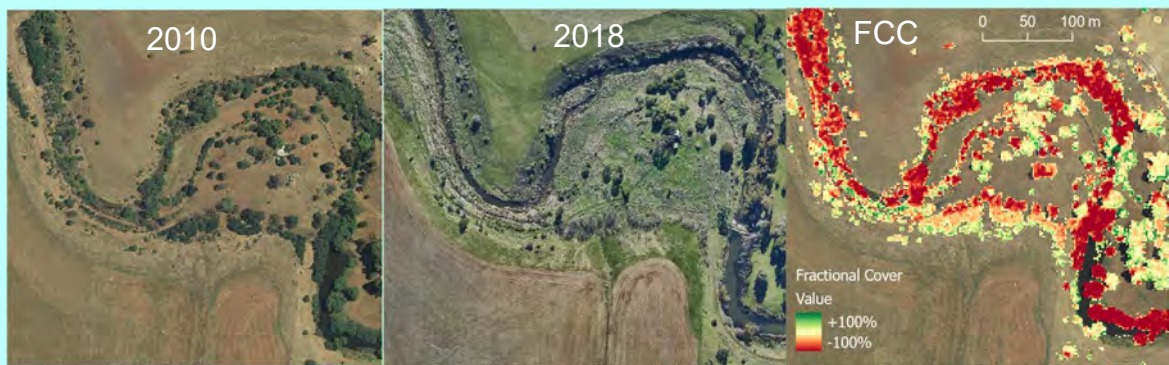
Significant willow removal was undertaken along sections of Birch's Creek in the upper Loddon catchment between 2010 and 2018. Willow removal has resulted in large decreases in fractional canopy cover at the reach scale (by 9%), canopy height (by 0.4m), and vegetation width (by 5%), with commensurate increases in fragmentation (by 8%). There is some evidence of regrowth of native woody vegetation with an increase in canopy at heights below 2.5m and canopy cover below 20%.

Aerial photography from 2010 and 2018 showing willow removal at Birch's Creek. Right panel shows changes in fractional canopy cover, with 100% reductions in red, and small patches of regeneration (increases in green).

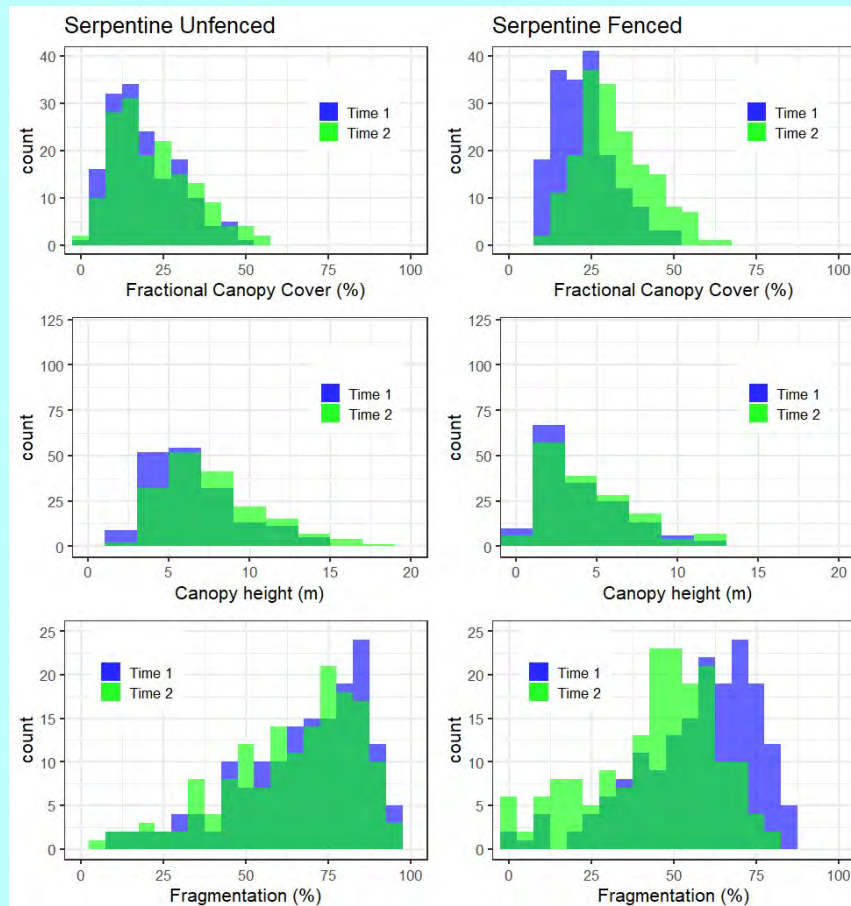
Summary of changes in vegetation metrics on Serpentine Creek

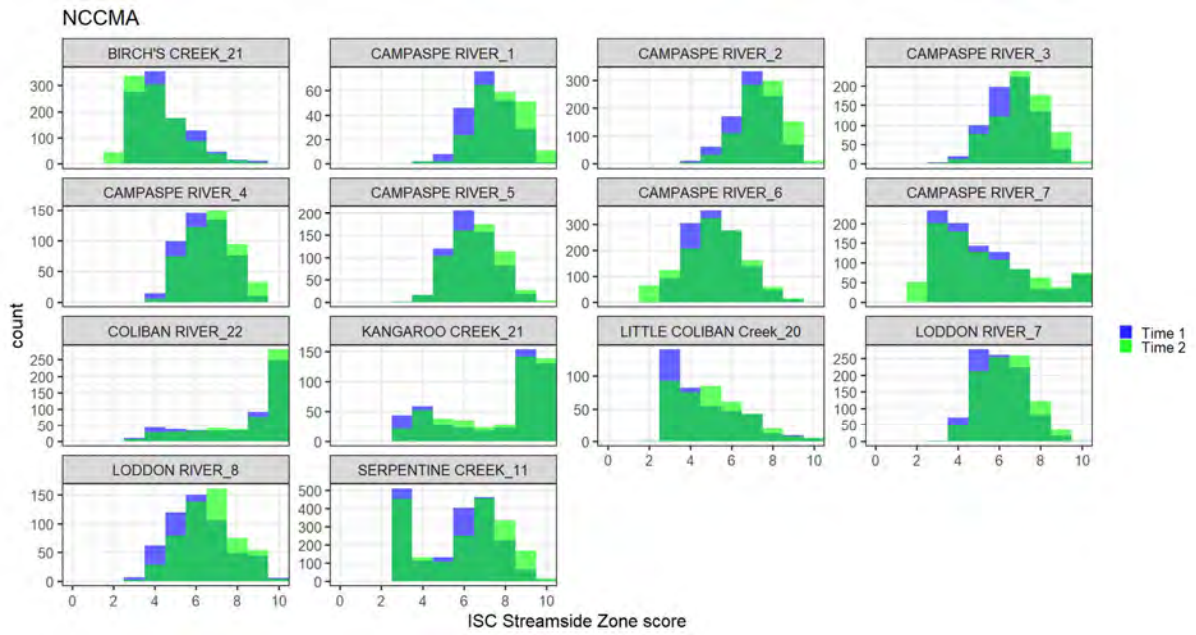
Figure 58 Streamside Zone ISC scores for locations in the NCCMA at the two assessment periods. The count on the y-axis is the number of sections.

ISC Streamside Zone scores increased by one unit at Campaspe River reach 1 but did not change at any other reaches (Figure 58; Table 10).

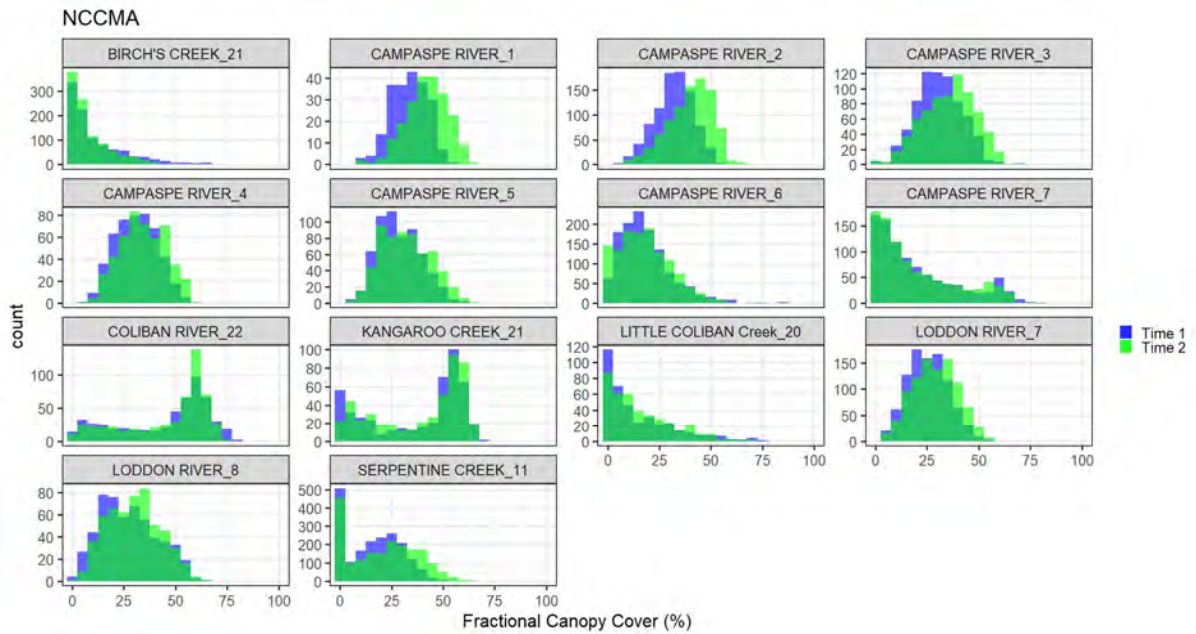
Figure 59 Fractional canopy cover for locations in the NCCMA at the two assessment periods. The count on the y-axis is the number of sections.

Increases in canopy cover occurred at some reaches, especially on the Campaspe River (Figure 59; Table 11; Table 12). At Campaspe River reaches 1, 2, 3 and 4, canopy cover increased at between 84 and 97% of sections, and by between 4 and 9%.

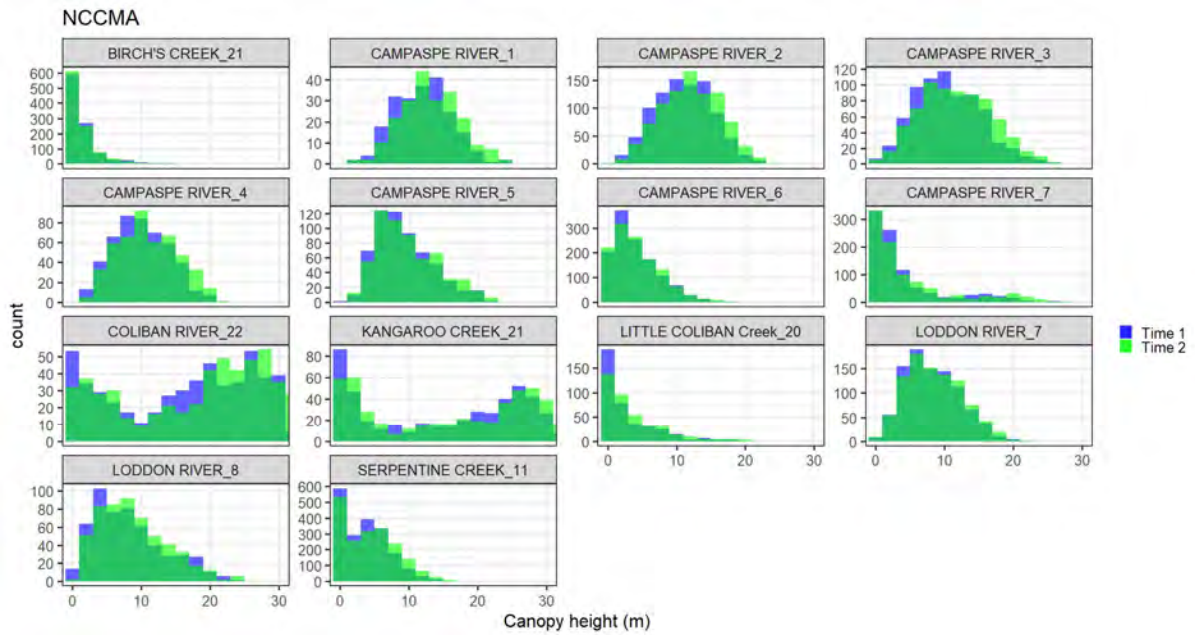
Figure 60 Canopy height for locations in the NCCMA at the two assessment periods. The count on the y-axis is the number of sections.

Canopy height increased at most reaches (Figure 60). The largest increases occurred at Coliban River reach 22 and Campaspe River reach 3, of 1.7m and 1.2m respectively.

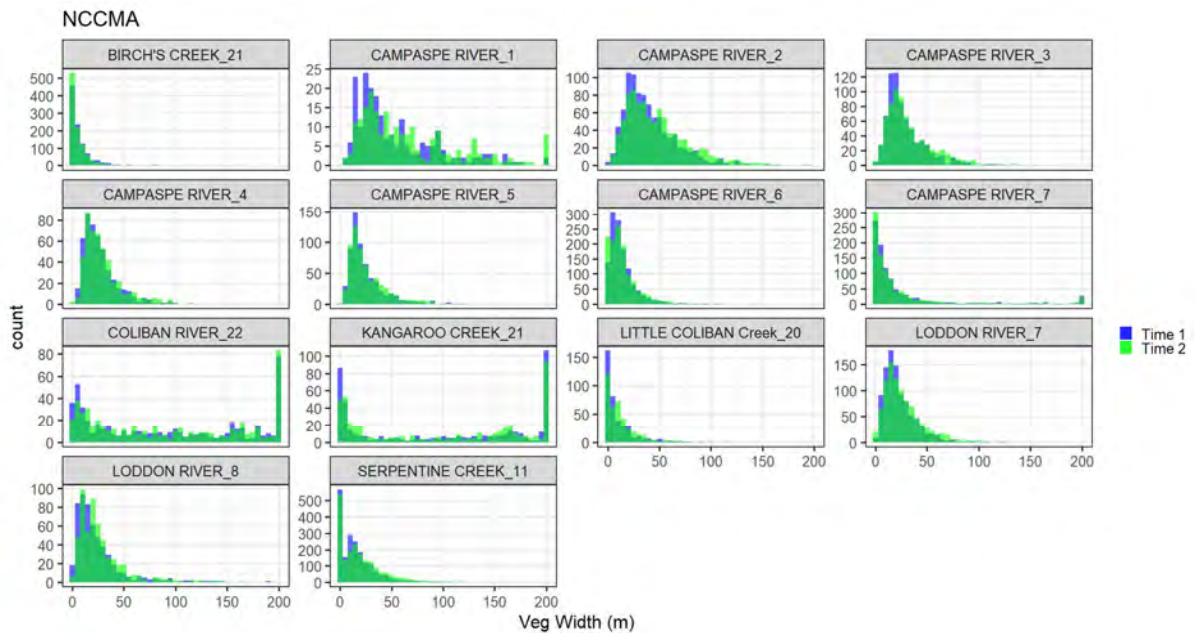
Figure 61 Vegetation width for locations in the NCCMA at the two assessment periods. The count on the y-axis is the number of sections.

Vegetation width also generally increased at all reaches, with the exception of Birch's Creek reach 21 (Figure 61). However, the magnitude of these changes was also small (on average less than 10m). The exception to this magnitude and extent of change was Campaspe River reach 1, where vegetation width increased at 69% of sections, and by on average 13m (Table 10).

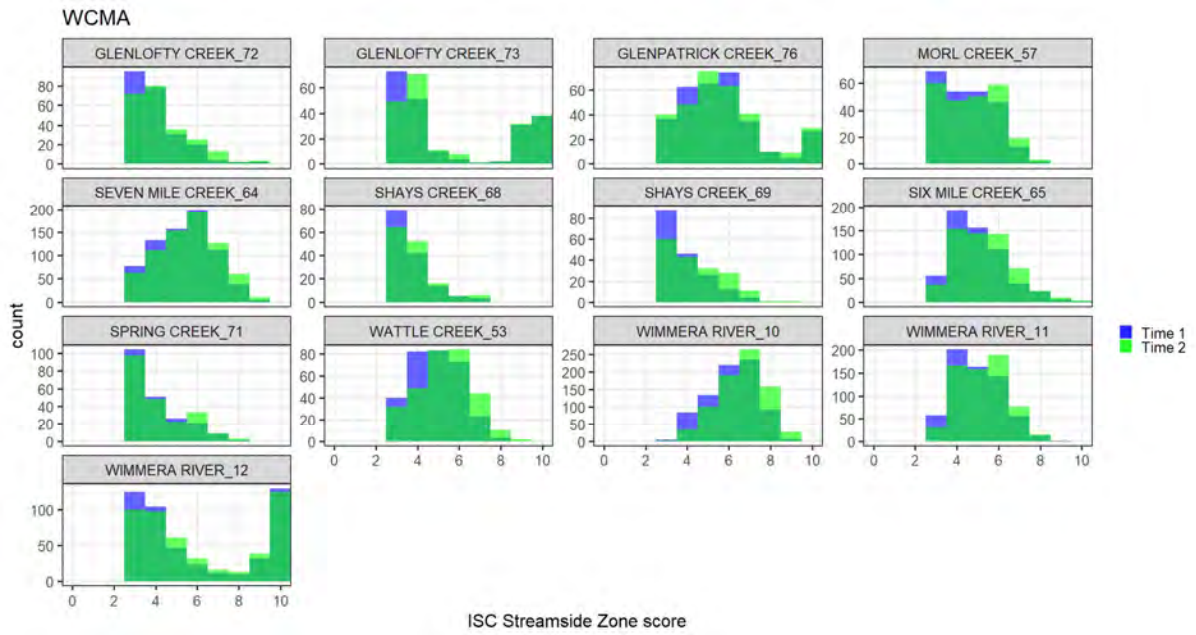
Figure 63 Streamside Zone ISC scores for locations in the WCMA at the two assessment periods. The count of the y-axis is the number of sections.

In general, ISC Streamside Zone scores and vegetation metrics were unchanged in the Wimmera region between 2010 and 2018 (Figure 63 - Figure 67; Table 10-Table 12).

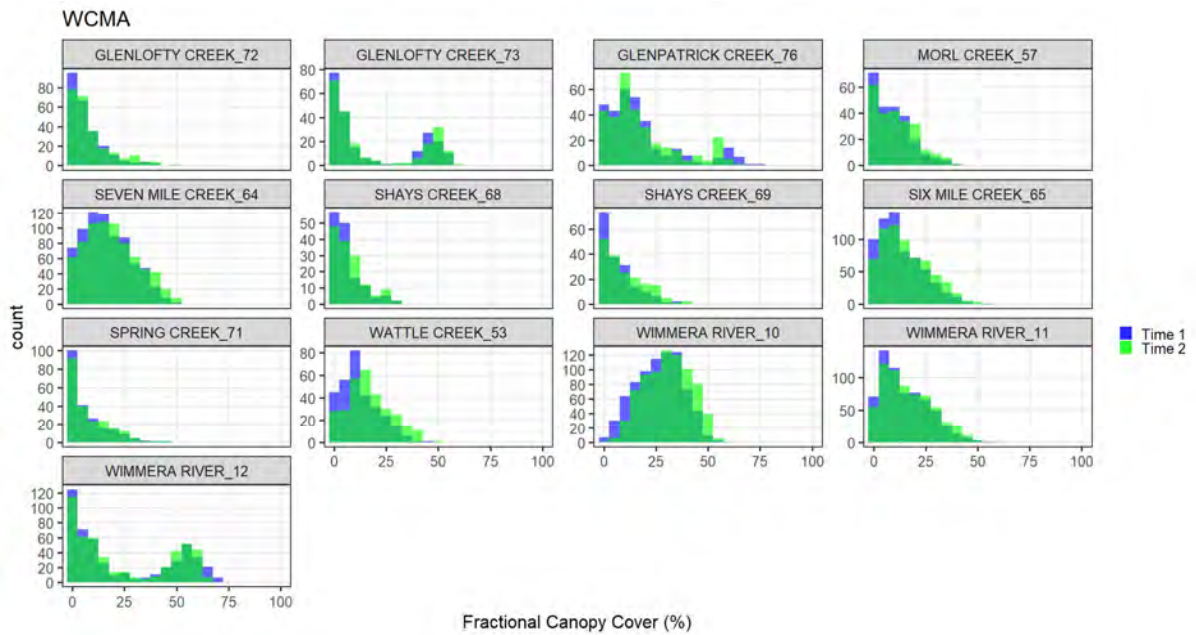
Figure 64 Fractional canopy cover for locations in the WCMA at the two assessment periods. The count of the y-axis is the number of sections.

Fractional canopy cover increased at more than 50% of sections across all reaches, but the largest changes were small i.e. ~4% increases at Wattle Creek Basin reach 53 and Wimmera River reach 10, and the mean change across all reaches was a 2% increase.

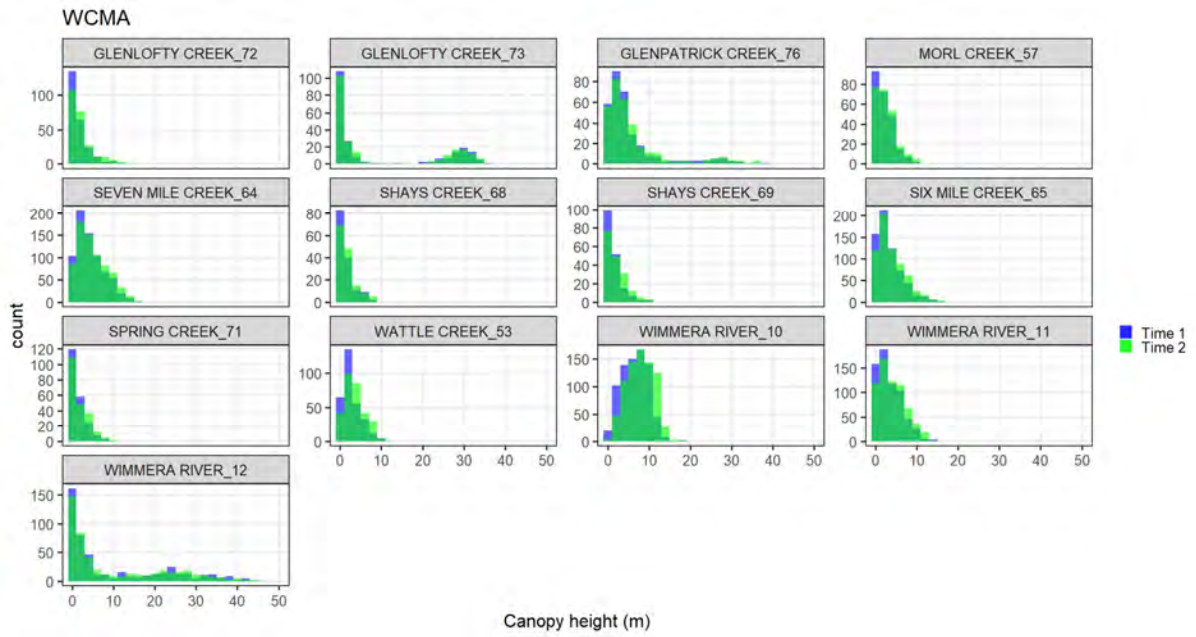
Figure 65 Canopy height for locations in the WCMA at the two assessment periods. The count of the y-axis is the number of sections.

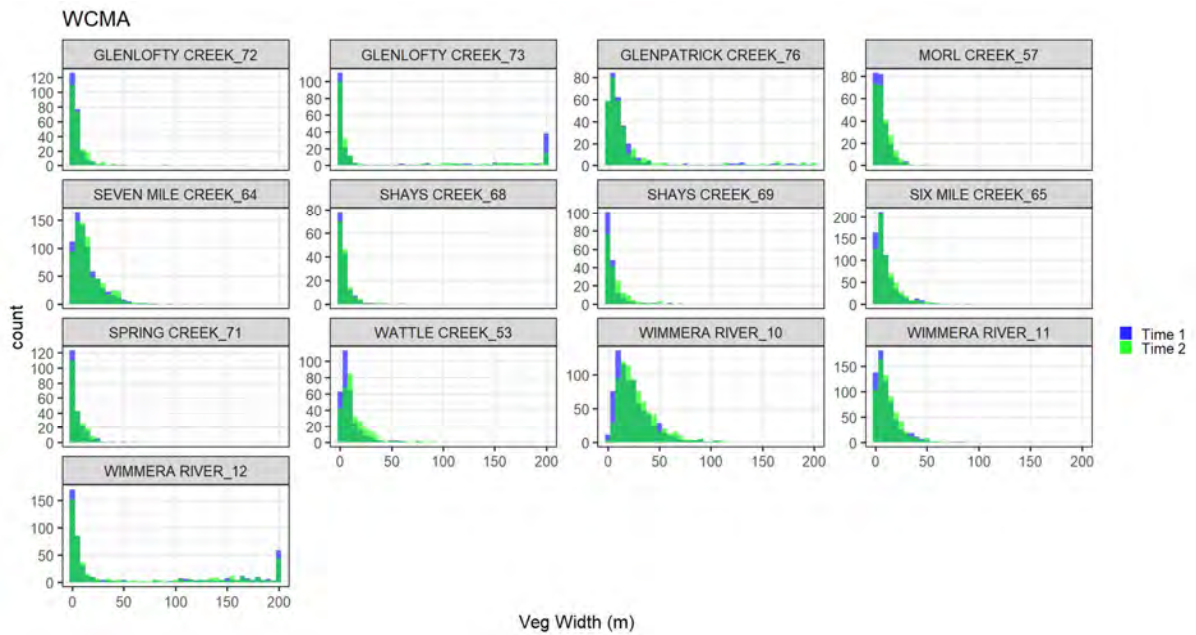
Figure 66 Vegetation width for locations in the WCMA at the two assessment periods. The count of the y-axis is the number of sections.

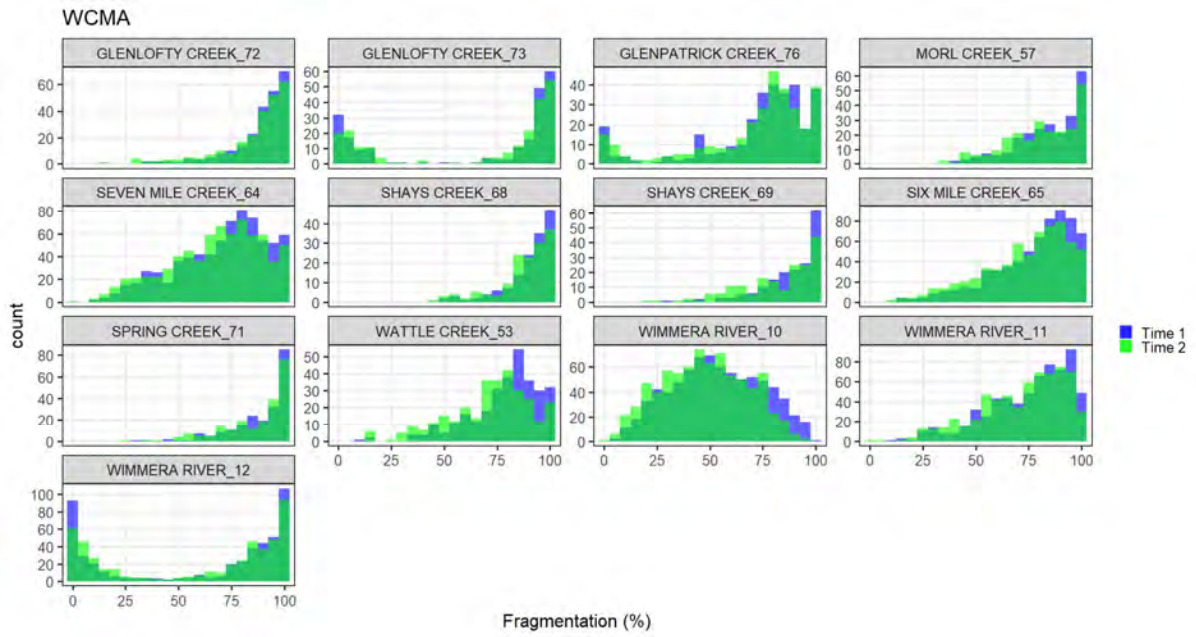
Figure 67 Fragmentation for locations in the WCMA at the two assessment periods. The count of the y-axis is the number of sections.

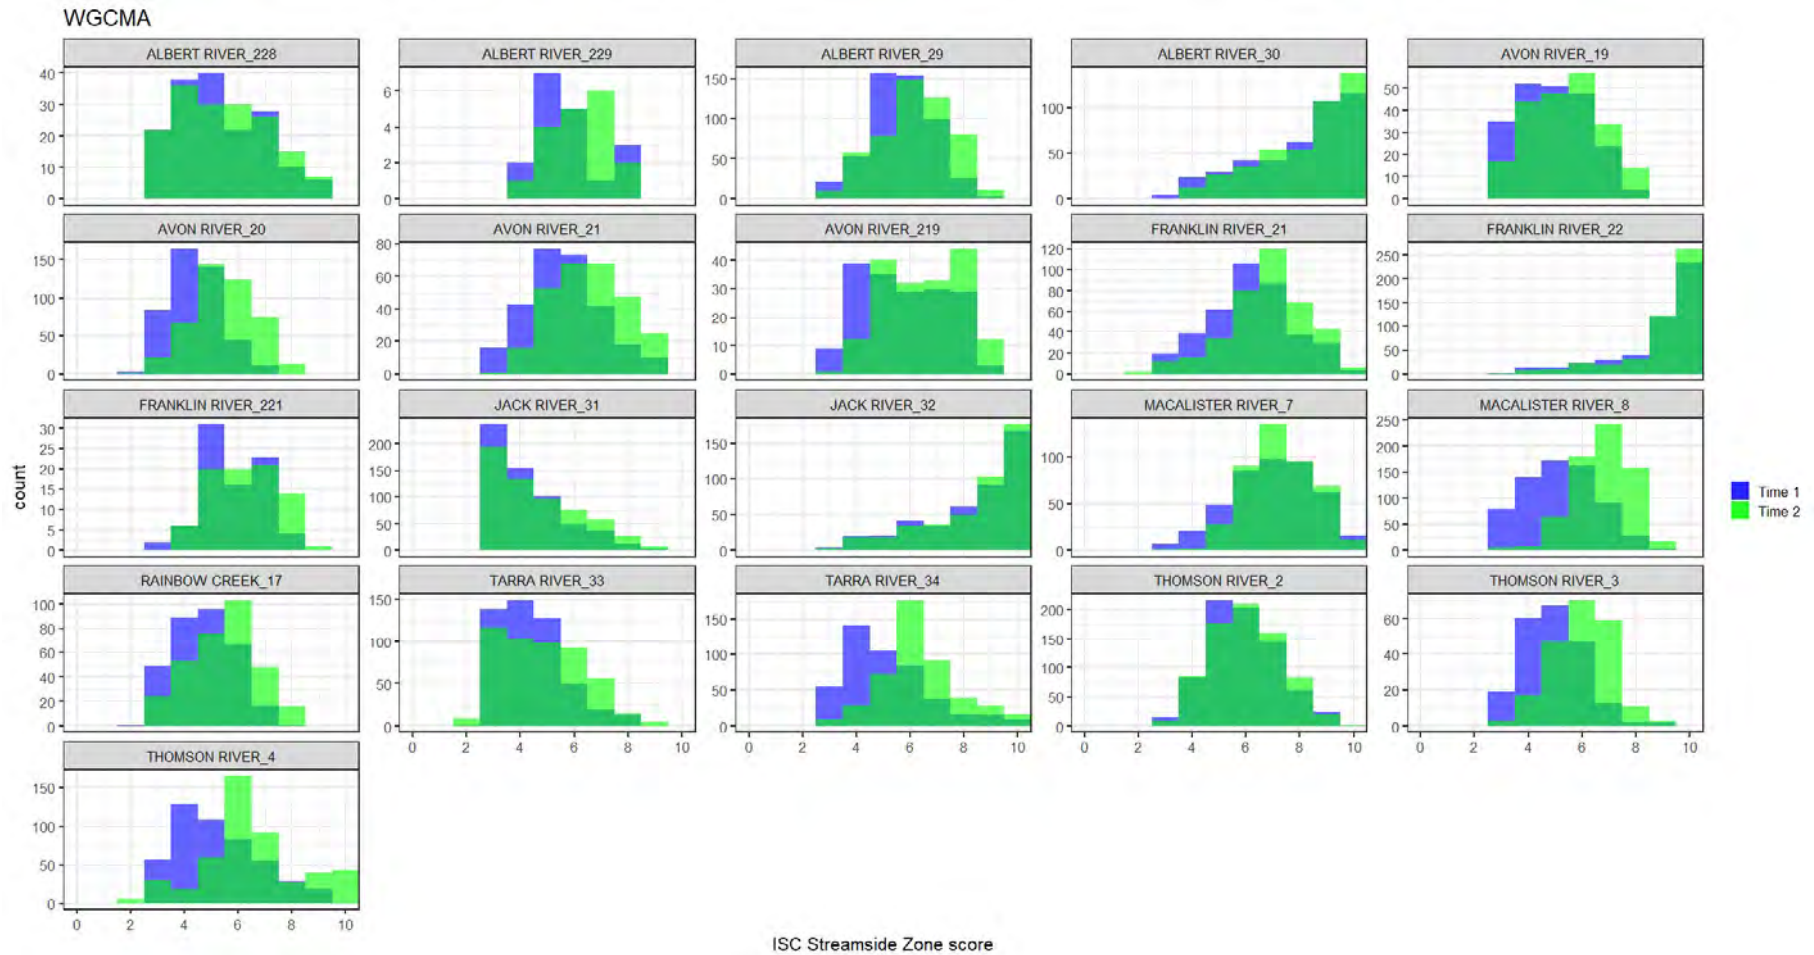
Figure 68 Streamside Zone ISC scores for locations in the WGCM at the two assessment periods. The count on the y-axis is the number of sections.

ISC Streamside Zone scores increased at 11 of the 21 reaches assessed (Figure 68; Table 10). but at ten reaches, this increase was by one unit only. The exception was Macalister River reach 8, where a two unit increase was observed.

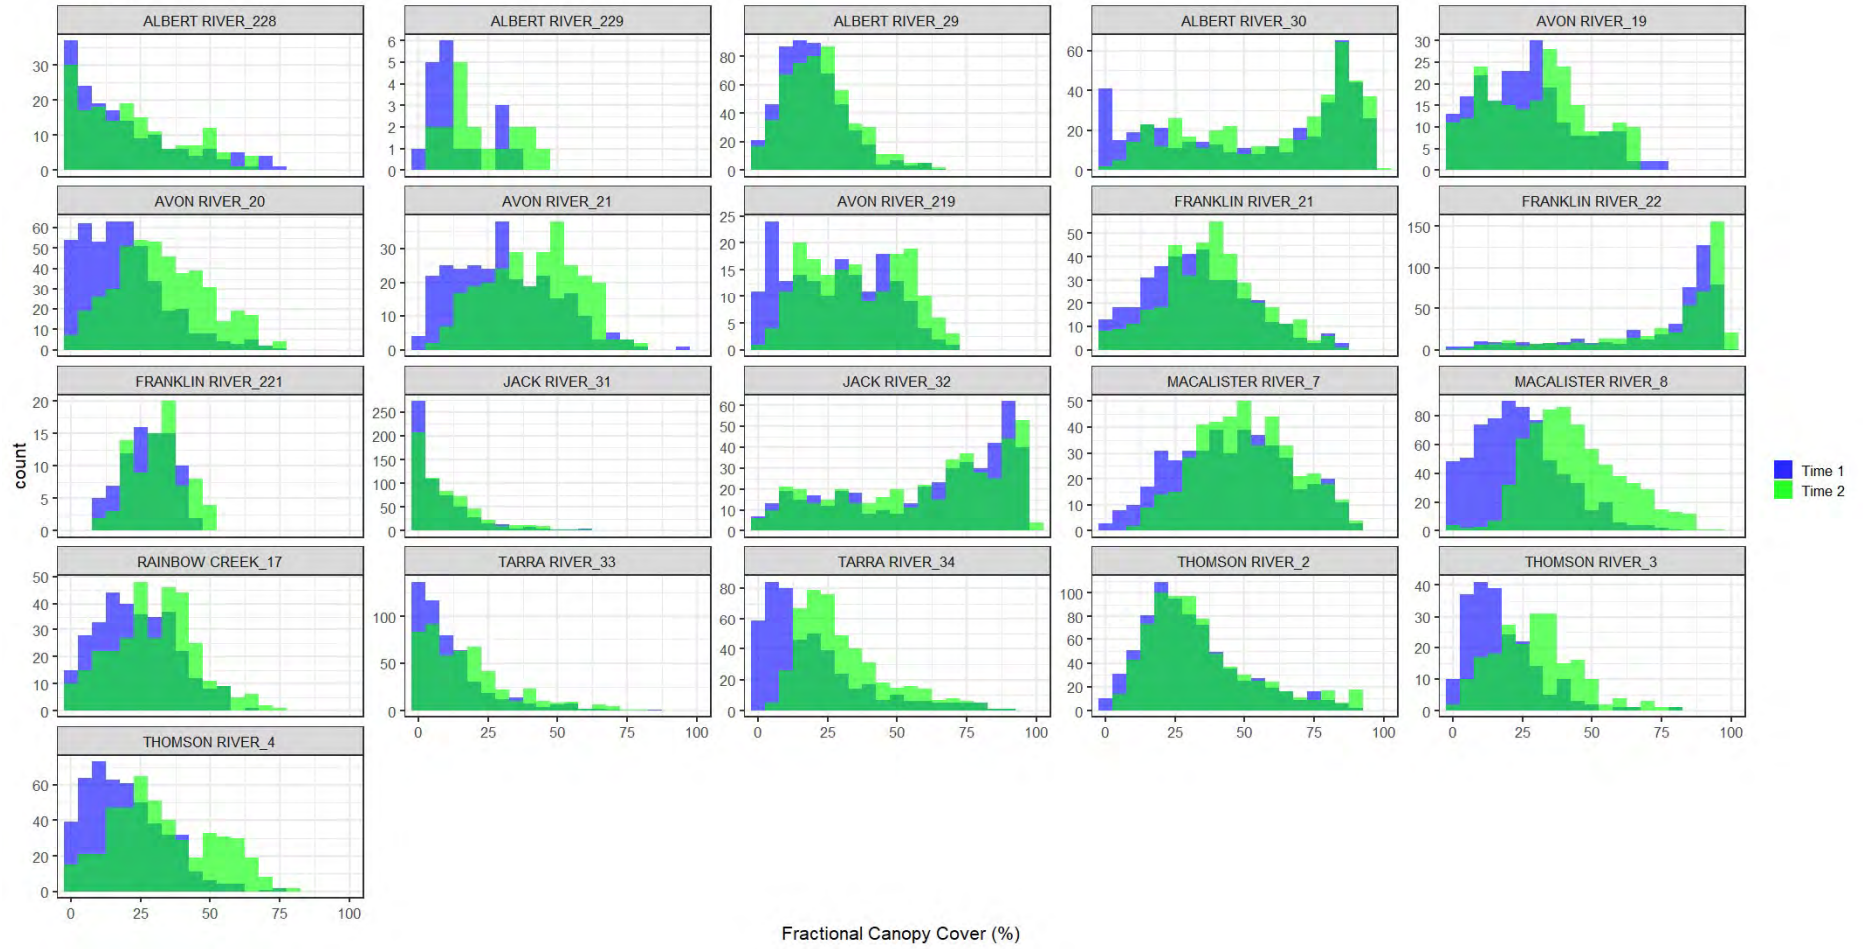
Figure 69 Fractional canopy cover for locations in the WGCMA at the two assessment periods. The count on the y-axis is the number of sections.

Canopy cover increased at more than 50% of sections at all reaches except the Jack River reach 32 (Table 11; Figure 69). At the Macalister River reach 8, for instance, cover increased on average by 20%, and 38% more sections had canopy cover greater than 40% in 2018 than in 2010. Five other reaches had average increases in canopy cover of 10% or more: Tarra River Basin reach 34, Thomson River reach 3, Avon River reach 20, Avon River reach 21 and Thomson River reach 4. In contrast, canopy cover decreased at 54% of sections at Jack River reach 32, on average by only 1%. Most reaches had either negligible or small reductions in the percentage of sections with canopy cover greater than 60 or 80%.

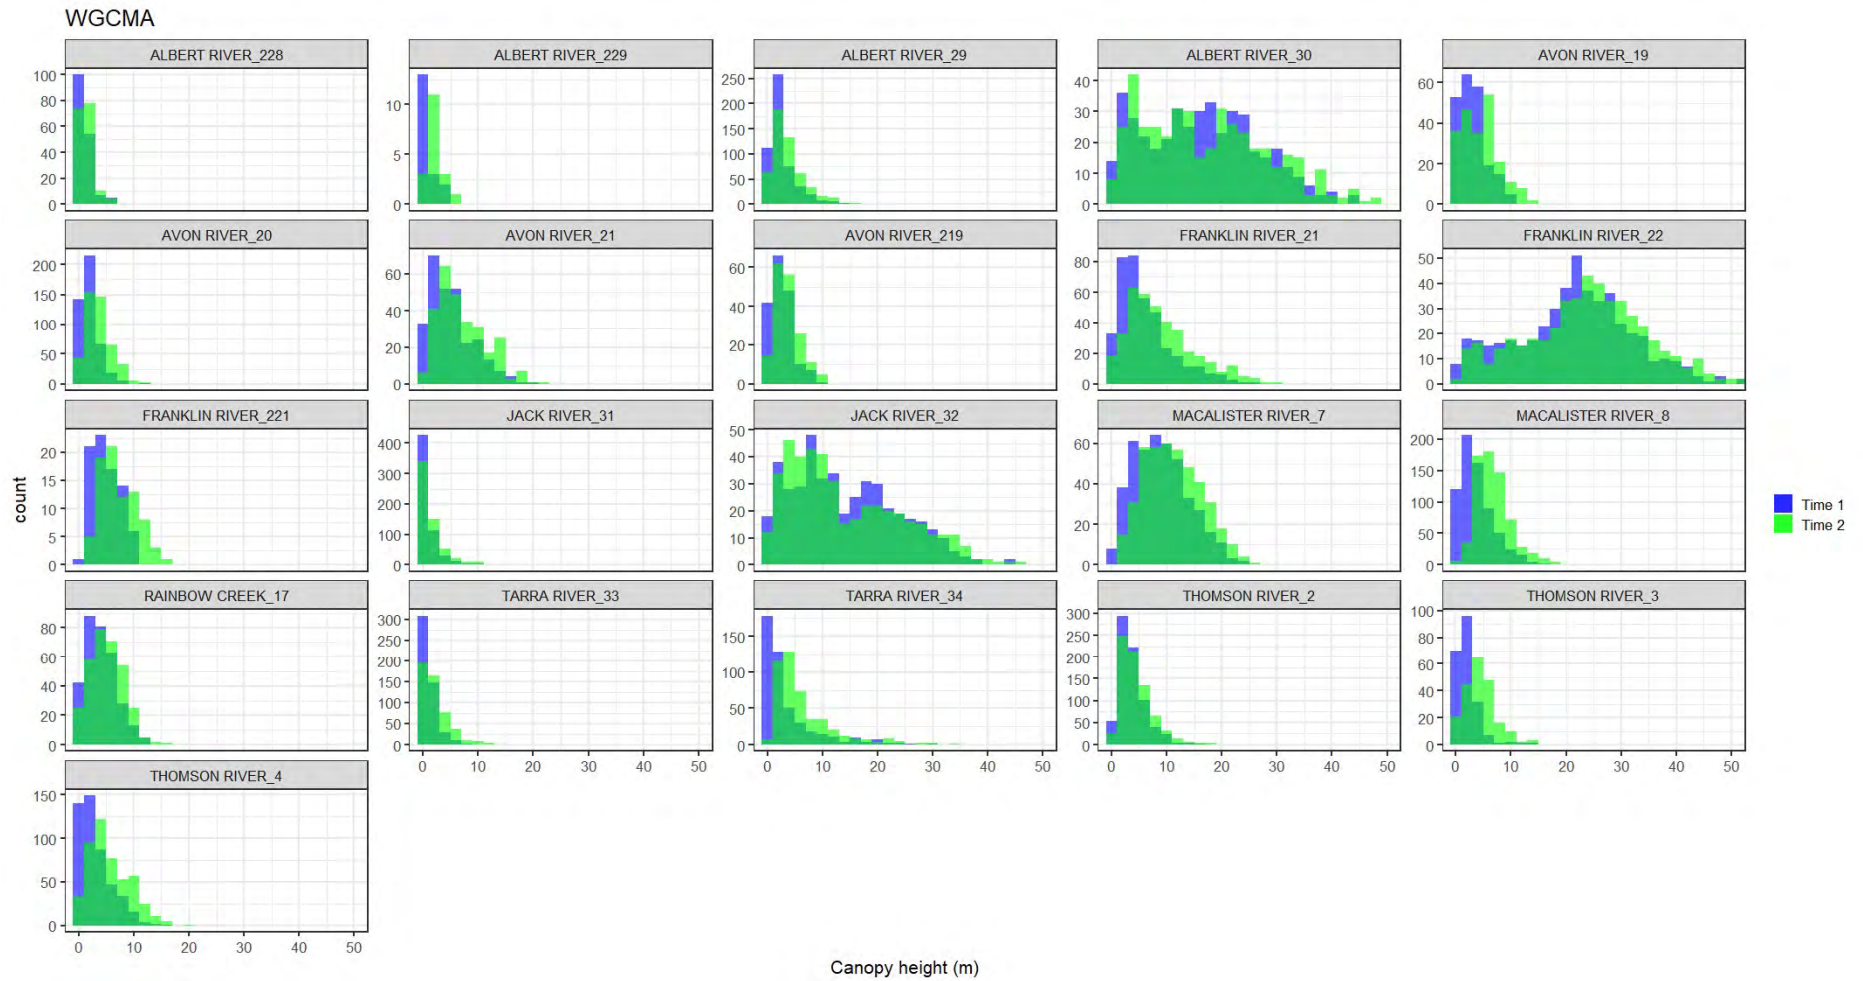
Figure 70 Canopy height for locations in the WGCMa at the two assessment periods. The count on the y-axis is the number of sections.

Canopy height increased at more than 60% of sections at all reaches. many reaches, especially in terms of the percentage of sections above 2 and 5m (Figure 70)). At the Macalister River reach 8, ~32 and 40% more sections had canopy heights above 2m and 5m in 2018 respectively. Across all reaches, the average increase in canopy cover was by 1.6m, with the largest increases at Macalister River reach 8 (3.1m), Franklin River reach 21 (2.9m) and Tarra River reach 4 (2.9m).

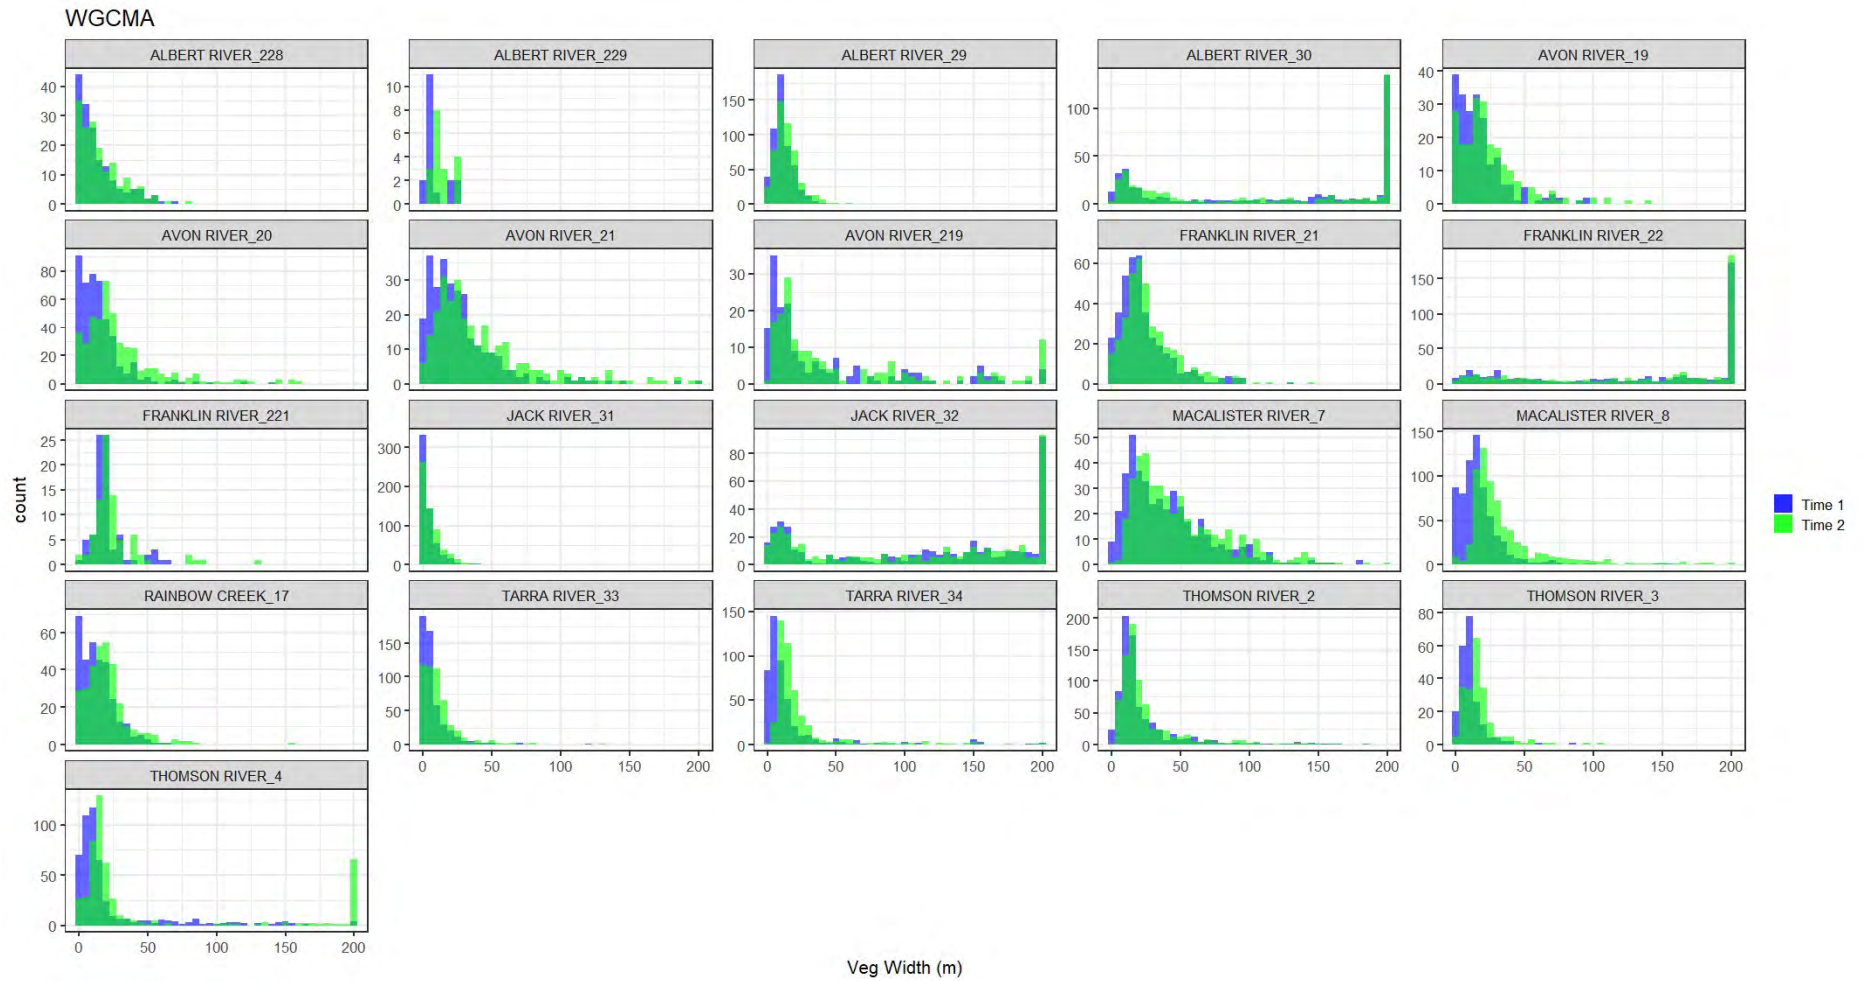
Figure 71 Vegetation width for locations in the WGCMa at the two assessment periods. The count on the y-axis is the number of sections.

Vegetation width also increased across almost all reaches (Figure 71). For example, at Macalister River reach 8, 39% more sections were wider than 20m in 2018 than in 2010, and 21% more sections were wider than 40m. Similarly at Avon River Basin reach 20, 33% more sections had riparian widths above 40m in 2018.

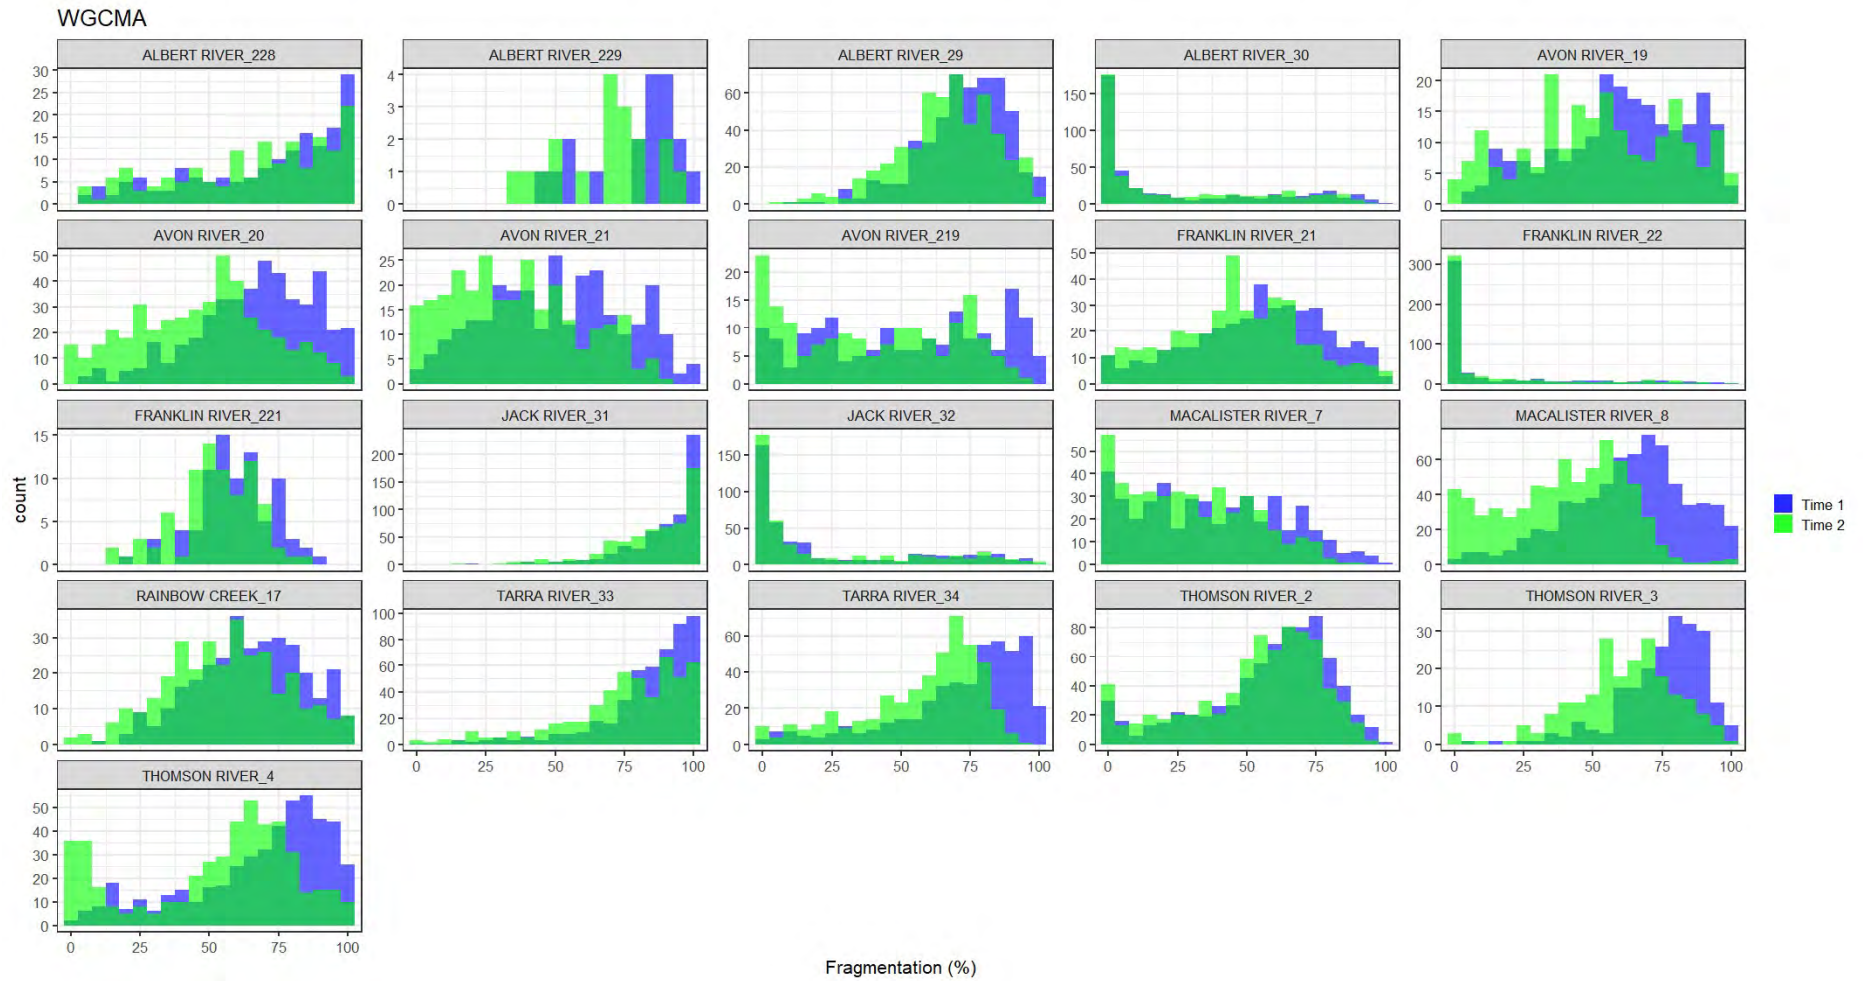
Figure 72 Fragmentation for locations in the WGCMA at the two assessment periods. The count on the y-axis is the number of sections.

Decreases in fragmentation were observed at more than 50% of sections at all but two reaches: Franklin River reach 22, and Jack River Basin reach 32 (Figure 72; Table 10, Table 12). At three reaches, fragmentation decreased on average by more than 15%: Avon River reach 20, Macalister River reach 8 and Thomson River reach 4.
