Stream Change Assessment: detecting change in riparian woody vegetation using LiDAR derived data

April 2022

Catchments, Waterways, Cities and Towns, Waterway Programs Branch

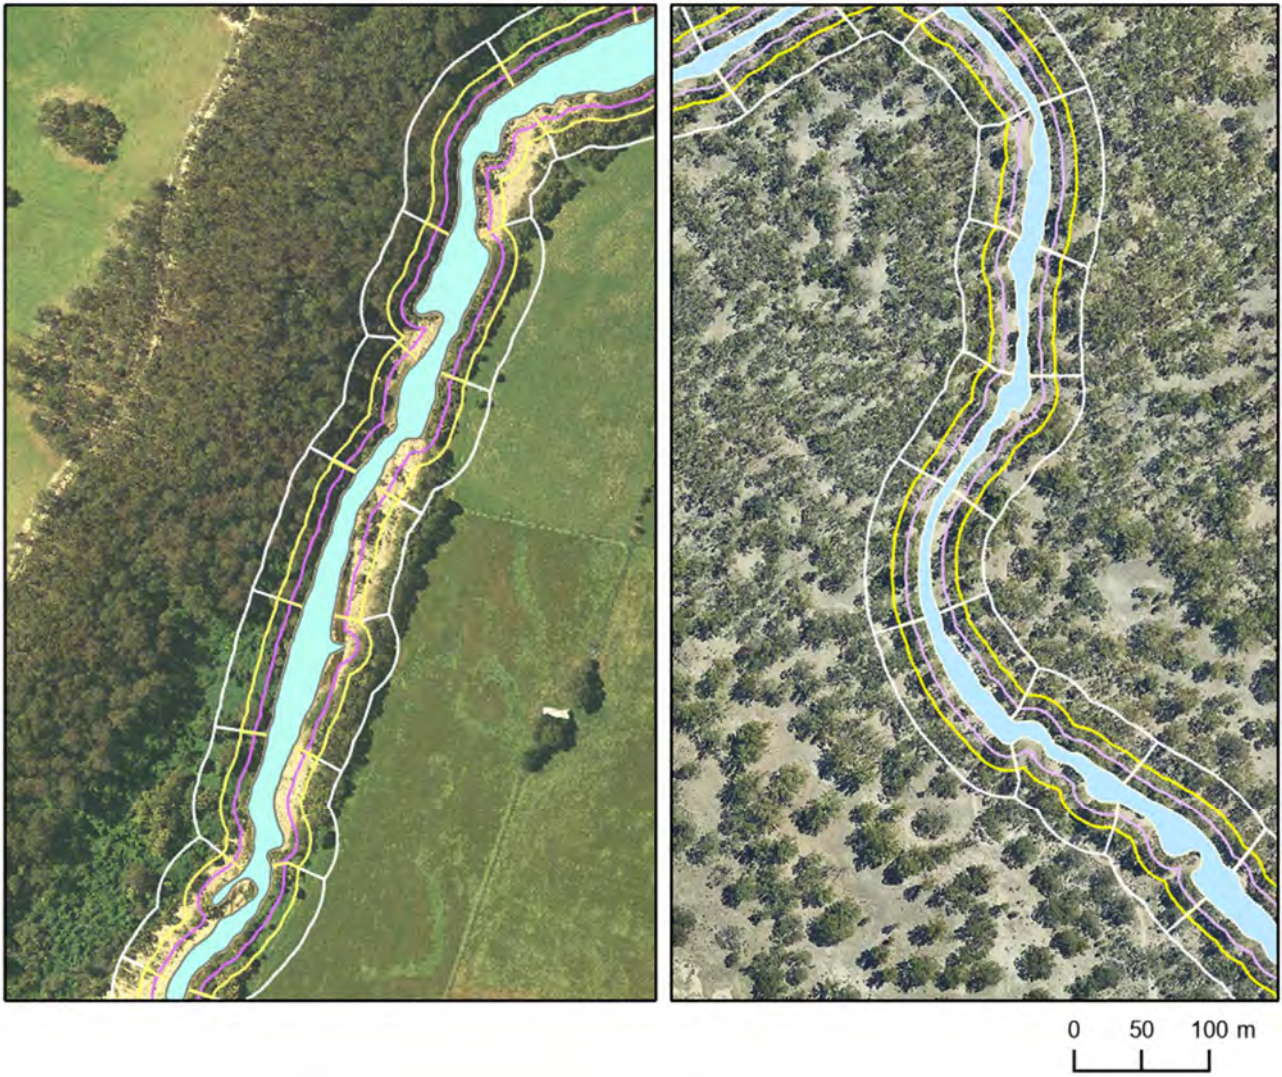
Figure 73 Two examples, from Cann River in the East Gippsland CMA (left) and Chalka Creek in the Mallee CMA (right), showing multiple buffer widths from the stream bed out laterally to 10m (purple line), 20m (yellow line) and 40m (white line).

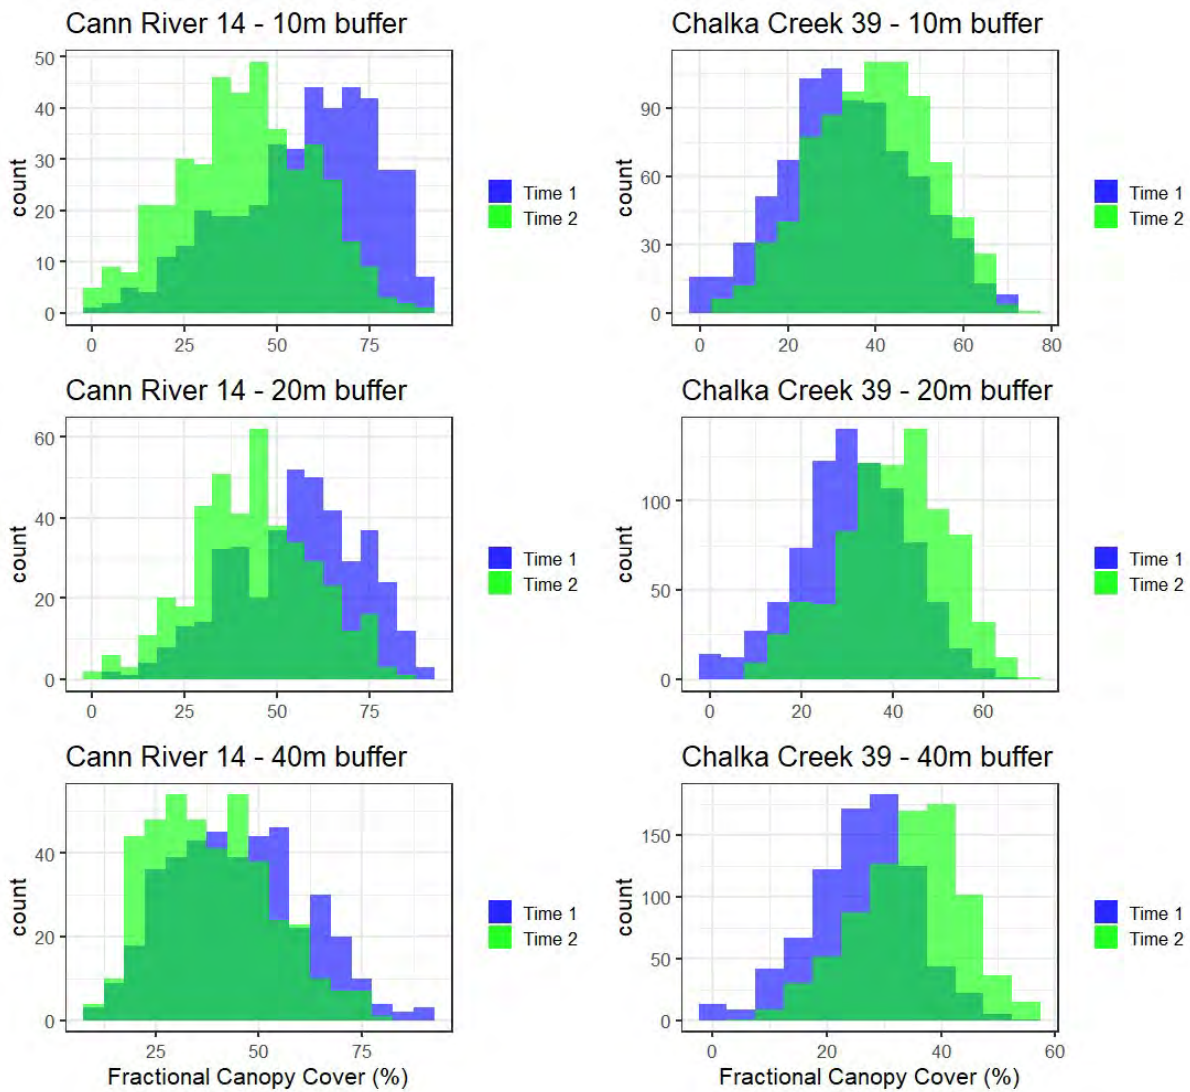
Figure 74 Canopy cover at Cann River 14 and Chalka Creek 30 across the two time periods and at three buffer widths.

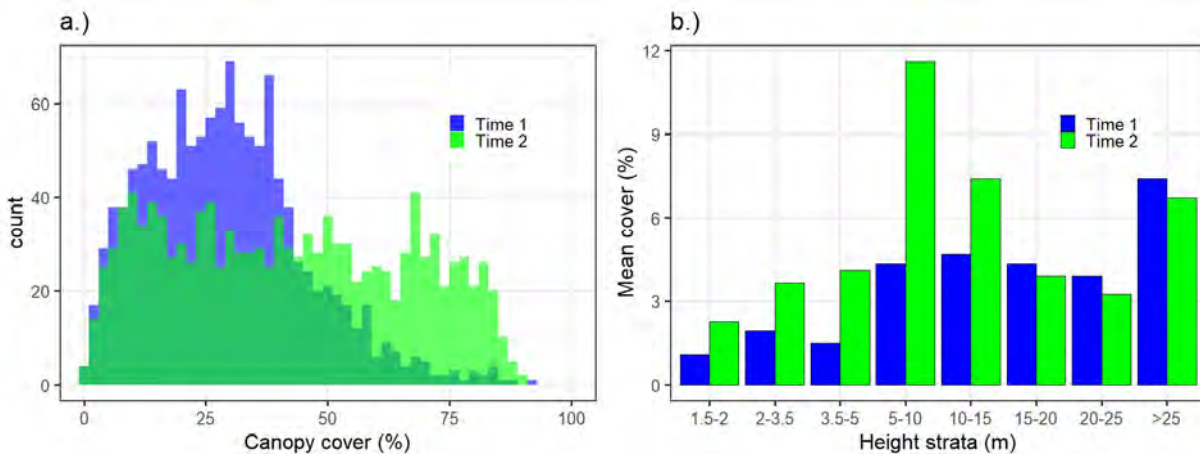
Figure 75 (a) overall canopy cover and (b) canopy cover at different height strata at Acheron River reach 62 in Time 1 (2010) and Time 2 (2018).

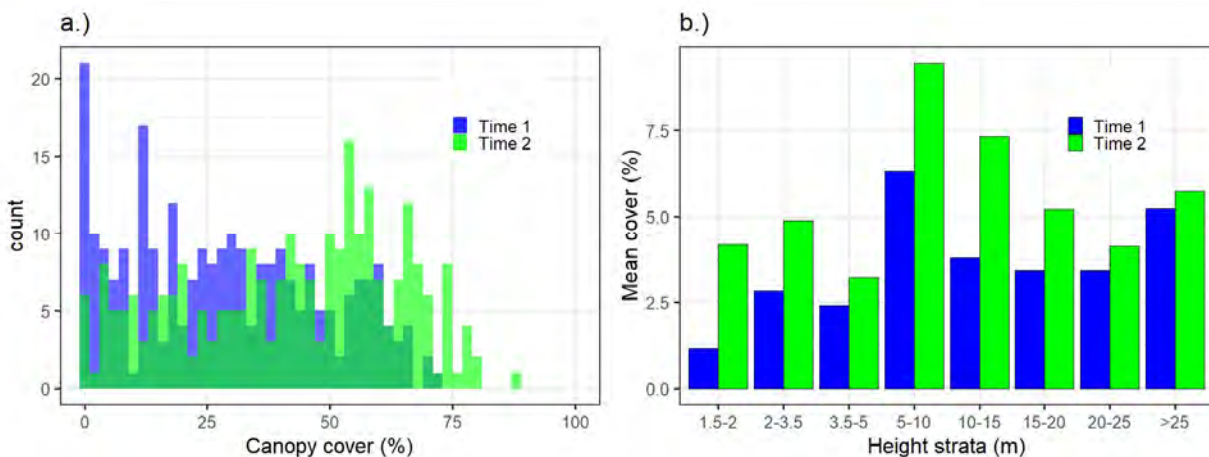
Figure 76 (a) overall canopy cover and (b) canopy cover at different height strata at Snowy River reach 4 in Time 1 (2010) and Time 2 (2018).

Alternatively at Snowy River reach 4, mean total canopy cover had increased from 29% in 2010 to 42% in 2018 (Figure 76a), however these increases were spread relatively evenly across all height intervals (Figure 76b). Increases in overall canopy cover were likely due to a sustained regime of re-vegetation across a longer time period.
