Published by the Victorian
Government Department of
Sustainability and Environment
Melbourne, August 2005.

The ISC combines information on five key aspects of river health. These components, or sub-indices, measure changes in hydrology, water quality, streamside zone (vegetation), physical form (bed and bank condition and instream habitat) and aquatic life.

The ISC brings together data from a variety of sources to give a detailed overall picture of river condition. Five sub-indices make up the ISC score – hydrology, water quality, streamside zone, physical form, and aquatic life. Each sub-index comprises individually measured variables. The ISC is evaluated for individual river reaches, which are generally between 10 and 30 km long and with similar hydrological, vegetation and landscape characteristics.

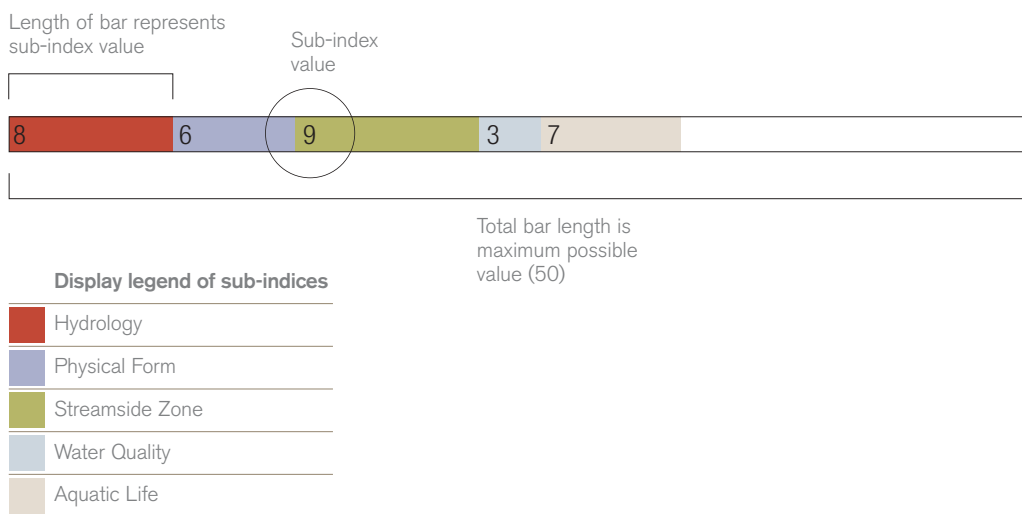
Figure 1
The ISC bar showing the 5 sub-indices

The ISC result is presented as a bar graph of the five sub-indices, as shown in Figure 1.

The total ISC score is then categorised into one of five broad groups of condition – excellent, good, moderate, poor and very poor. It is important to emphasise that while this overall condition class is useful for providing a general picture of the condition of a reach, the detail of each sub-index and its sub-components (i.e. the individual variables) are required to better understand the issues affecting the environmental condition of streams on a reach basis.

The basin results for condition class provide a useful snapshot of river health, but it is the results of the sub-indices for each reach that reveal the actual changes in stream condition. As described in the introductory section, the ISC is a composite of five sub-indices, weighted to reflect the individual components of river health (see Figure 1).

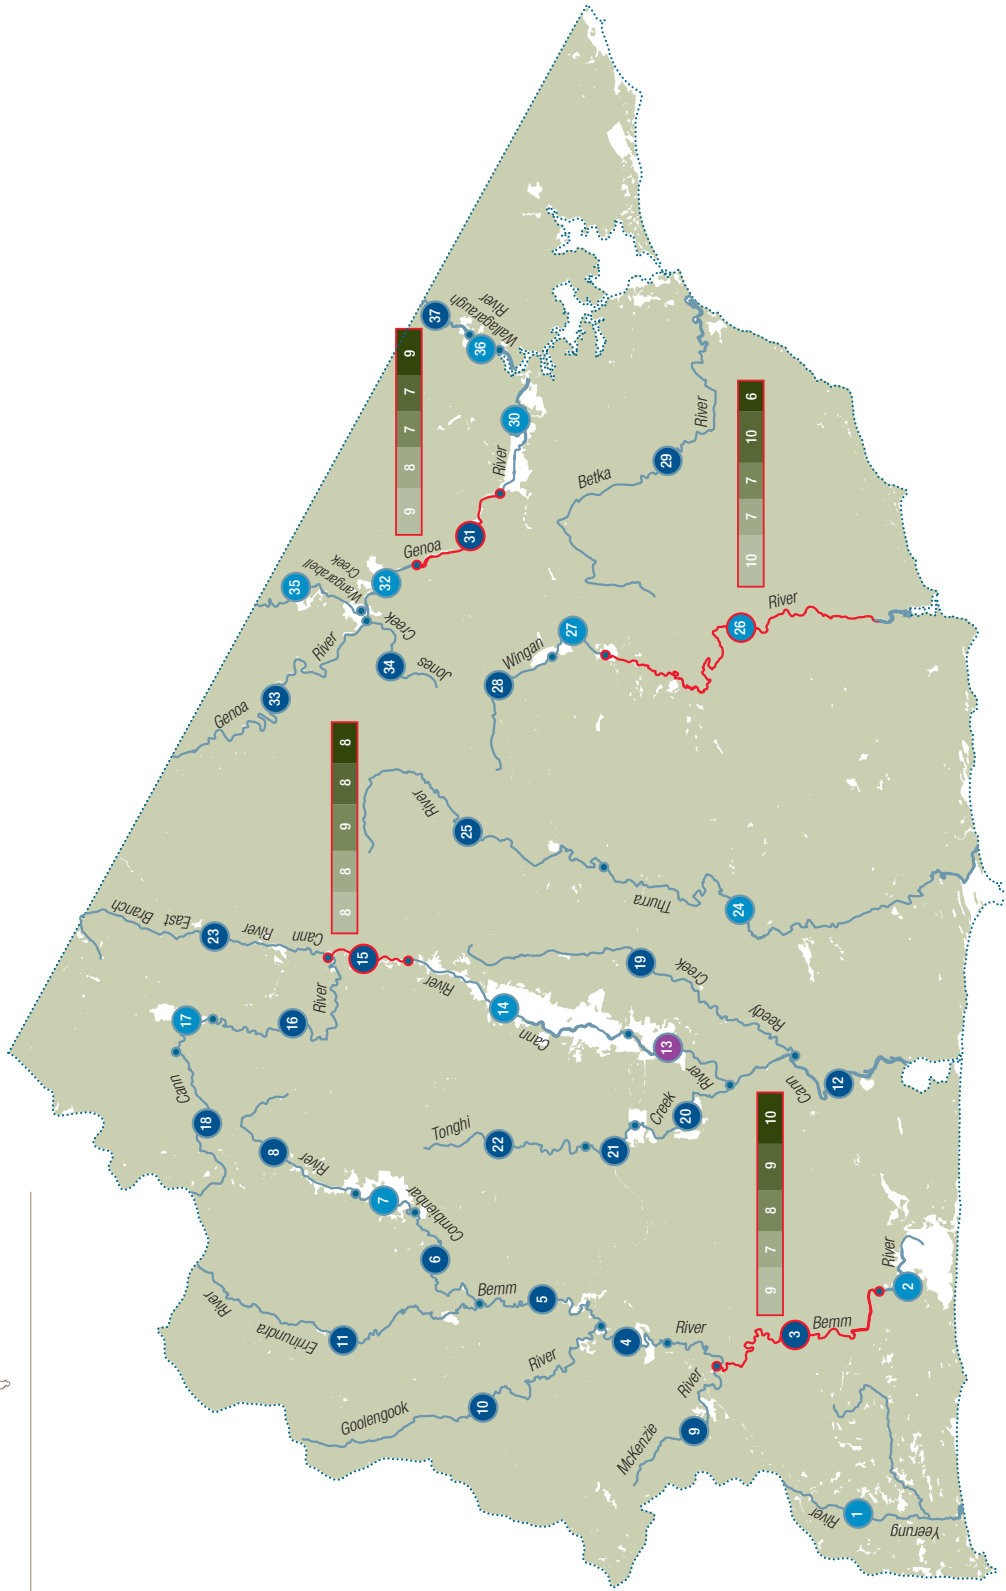
Basin 21 East Gippsland

Environmental Condition

- Excellent
- Good
- Moderate
- Poor
- Very Poor
- Insufficient Data

The high proportion of natural forest and the absence of hydrological development have resulted in the basin having Victoria's highest percentage of reaches in good to excellent condition. Nearly 100% of stream length was classified in excellent (69%) or good condition (30%). The remainder, which was in moderate condition, comprises only one reach (reach 13) on the lower Cann River. The land surrounding this reach has been extensively cleared.

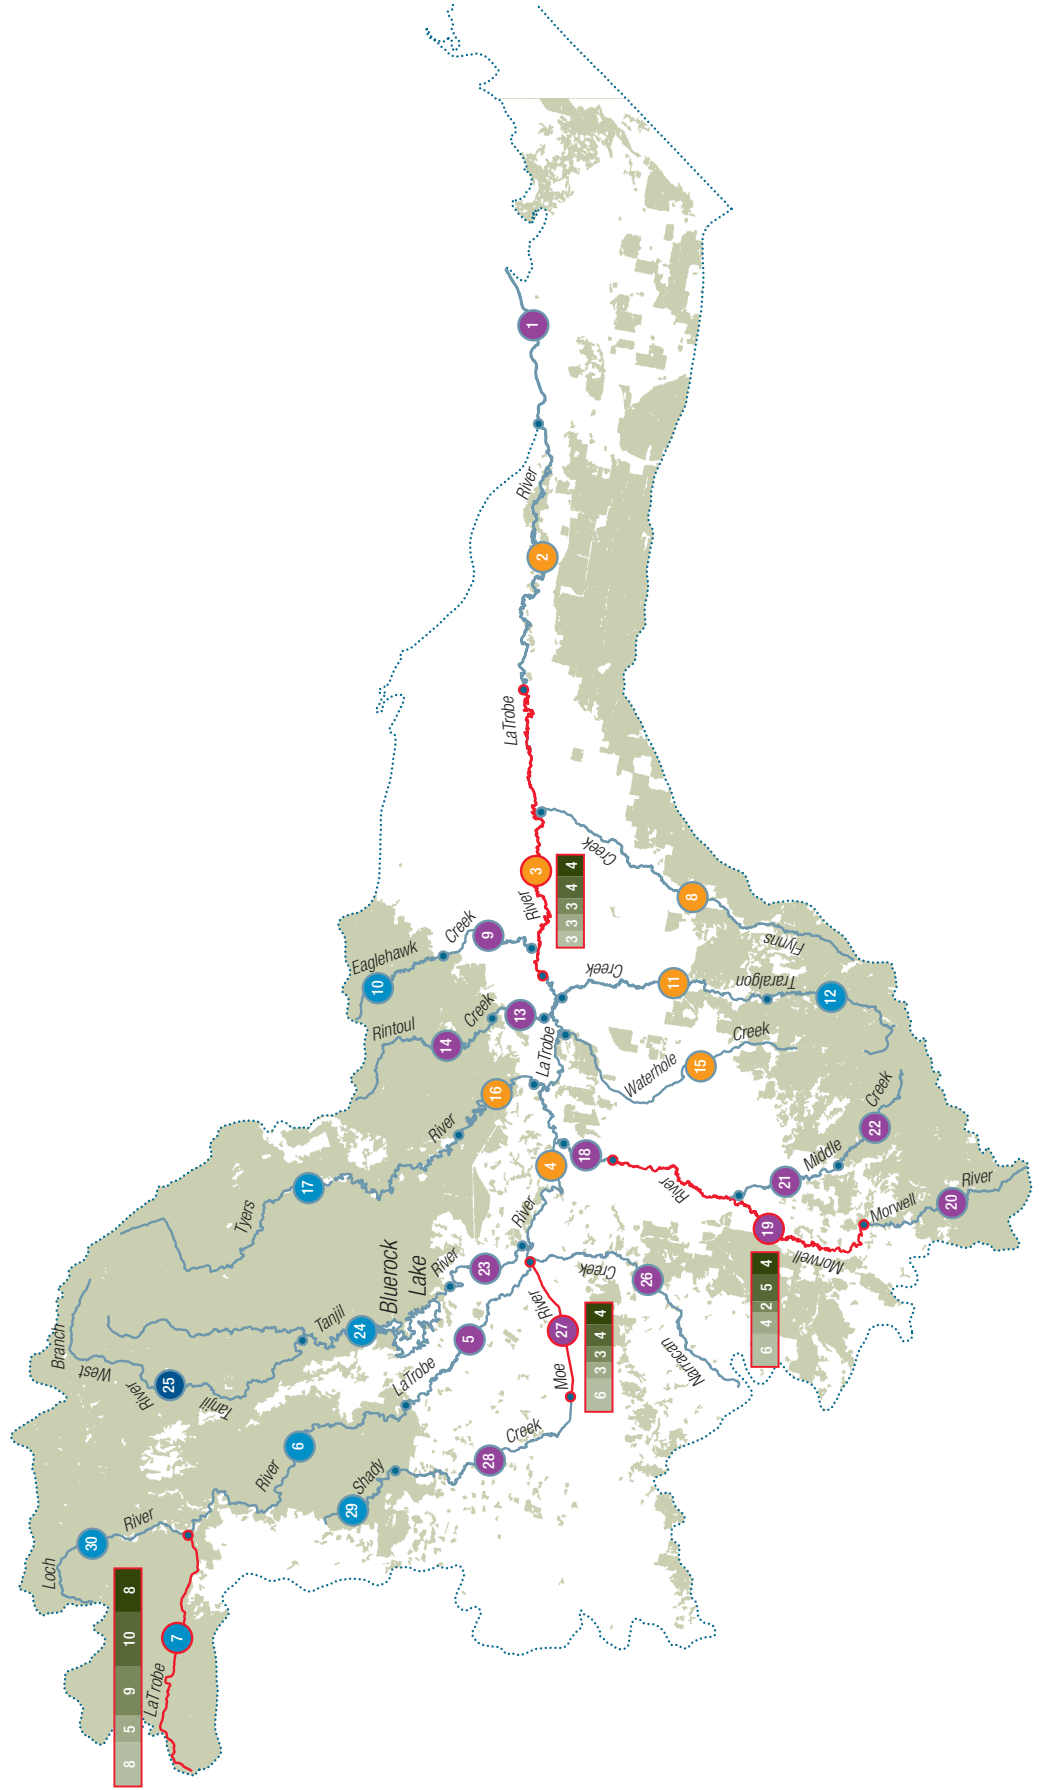
Basin 26 LaTrobe

Environmental Condition

Reaches rated in good to excellent condition dominated the northern forested region, making up 35% of total stream length. The remainder of reaches were in moderate to poor condition (65%) and are distributed in a band running east to west across the centre of the catchment. Notably, the health of both the LaTrobe and Tanjil Rivers deteriorates markedly as they wind downstream. This was attributed largely to modified hydrology and a lack of native vegetation.
