North East Region

Three river basins form the region – Upper Murray (basin 1), Kiewa (basin 2) and Ovens (basin 3).

Index of Stream Condition

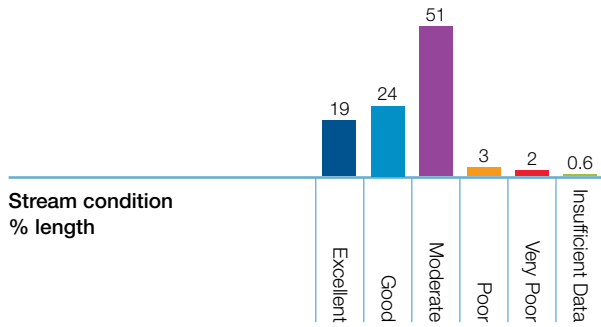
/ North East Region

Environmental Condition

● Excellent

● Very Poor

● Insufficient Data
