# **Audit of Irrigation Modernisation Water Recovery by the SWEP**

**Audit report – Final**

**November 2023**

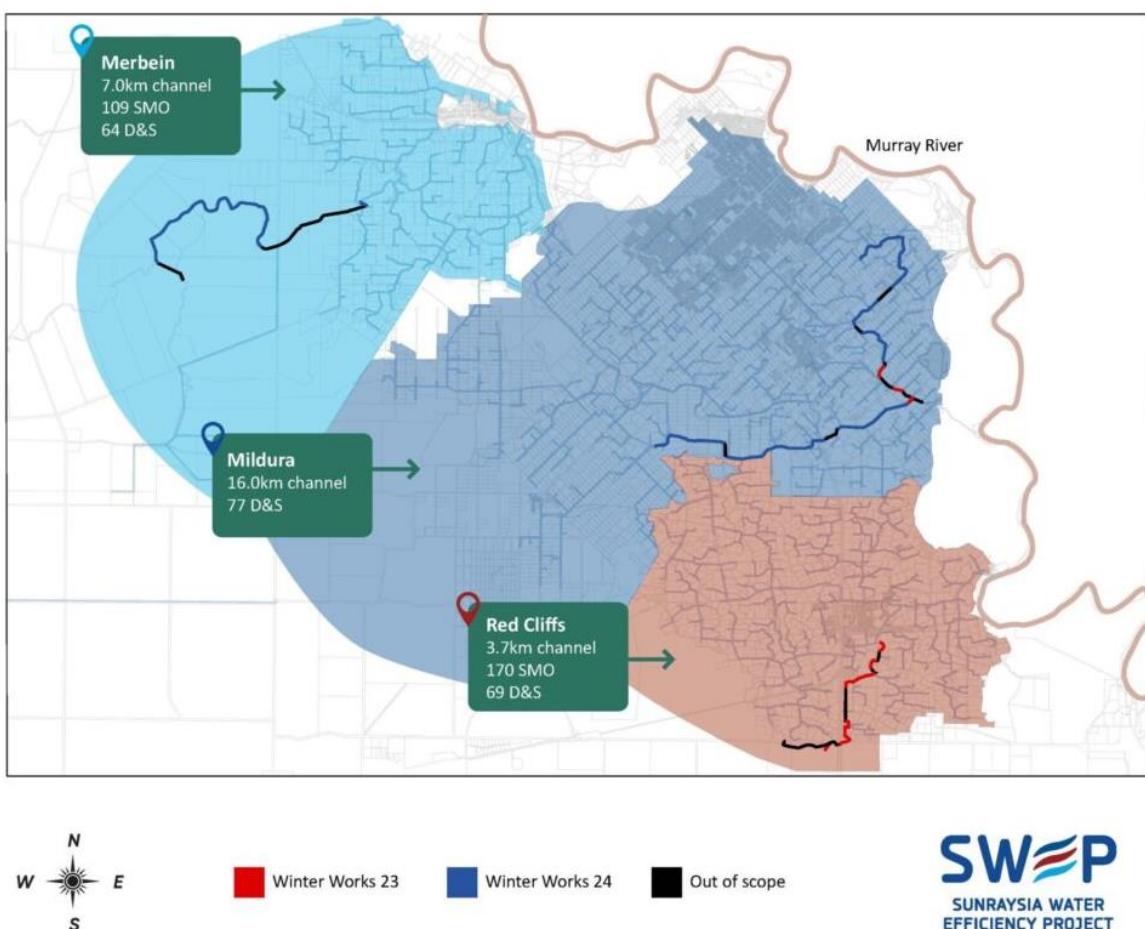
Figure 1-2: SWEP irrigation modernisation and efficiency works (LMW, 2023c)

The LMW Sunraysia Water Efficiency Project (SWEP) is an off-farm irrigation infrastructure modernisation project that is removing and upgrading outdated water infrastructure in the Mildura, Red Cliffs and Merbein irrigation districts (Figure 1-2).

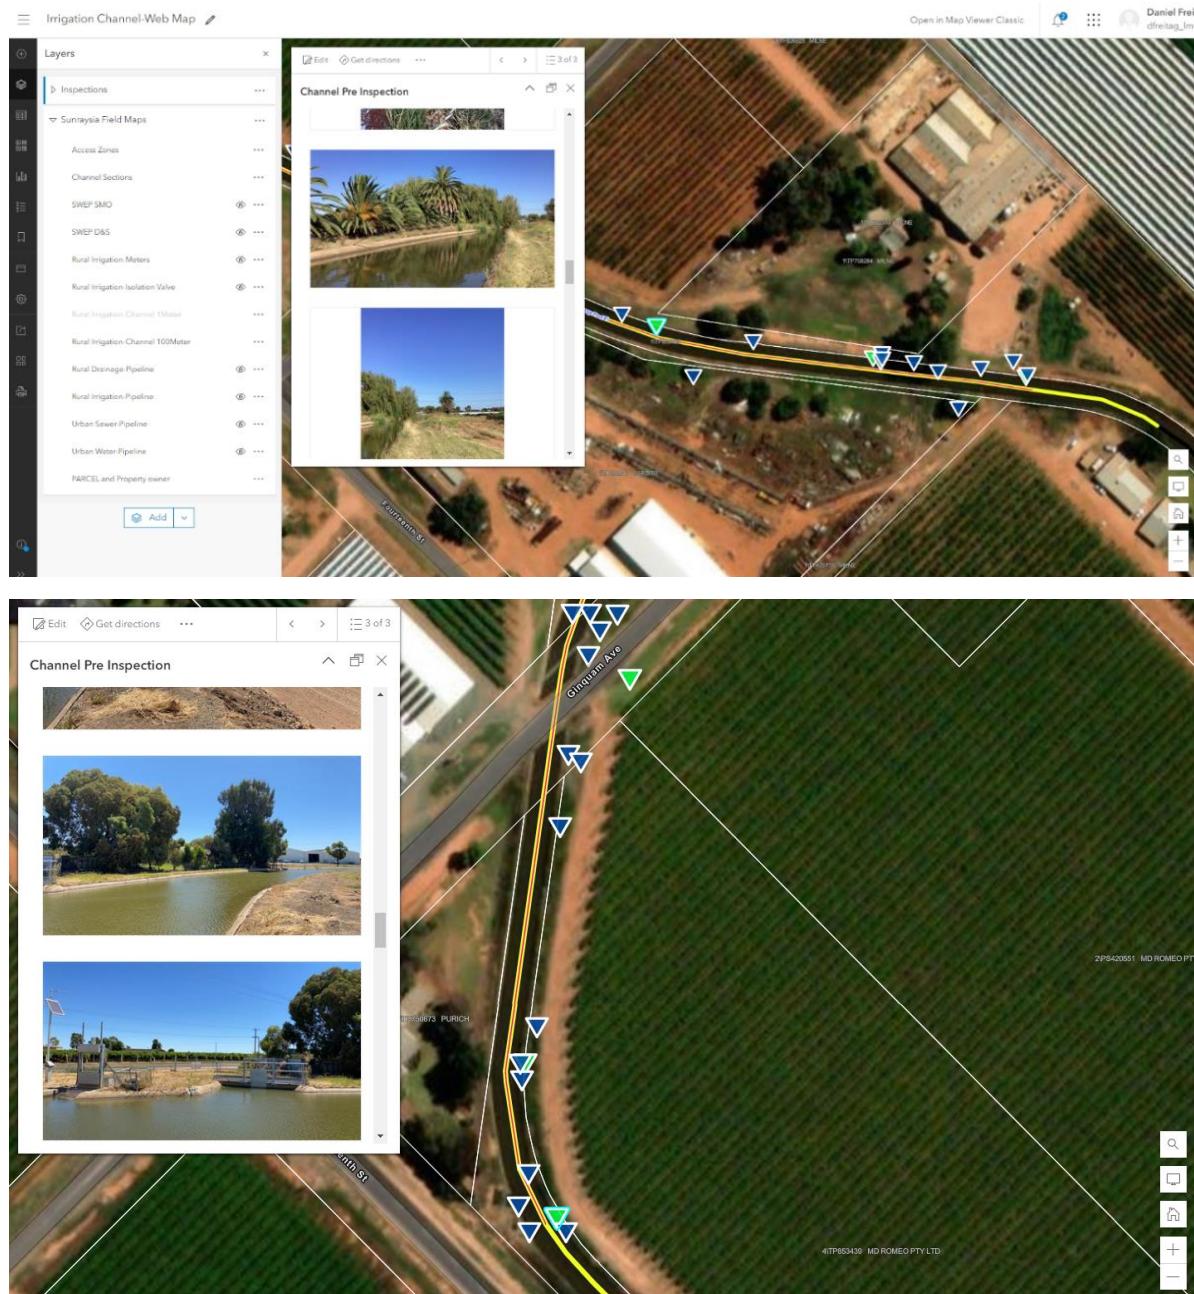
Figure 3-1: Review of record management – Screen captures from the Survey123 application, demonstrating its linkage of site survey data and pre- and post-construction imagery

With respect to the verification of works, the use of the *Survey123* application supports transparency around the capture of pre- and post-construction works photos. It does this by directly linking the capture of geo-located site photos, using tablet devices in the field, to the project's survey data. Two examples of this linkage, provided by LMW, are shown in Figure 3-1.

HARC finds that in addition to its ISO 9001:2015 accredited quality management systems the use of the *Survey123* application, which the provided records were extracted from, supports confidence in the site survey data and information used in the remote audit verification of the constructed works.

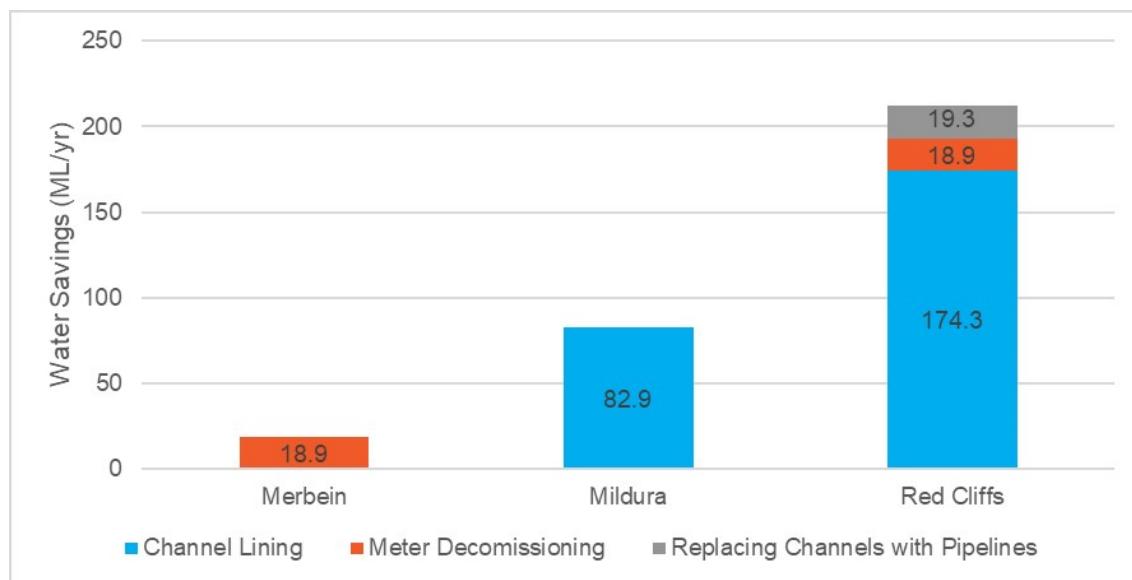
Figure 4-1 A summary of the audited estimated water savings, by irrigation district and intervention.

Figure 4-1 and Table 4-19 summarise the audited water savings per irrigation district and intervention type.

The remaining difference in the pre and post audit water saving estimates is attributable to minor spreadsheet calculations and reporting errors that resulted in a net under estimation of the water savings by approximately 17 ML (LTAAY).

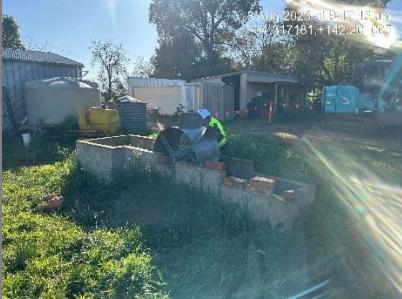
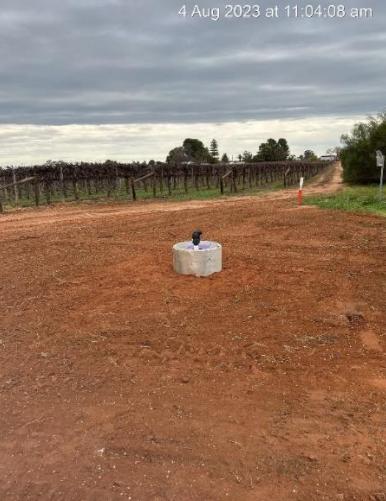
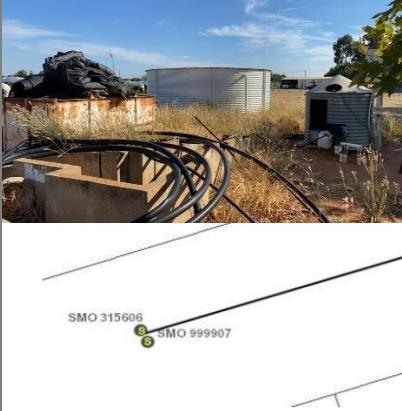
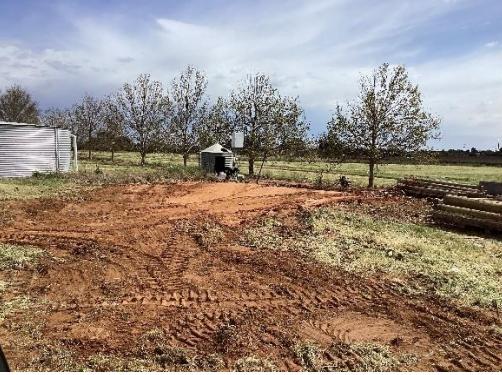
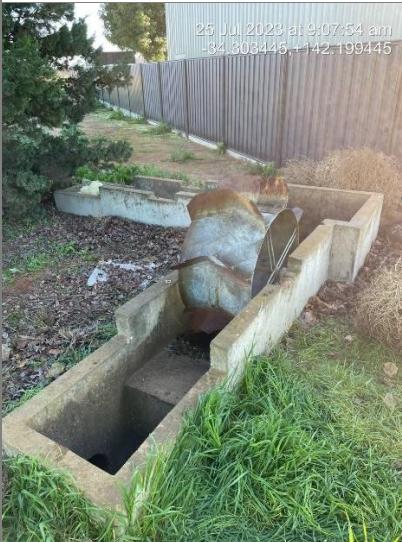
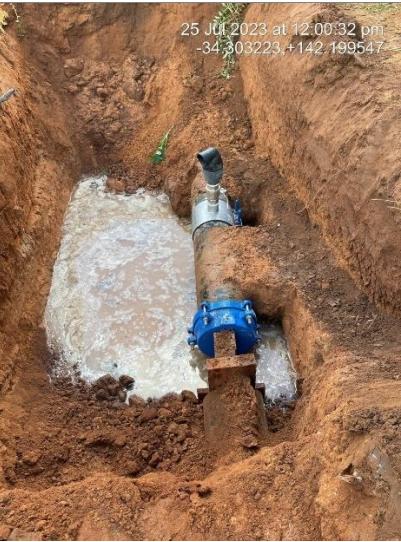
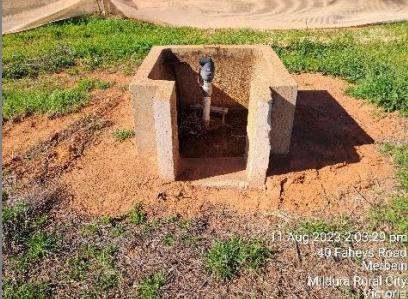
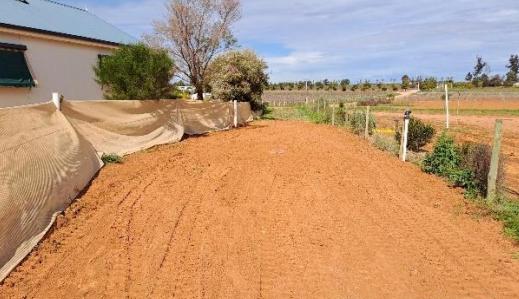
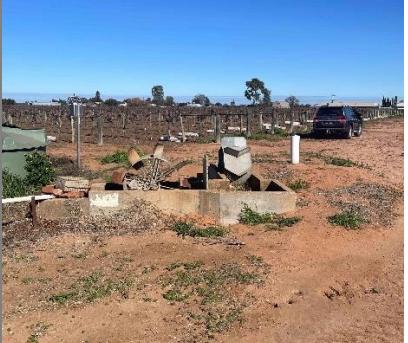
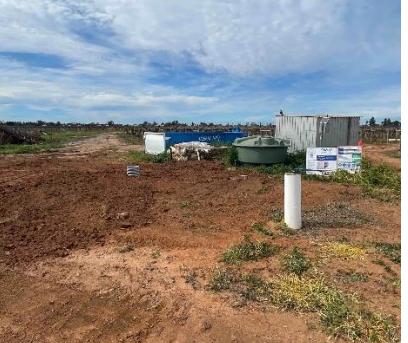
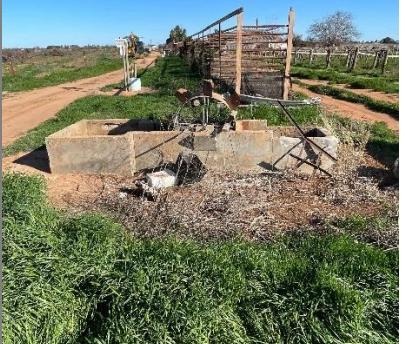
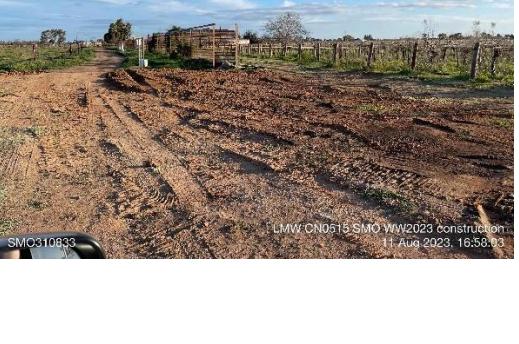
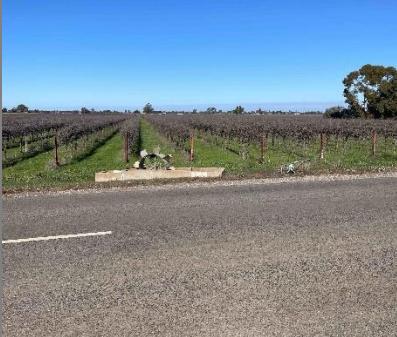
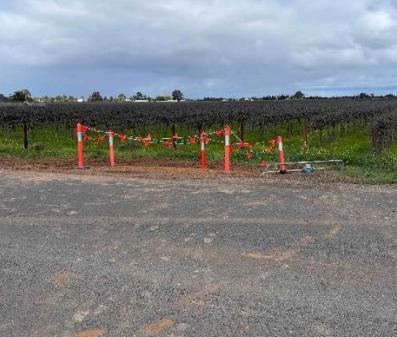
Table B-2: Pre- and post-construction photos for a sample of meter works.

District	Asset ID	Pre-construction	Post-construction
Red Cliffs	241822

\*Note: these photos are identical because outlets are adjacent to each other
