Meran Lakes Complex Environmental Water Management Plan

NORTH CENTRAL
Catchment Management Authority
Connecting Rivers, Landscapes, People

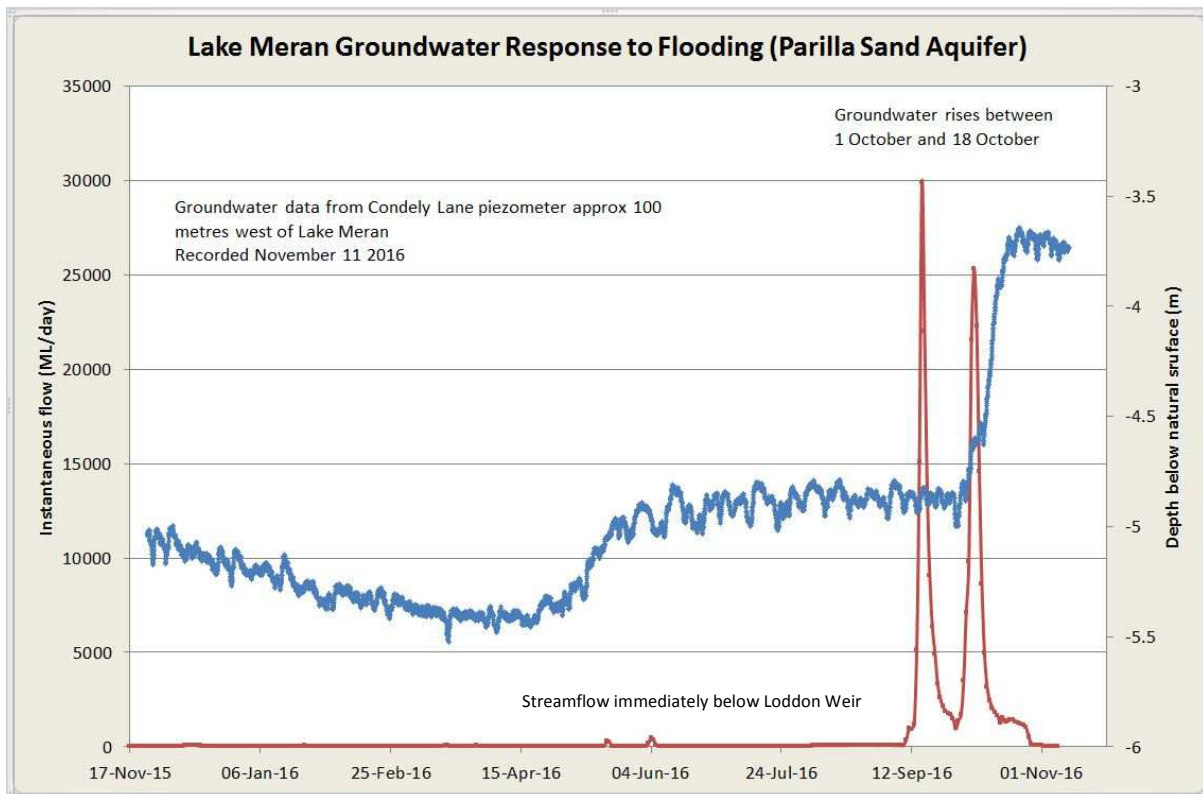
Figure 4: Groundwater response to during 2016. Aligning with filling events in Lake Meran

For around 30 days from mid-April to 15 May, the North Central CMA delivered 2,000 ML of environmental water to Lake Meran; this appeared to register in the groundwater bore 100 m to the west of Lake Meran (Figure 4). The groundwater response was more evident in October 2016, when natural flooding filled the lake from 79.2 mAHD to around 82.3 mAHD when the groundwater rose by 1.2 metres (North Central CMA, 2016a).

The post flood results of 2016 explain the enigma that is low salinity, where almost fresh groundwater (1,160 EC) in the immediate region of the lake displaces high salinity groundwater normally found within the Parilla Sand (30,000 to 50,000 EC) (North Central CMA, 2016a; GHD, 2016; AECOM, 2016). Vertical flow of lake water directly into the Parilla Sand also explains the lower

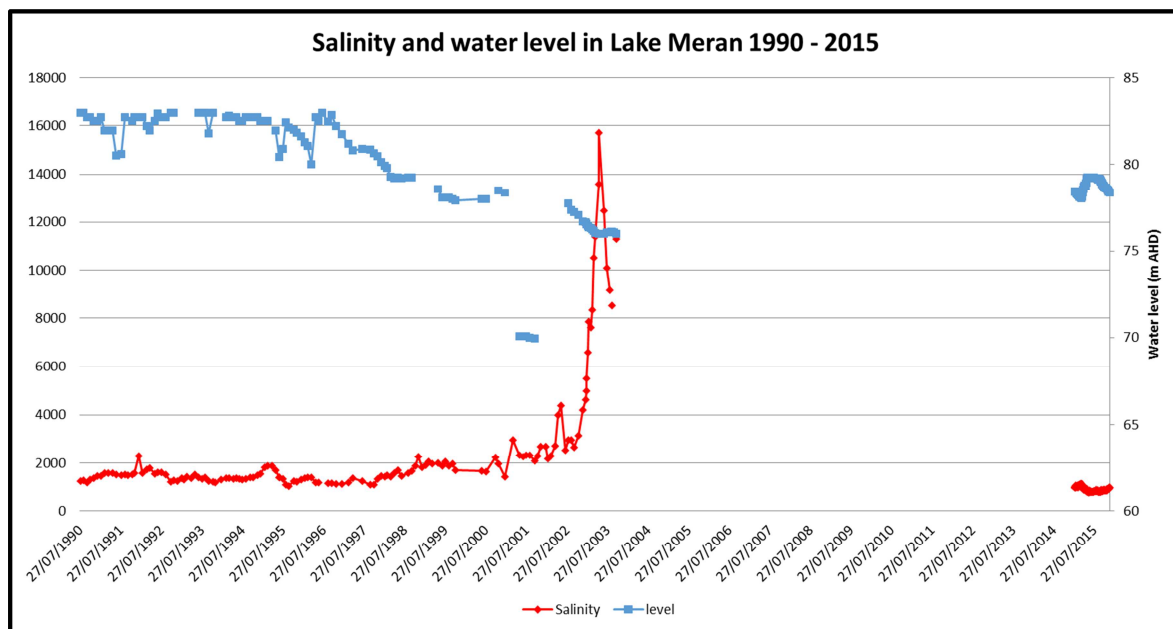
Figure 5: Plot of salinity and water level at Lake Meran from 1990 to 2015. Source: DPI and NCCMA.

Water quality measurements taken in Lake Meran between 1990 and 2015 show that electrical conductivity remained below approximately 2,000 µS/cm (EC) for most of the time and only rose above 4,000 µS/cm, when the water level dropped below 77.0 m AHD (Figure 5). The highest conductivity measured in Lake Meran was 16,000 µS/cm (EC), and that occurred in 2002/03 just before it dried out. No data were collected while the lake was dry.

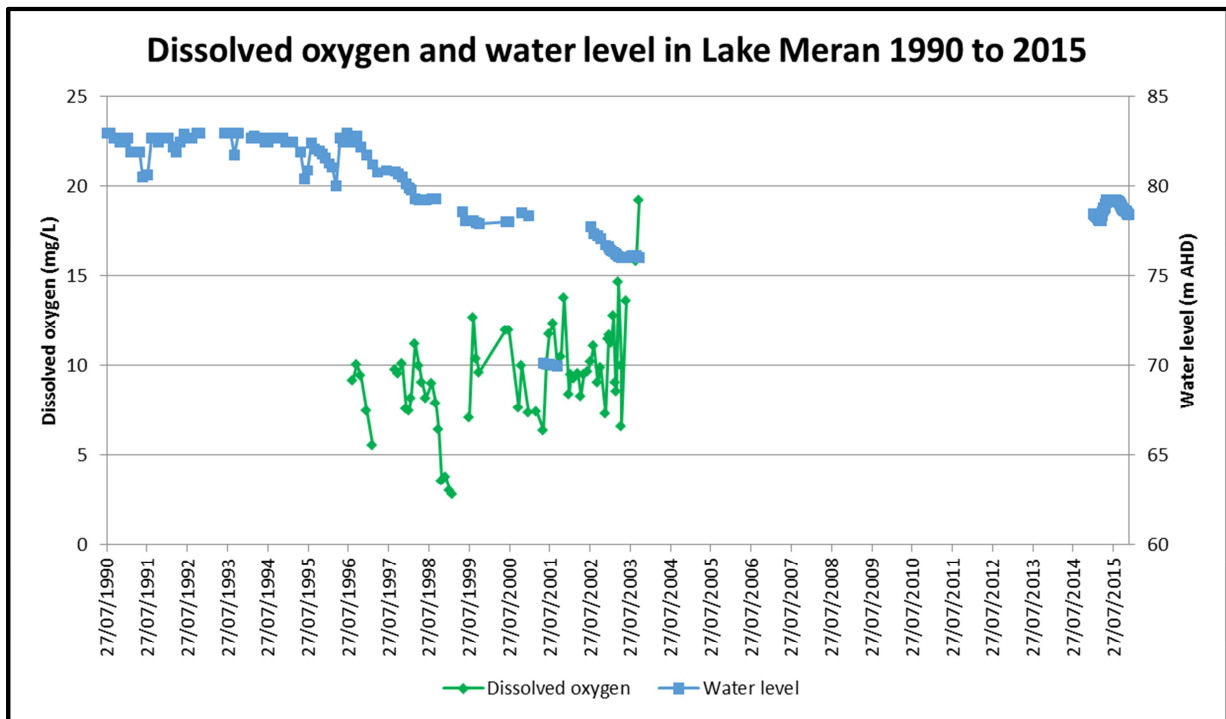
Figure 6: Plot of dissolved oxygen and water level at Lake Meran from 1990 to 2015. Source: DPI and NCCMA (water level only).

Dissolved oxygen was measured approximately monthly in Lake Meran between 1996 and 2003 (Figure 6). Dissolved oxygen concentrations in the lake have generally been within the tolerance limits for aquatic biota. The only times when dissolved oxygen concentrations have been a potential threat were between November 1998 and February 1999, when it dropped below 4 mg/L and in September and October 2003 when it was more than 15 mg/L. According to DPI data notes, these very high and very low concentrations coincided with algal blooms or large amounts of filamentous algae in the lake, rather than specific water levels. Algae photosynthesise during the day and respire at night. High concentrations of algae in standing waters often cause large daily fluctuations in dissolved oxygen with very high concentrations in the afternoon and very low concentrations first thing in the morning.

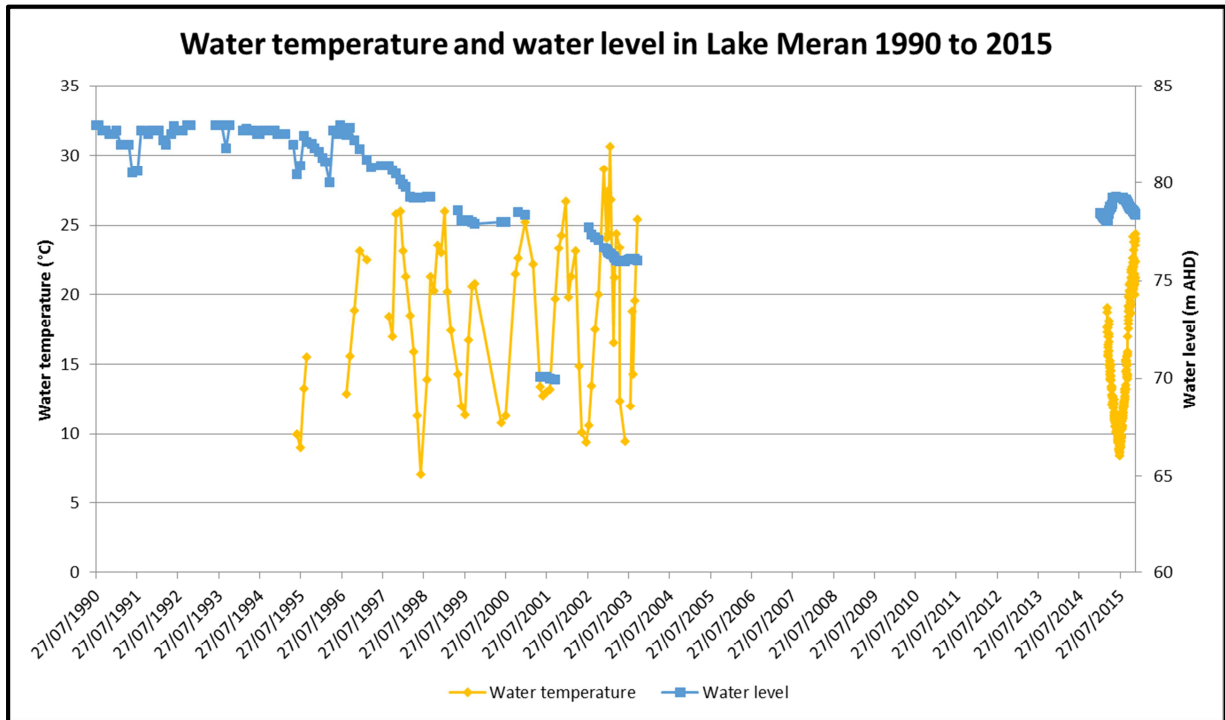
Figure 7: Plot of water temperature and water level at Lake Meran from 1990 to 2015. Source: DPI and NCCMA

Water temperature in Lake Meran followed a seasonal pattern (Figure 7). It ranged from approximately 7-12 °C in winter to approximately 25-27 °C in summer. Higher summer temperatures may occur when the lake level drops below approximately 77 m AHD, which may represent a threat to some aquatic biota.

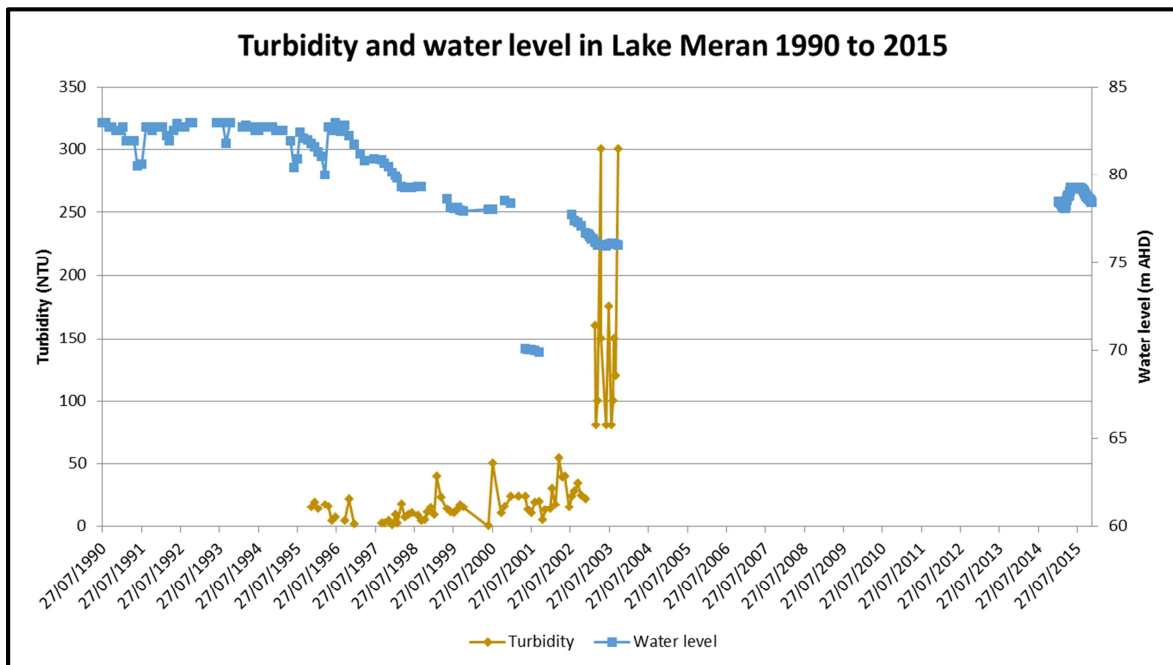
Figure 8: Plot of turbidity and water level at Lake Meran from 1990 to 2015. Source: DPI and NCCMA (water level only)

Turbidity recorded from 1990 to 2003 was generally suitable for aquatic biota. However turbidity reached very high levels just before the lake dried in 2002/03 (Figure 8).

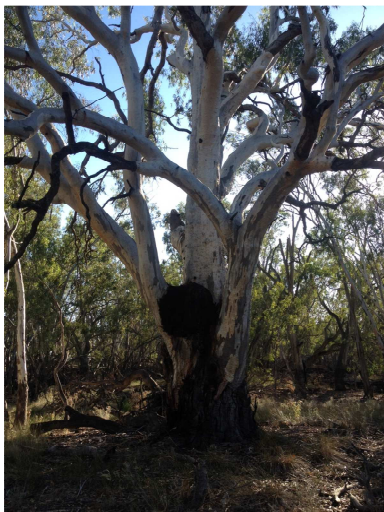
Plate 1: Large old River Red Gum in Southern Basin

Current EVC mapping is shown in Appendix D2. The dominant vegetation is Intermittent Swampy Woodland (EVC 813), which has been mapped into three distinct zones. The upper most zone has a canopy of mature River Red Gum trees (Plate 1) with an understory of small trees such as Willow Wattle (*Acacia salicina*), sedges such as Spiny Flat-sedge (*Cyperus gymnocaulos*), wetland herbs and grasses. Below this zone Intermittent Swampy Woodland is associated with Lake Bed Herbland (EVC 107) when dry and Aquatic Herbland (EVC 653) when wet. In the mid zone all the mature trees have died and the zone is characterised by a young River Red Gum canopy (Plate 2) and Lake Bed Herbland supports threatened species including FFG listed Hoary Scurf-pea (*Cullen cinereum*) and terrestrial Downy Swainson-pea (*Swainsona swainsonioides*) (Rakali Ecological Consulting, 2015). The lowest zone, occurring in the deeper areas of the wetland, has no live trees, although there are stumps on the wetland bed. Aquatic Herbland also occurs in the lowest zone and is characterised by very small patches of aquatic herbs such Red Water-milfoil (*Myriophyllum verrucosum*).

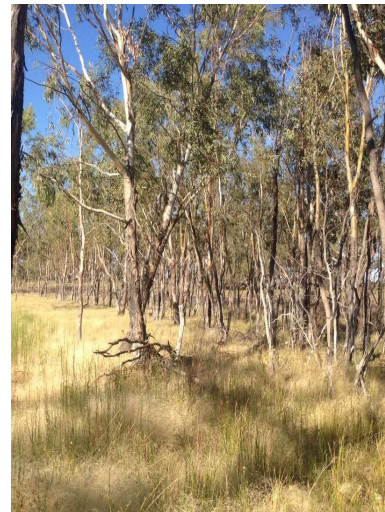
Plate 2: River Red Gum regeneration in the southern basin

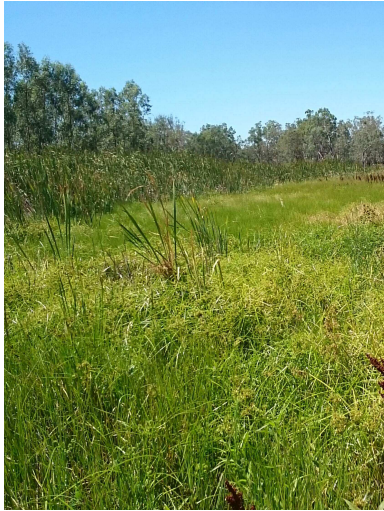
Plate 3: Tall Marsh and extensive stand of Club Rush in southern basin

The upper creek line that carries water through the southern basin of Lake Meran has elements of Tall Marsh (EVC 821), which is characterised by Cumbungi (*Typha spp.*) and Giant Rush (*Juncus ingens*) (Plate 3). The mid creek line that carries water through the middle basin has elements of Floodway Pond Herbland (EVC 810), which is dominated by Knotweed (*Persicaria spp.*) (Plate 4) (Rogers L. personal observation 2016 [North Central CMA], February). Large areas of Marsh Club-rush (*Bolboschoenus caldwellii*) are also located adjacent to the primary creek line in both the southern and the middle basins (Rogers L. personal observation, [North Central CMA], February 2016) (Plate 3).

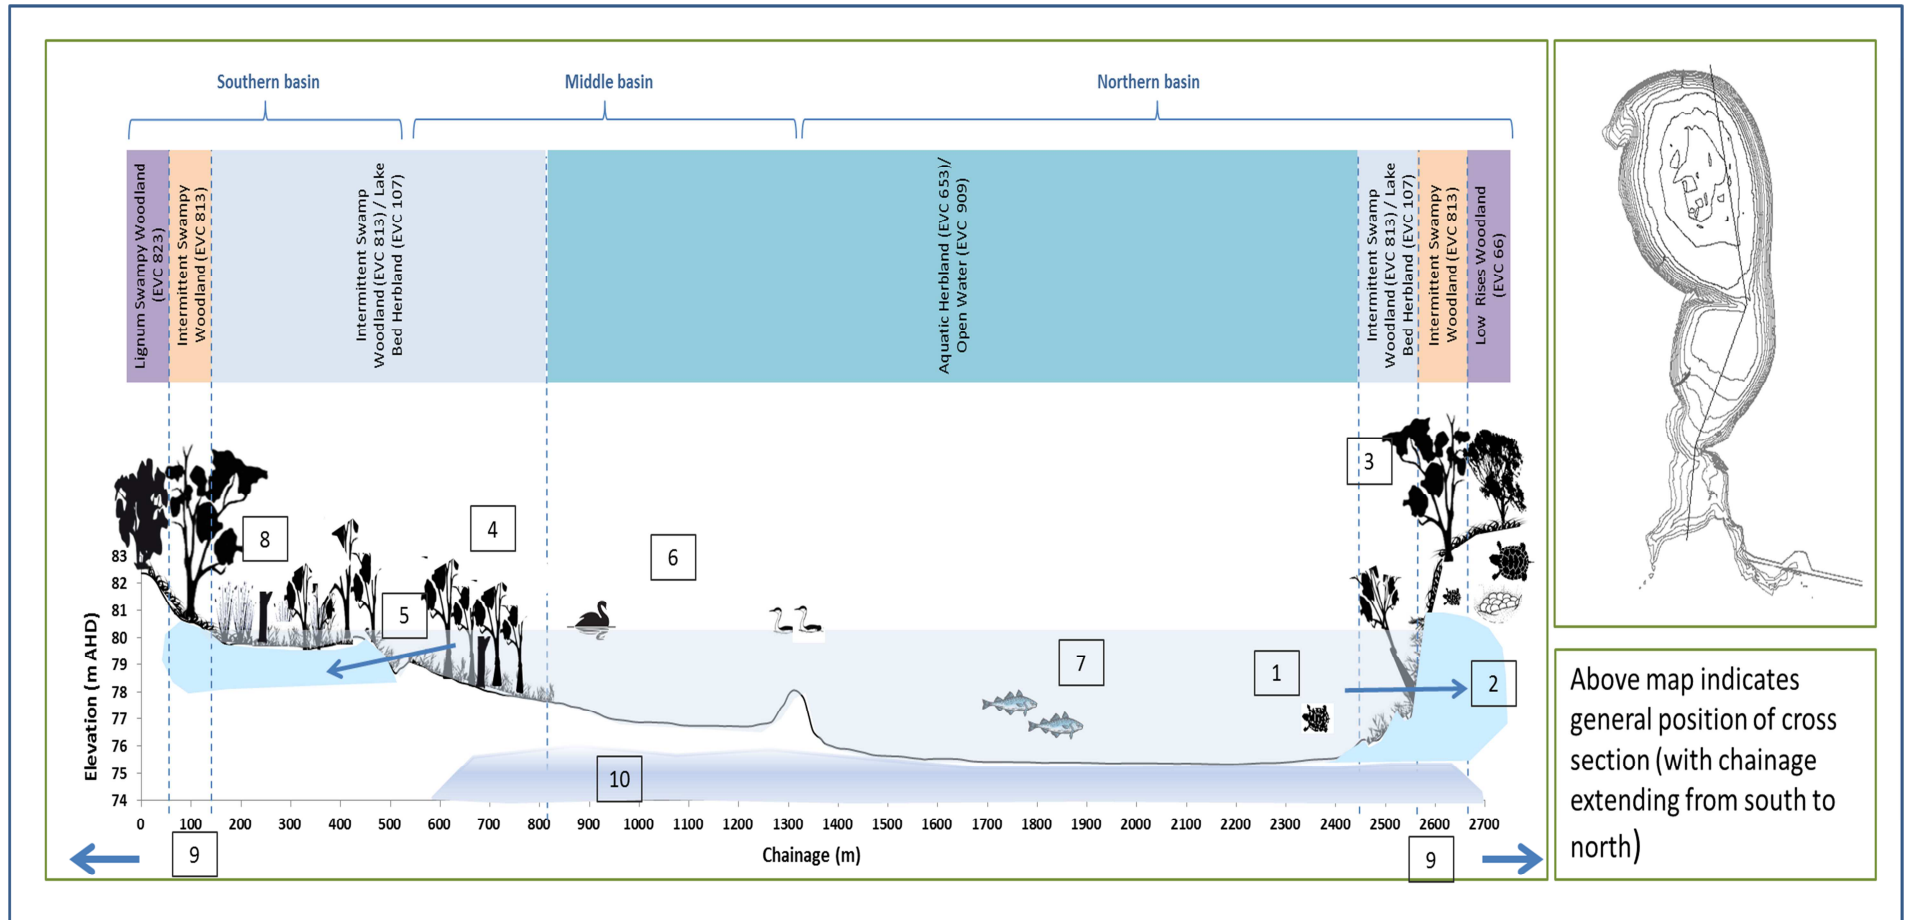
Figure 9: Cross section indicating conceptual understanding of Lake Meran ecology

10. A freshwater lens is located under Lake Meran indicating groundwater seepage has occurred over time. The current seepage rate is negligible (see Section 3.3 and two bores adjacent to the wetland will be monitored on an ongoing basis to assess changes to groundwater/ surface water interactions going forward.

The EWMP conceptualises the values and ecological functions for Lake Meran and Little Lake Meran (Figure 9 and Figure 10 respectively) as these are the two wetlands that the CMA can deliver environmental water to. The numbers in the figures are described on the page following each figure.

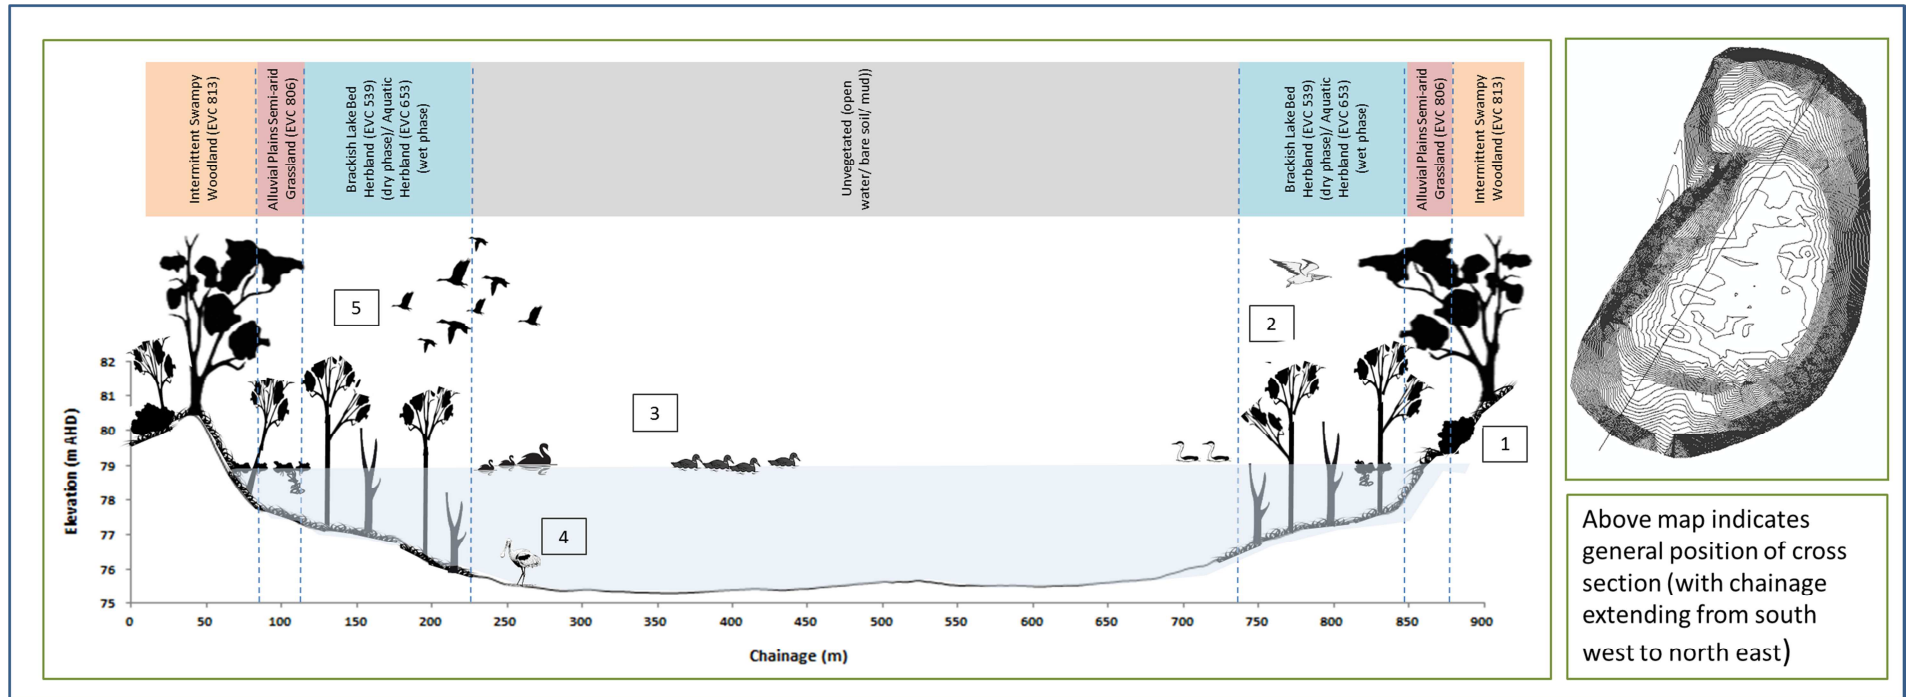
Figure 10: Cross section indicating conceptual understanding of Little Lake Meran ecology

1. Little lake has large old River Red Gum trees persisting in a narrow band higher on the wetland profile, their location evidence of the high water levels that Lake Meran has been managed at for many years.

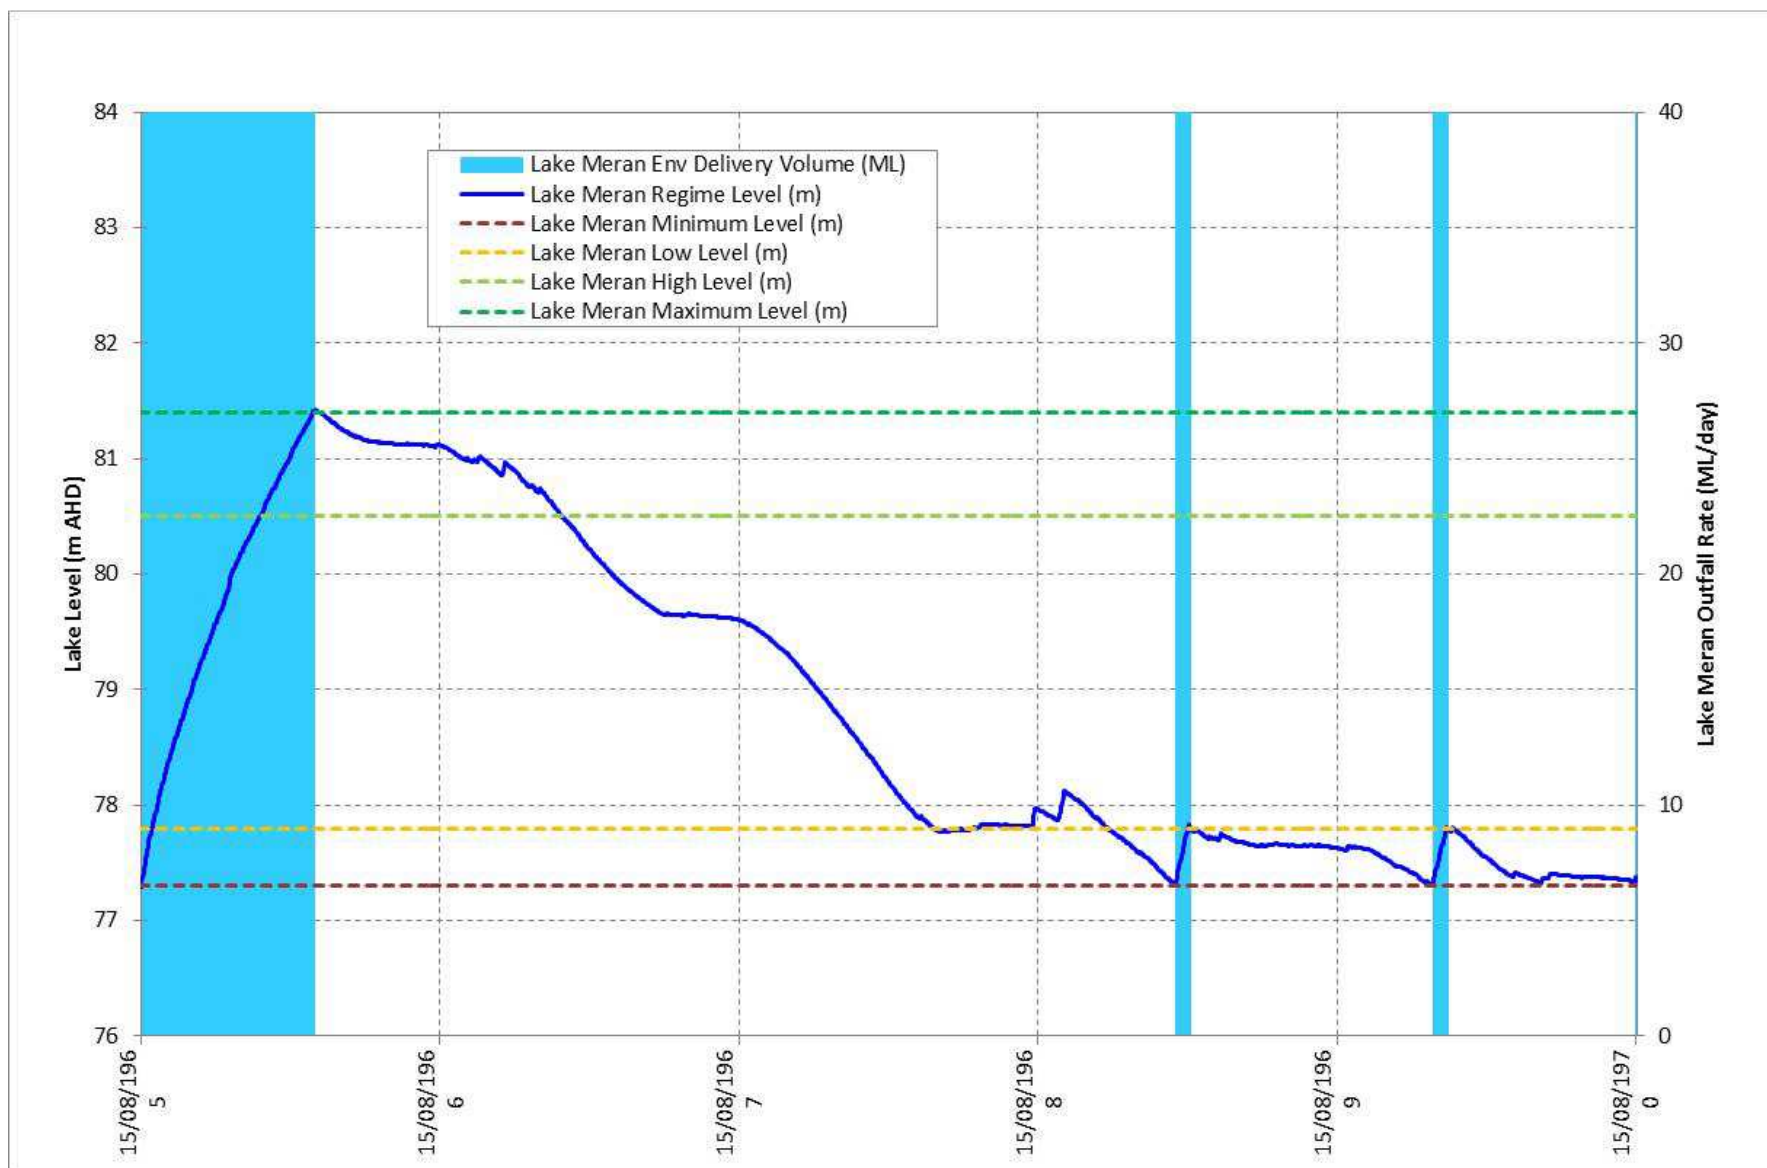
Figure 11: Lake Meran Optimum Environmental Water Regime hydrograph for one five year cycle

Dry period: Allow exposed lake bed above 77.8 mAHD to dry completely for up to one year.

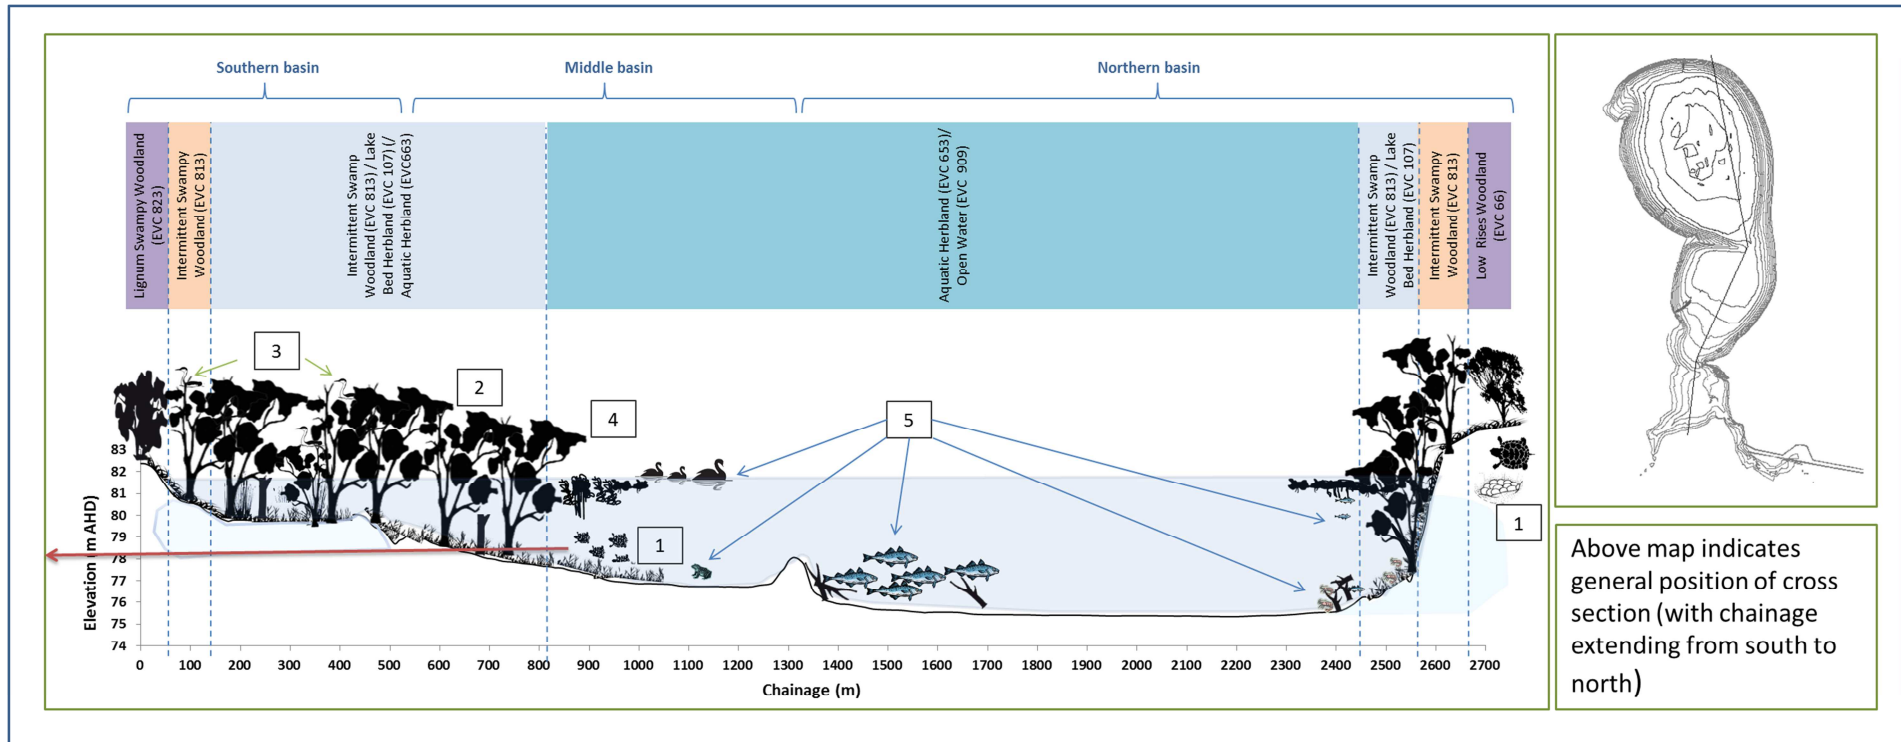
Figure 12: The conceptual vision for Lake Meran when at the maximum level that will be achieved by the proposed water regime

Figure 12 and Figure 13 pictorially represents the vision of Lake Meran after the implementation of the water regime described above achieves the ecological objectives, subject to the implementation of complementary actions outlined in Section 8.

1. Successful recruitment of Murray River Turtles continues and Lake Meran is possibly a source population for the Loddon River Basin when the system is in flood (connectivity via Pickles Canal and Wandella Creek).

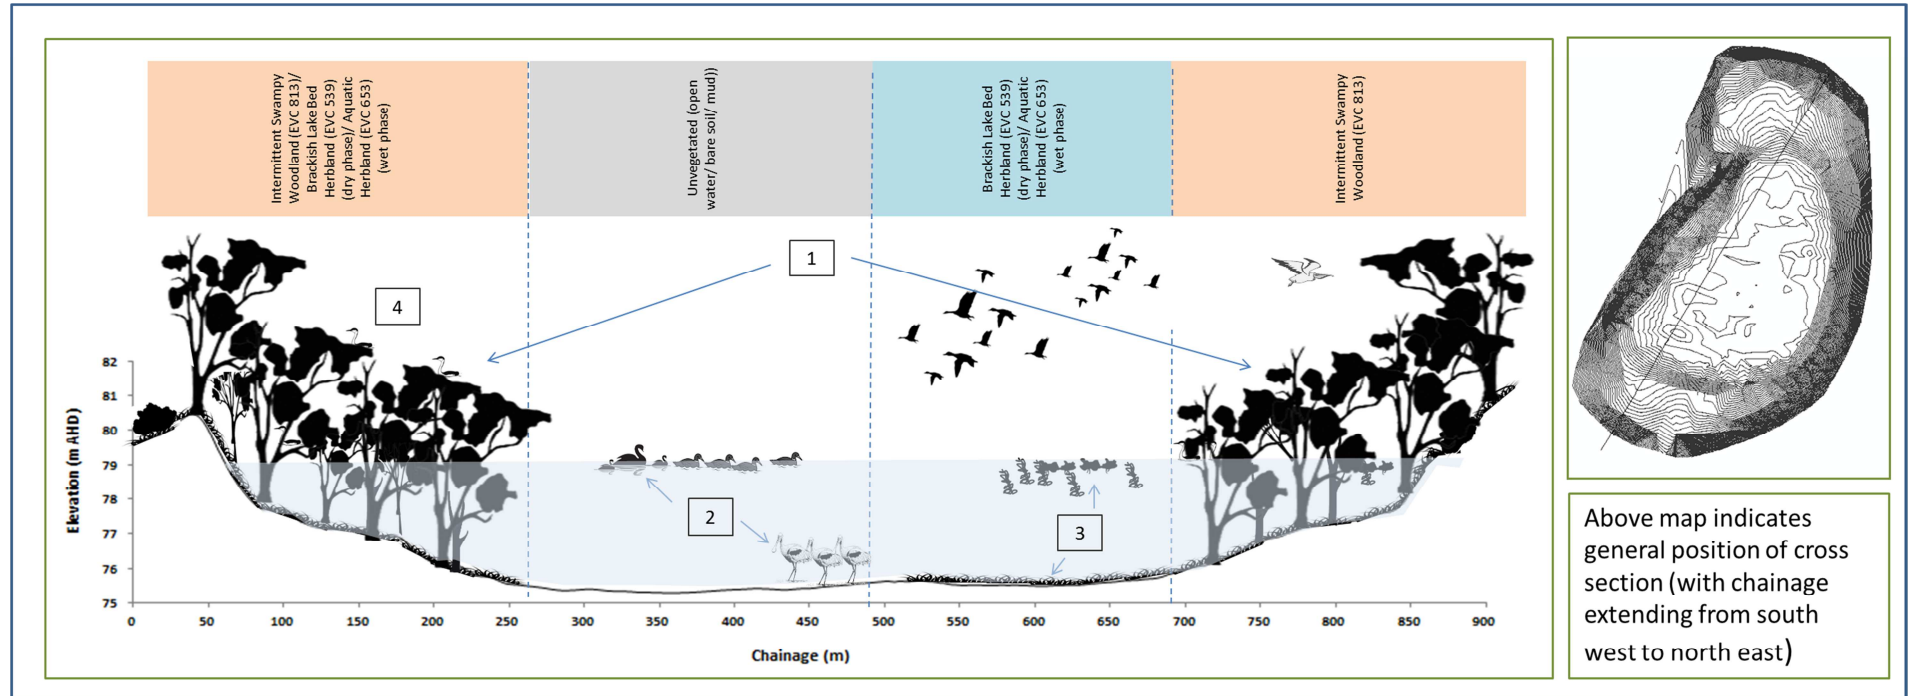
Figure 14: The conceptual vision for Little Lake Meran that will be achieved by the proposed water regime

Figure 14 pictorially represents the vision of Little Lake Meran after the implementation of the water regime described above achieves the ecological objectives, subject to the implementation of complementary actions outlined in Section 8.

1. Intermittent Swampy Woodland extends down the wetland profile where maximum inundation level is around 2.5 to three metres. The extension of this EVC will provide structure, feeding and breeding habitat, shading and carbon to the wetland.

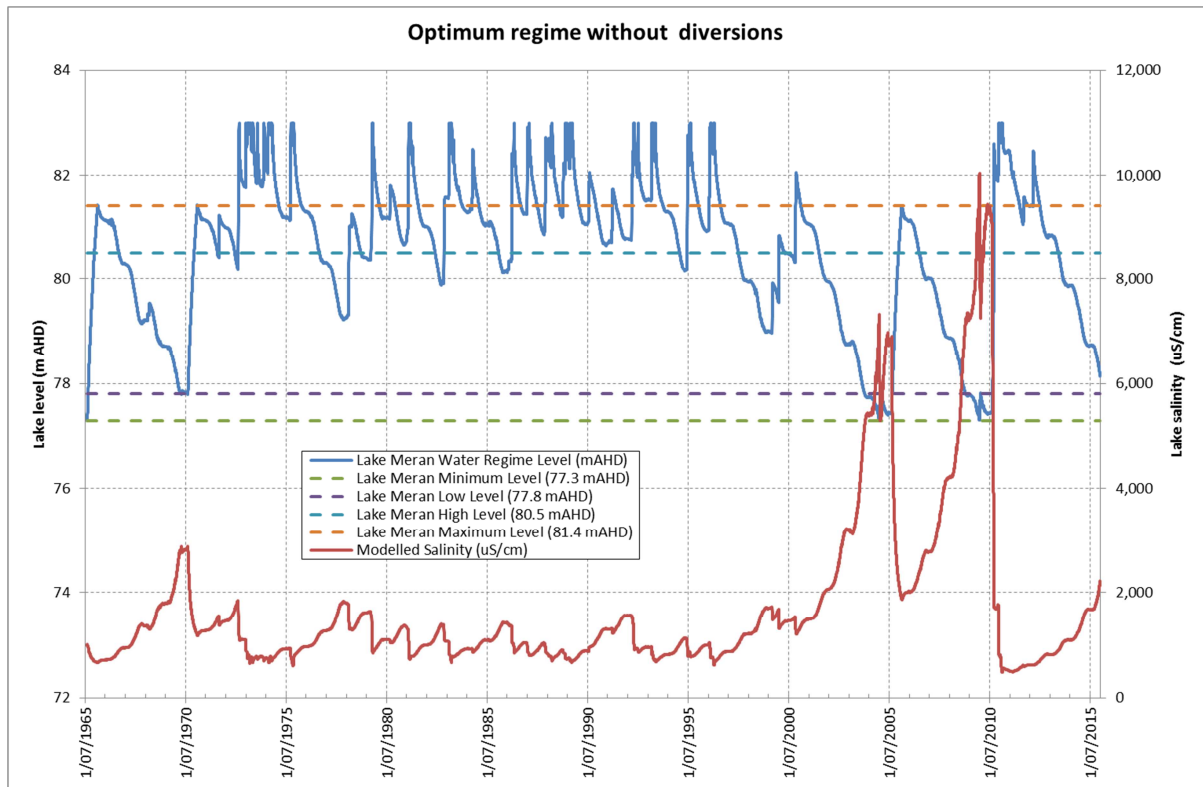
Figure 15: Optimum regime without diversions delivered over historic climate showing salinity peaks if water regime had been delivered over the Millennium Drought.

⁸ The CMA acknowledges that the modelled flooding frequency and magnitude of flooding does not align with the local community's knowledge, as documented in Section 3.2 of the Meran Lakes Complex EWMP, or the physical capacity of the outlet infrastructure. However, the salinity risk assessment and management strategies documented in the EWMP are not informed by the modelled flooding frequency or magnitude but rather by the modelled salinity response during extended dry periods. The modelling difference is due to the way flow data from the Loddon River were modelled through the State approved Wandella Creek REALM model and is not due to issues with the data itself.

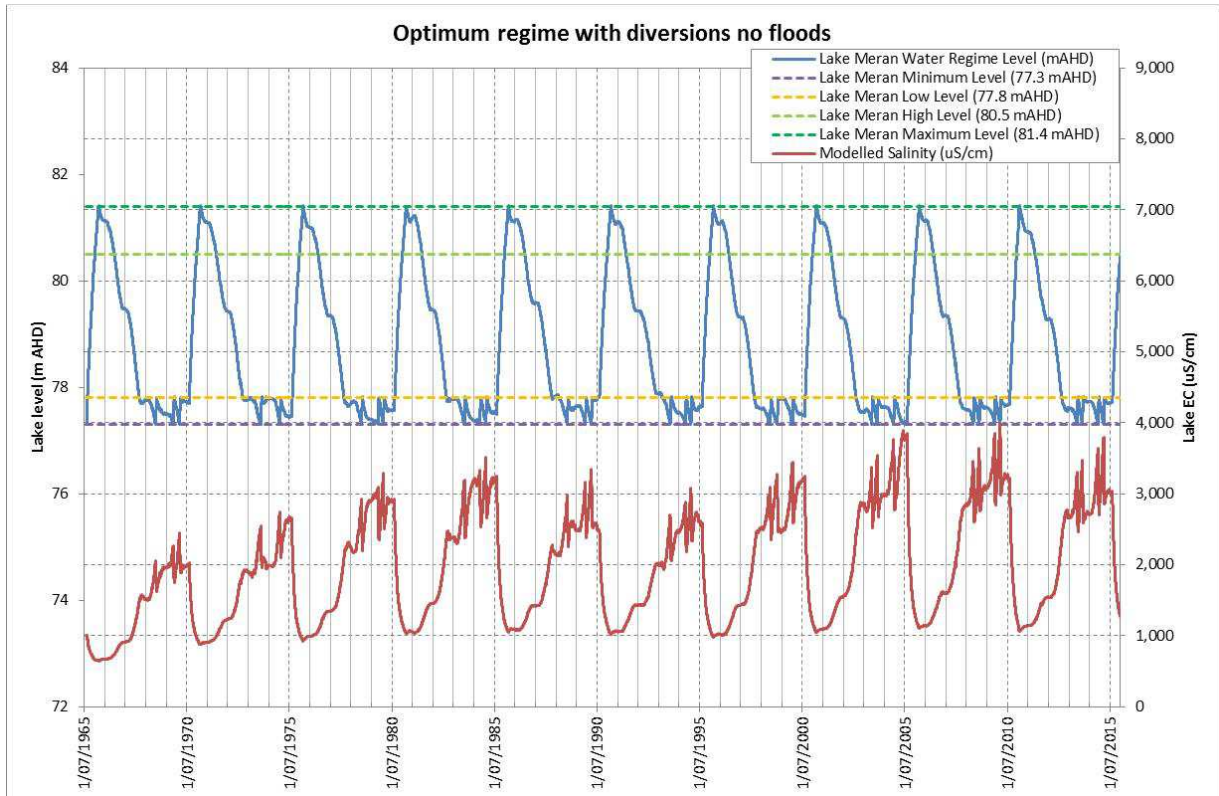
Figure 16: Optimum regime with water extraction delivered over the historic climate assuming no floods

Water extraction when the wetlands are drawing down from the maximum to the minimum levels was confirmed as the appropriate mitigation option to retain salinity under the selected salinity threshold for a freshwater ecosystem. The CMA requested a scenario that modelled a hypothetical (extremely unlikely) period of 50 years with no floods for Lake Meran (Figure 16). The model output from this scenario demonstrated the water quality remained well within the threshold for the entire period (Figure 16).
