Corangamite Region

Index of Stream Condition

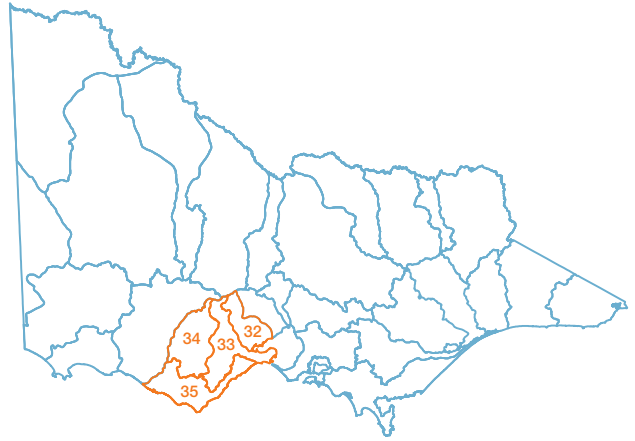
- Excellent
- Good
- Moderate
- Poor
- Very Poor
- Insufficient Data

- / Moorabool – basin 32 (part)
- / Barwon – basin 33
- / Corangamite – basin 34
- / Otway – basin 35
